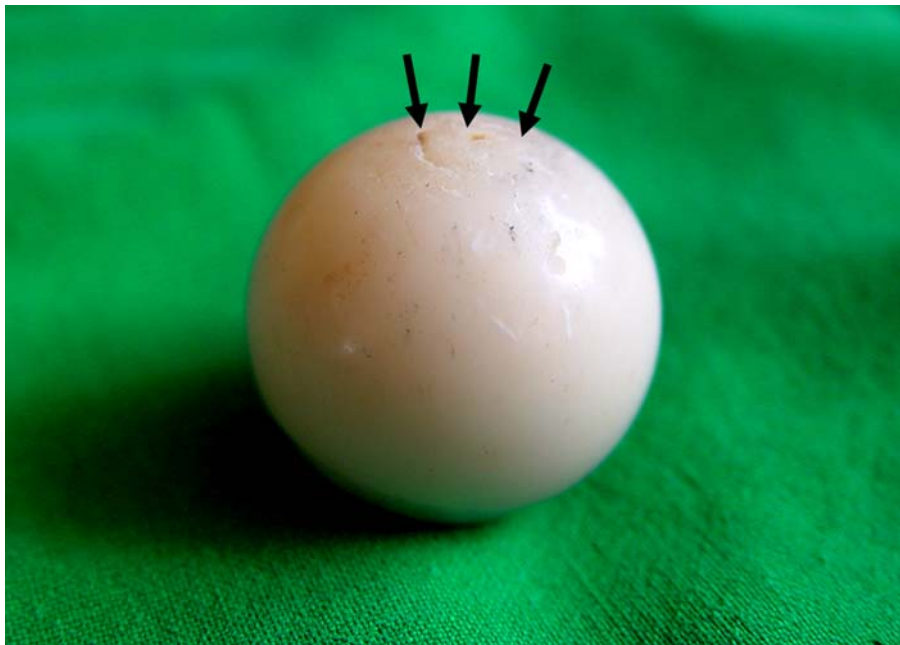
Fig. E-1A

**Figs. E1-A and E1-B** Case 5. Photograph and scanning electron microscopic images showing the retrieved alumina head. **Fig. E1-A** Photograph of the retrieved alumina head, showing some surface scratches (arrows).

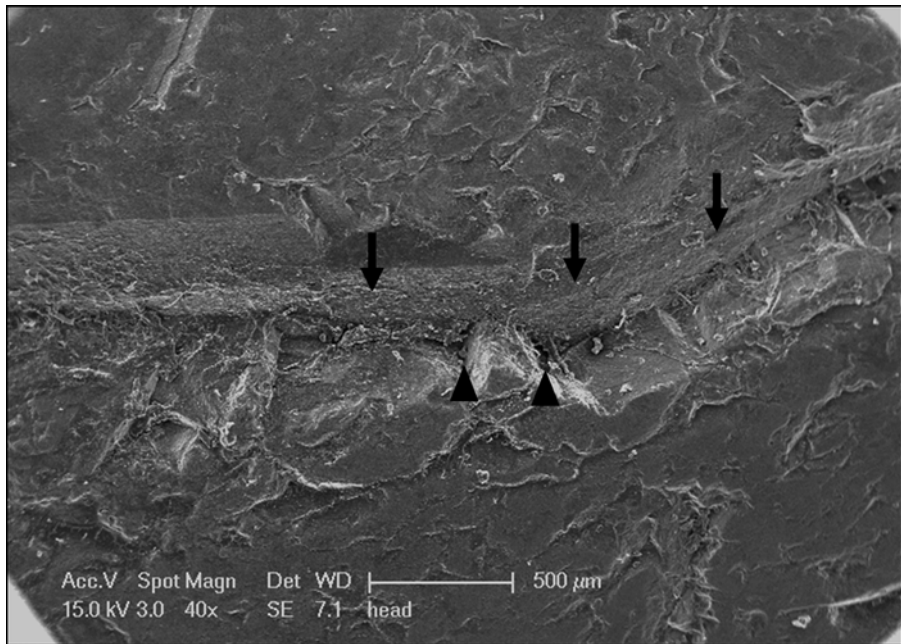
Fig. E-1B

Scanning electron microscopic image of the loaded area of the retrieved alumina head, showing machine tracks (arrows) and cracks (arrowheads).

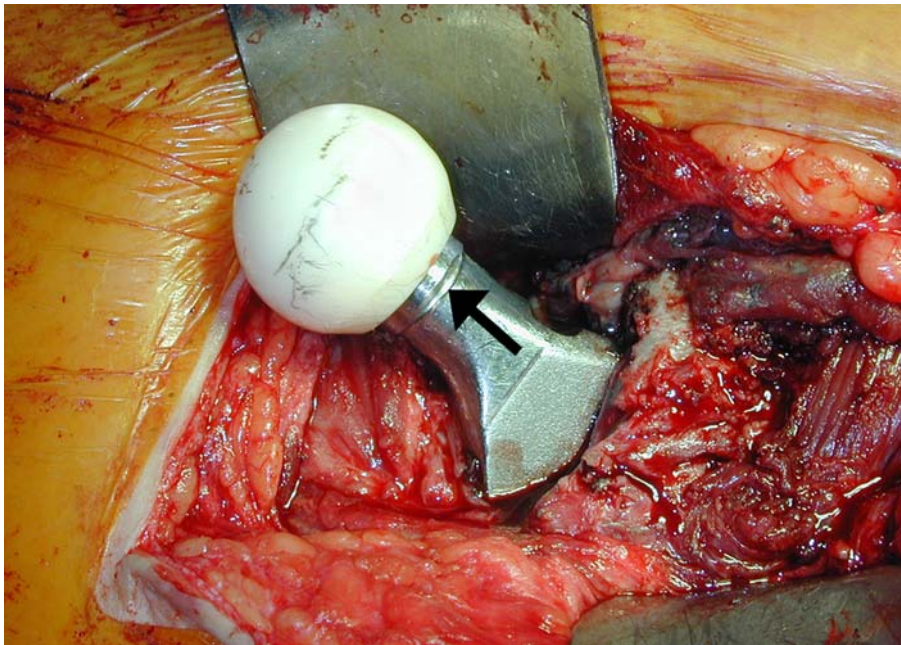
Fig. E-2

Case 4. Intraoperative photograph showing a deep notch (arrow) on the anterior aspect of the femoral neck.
