Supplemental Image 1 – Continued valgus talar tilt despite lateral column and syndesmotic fixation

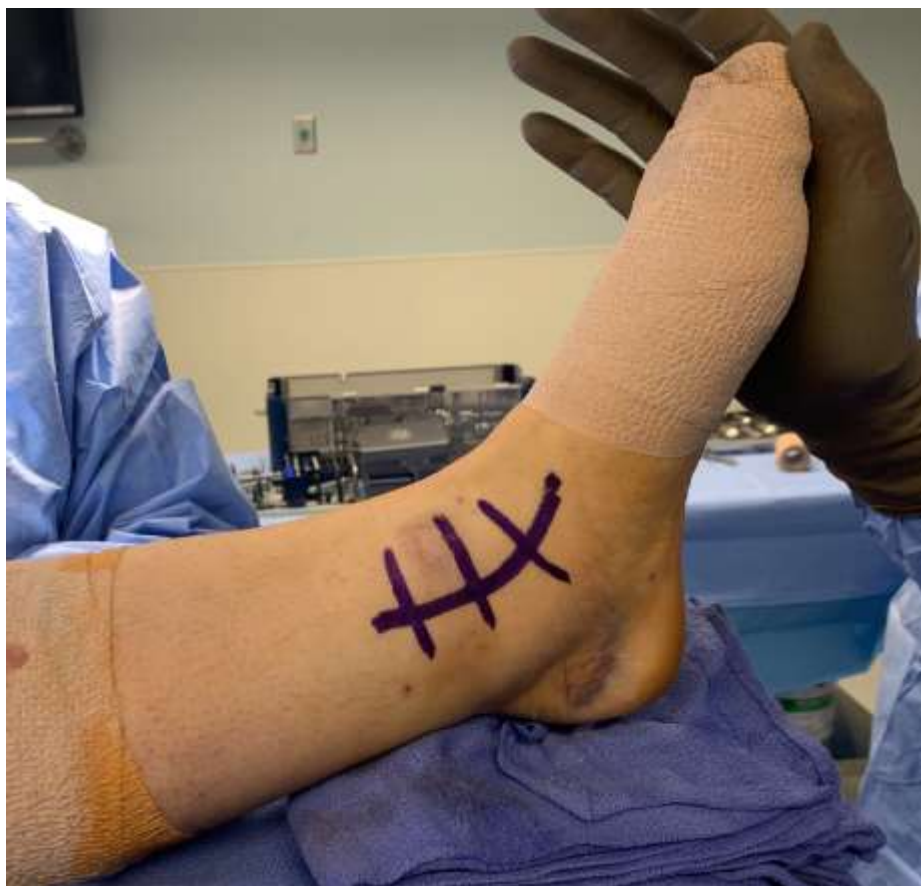
Supplemental Image 2 – Curvilinear incision at medial ankle

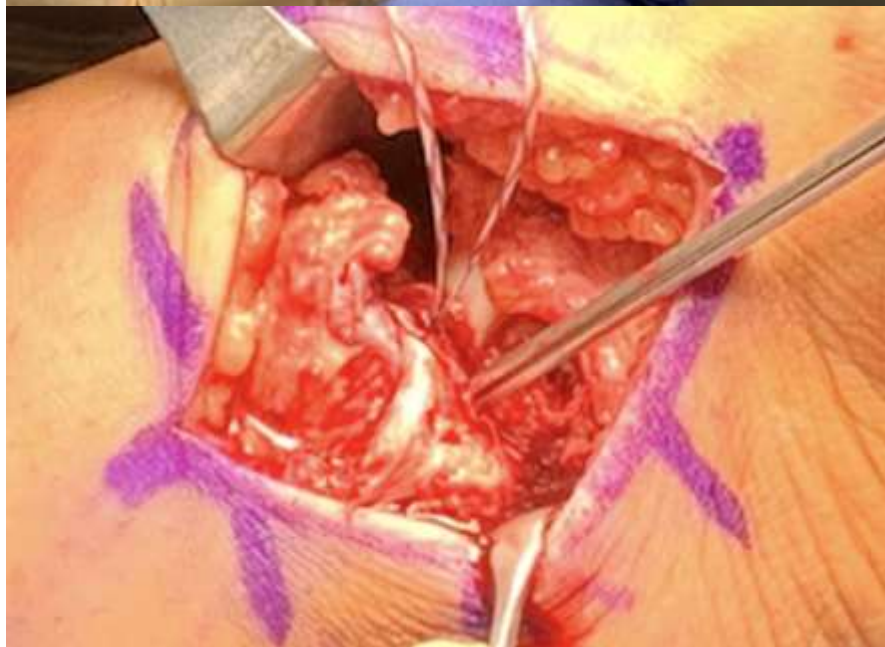
Supplemental Image 5 – Drilling two suture anchors 1 cm apart from each other at tip of the medial malleolus (with zoomed in version).

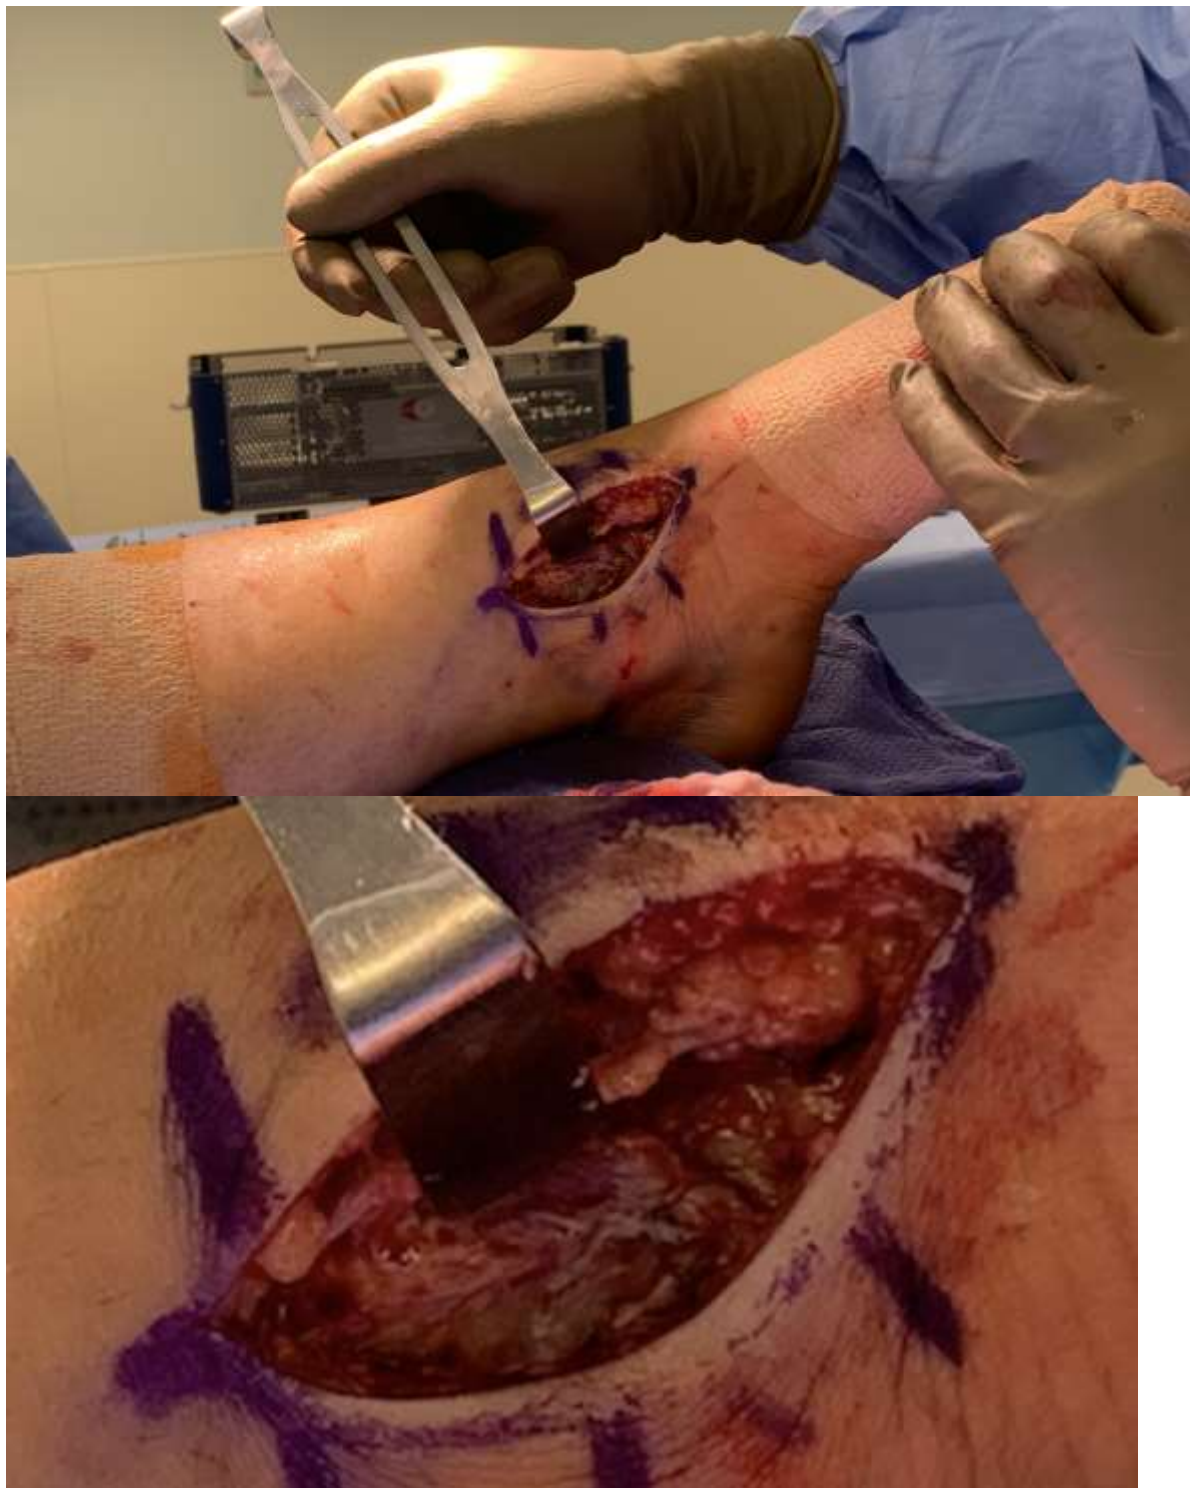
Supplemental Image 8 – Repair demonstrating confluence of deltoid ligament tissue (with zoomed in version).

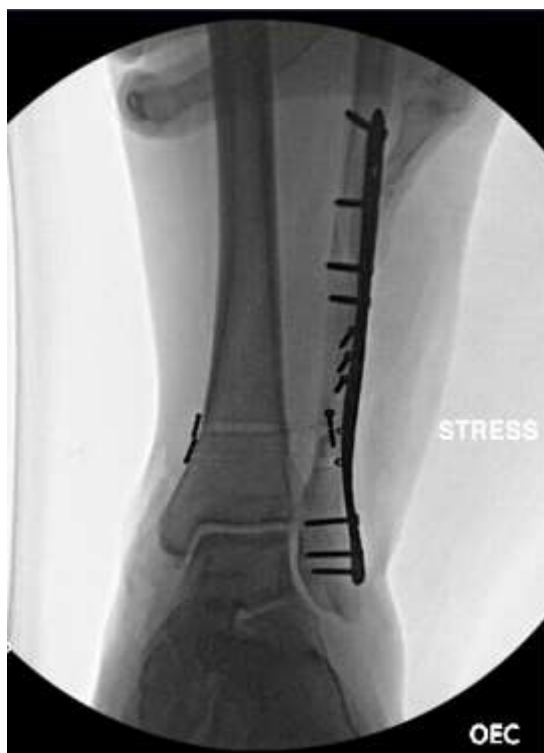
Supplemental Image 9 – Stable ankle mortise after deltoid ligament repair
