Figs. E-1A, E-1B, and E-1C Anteroposterior and outlet radiographs of a displaced, valgus impacted four-part fracture of the proximal part of the humerus in an eighty-eight-year-old woman with a local bone density of 56.41 mg/cm³. **Fig. E1-A** Preoperative radiographs. **Fig. E1-B** Radiographs made after fixation of the fracture with a five-hole plate in anatomical alignment; medial cortical support (red arrow) was not achieved because the shaft was impacted into the head fragment.

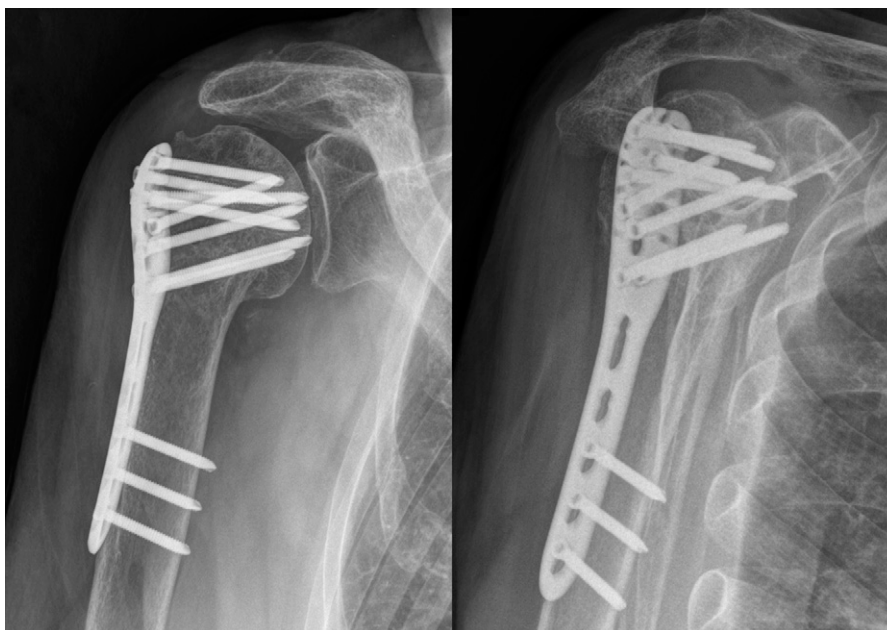
Fig. E-1C

Fig. E1-C Radiographs made at the one-year follow-up evaluation show subsidence of the head fragment with minimal protrusion of some screws without corresponding erosion of the glenoid. The patient had good clinical function.
