Appendix

Detailed Description of Radiographic Analysis of Humeral and Glenoid Implants

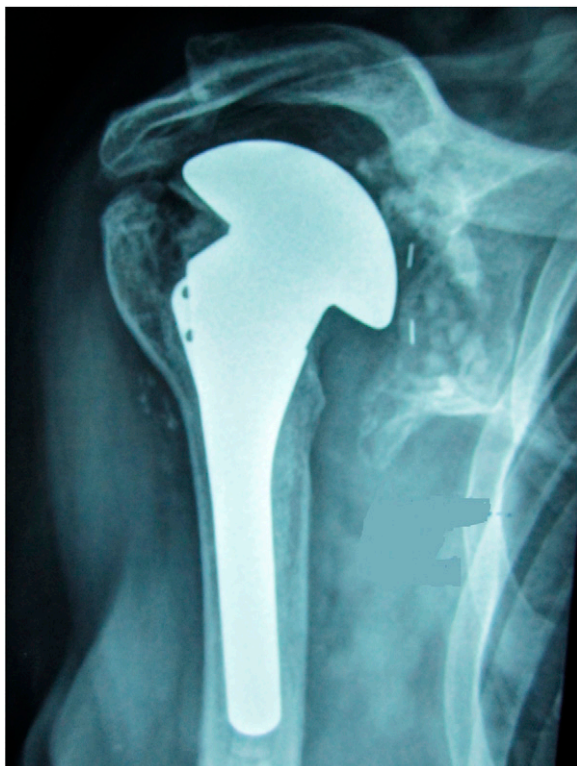
Fig. E-1
Anteroposterior radiograph of a right shoulder made ten years after im-
plantation of a cemented total shoulder replacement with a flat-backed
glenoid component. There is evidence of glenoid subsidence and complete
osteolysis of the greater tuberosity and the calcar.

1. Osteolysis of the greater tuberosity and/or the calcar was rated as none, partial, or complete. The definition of complete osteolysis was total resorption of the greater tuberosity and/or lesser tuberosity, so that parts of the proximal part of the stem or cement mantle were not covered by bone. Partial osteolysis was defined as partial resorption of the greater tuberosity and/or calcar when the proximal part of the stem and/or cement mantle was covered by bone.

5. Tilting or subsidence of the humeral and glenoid component (tilt or subsidence resulted in the maximum score for radiolucent lines) was diagnosed if both reviewers detected a change in the position of the implant⁶.

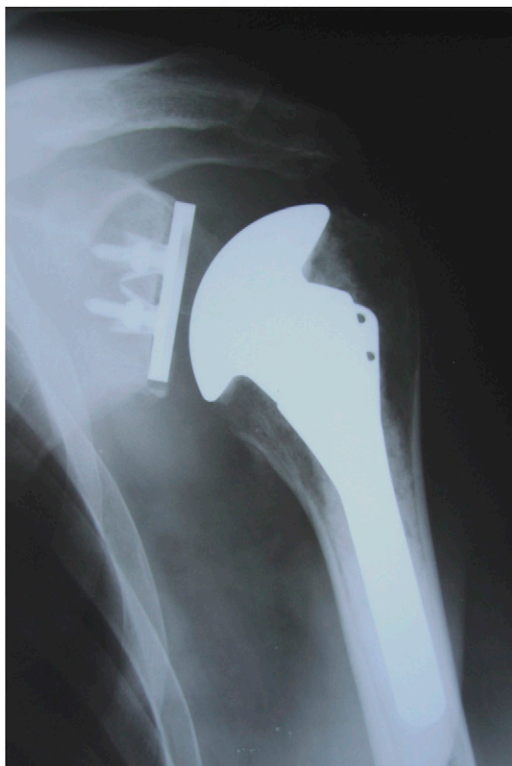
Fig. E-2A

Figs. E-2A and E-2B A patient who had a total shoulder replacement on the left side with a cemented stem and an uncemented glenoid component. **Fig. E-2A** Anteroposterior radiograph made immediately after the operation. **Fig. E-2B** Anteroposterior radiograph made nine years postoperatively. There is complete wear of the polyethylene, with metal-on-metal contact between the humeral head and the glenoid component. Osteolysis of the greater tuberosity and the calcar is also present.

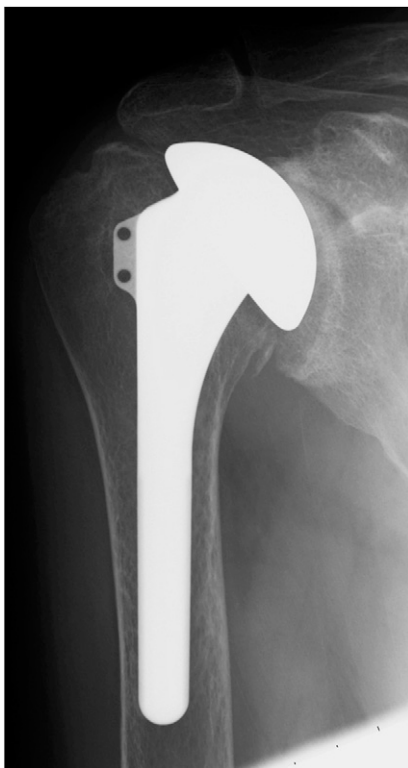
Fig. E-3A

Figs. E-3A and E-3B A patient who had an uncemented hemiarthroplasty in the right shoulder. **Fig. E-3A** Anteroposterior radiograph made immediately after the operation. There is no evidence of bone resorption around the stem. **Fig. E-3B** Anteroposterior radiograph made four years postoperatively. The bone in the metaphysis has become less dense, and there is some bone resorption around the fin of the proximal part of the stem.
