Figs. E-1A, E-1B, and E-1C A patient with a terrible triad injury of the elbow and a displaced crista supinatoris fracture. **Fig. E-1A** Anteroposterior and lateral radiographs showing the unstable terrible triad injury. **Fig. E-1B** An axial CT image visualizes the displaced crista supinatoris fracture.

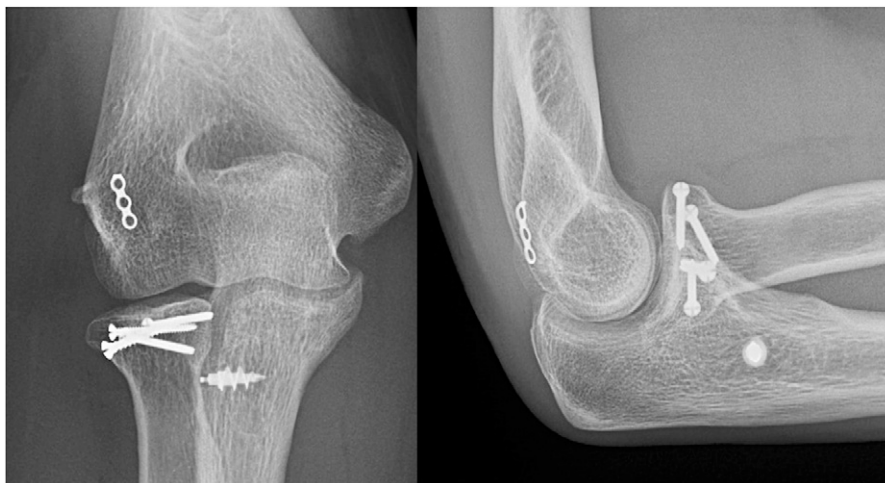
Fig. E-1C

The patient was managed with open reduction and internal fixation of the radial head and suture anchor fixation of the crista fracture. The common extensor tendon origin, which was also partially torn, was secured to the lateral epicondyle via transosseous sutures tied over a minimifragment plate placed on the posterior humeral cortex.

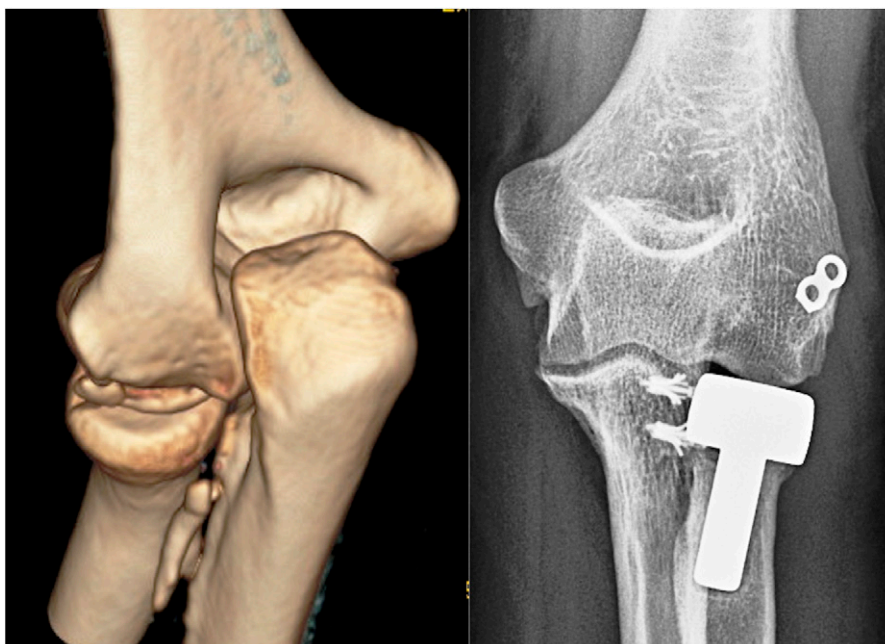
Fig. E-2

A three-dimensional CT scan of a patient with a comminuted unstable radial head fracture associated with elbow instability and a displaced crista supinatoris fracture who was managed with metallic radial head arthroplasty and suture anchor fixation of the crista fracture (left). The radiograph (right) shows the securing of the common extensor tendon origin, which was also partially torn, to the lateral epicondyle via transosseous sutures tied over a minimifragment plate placed on the posterior humeral cortex.

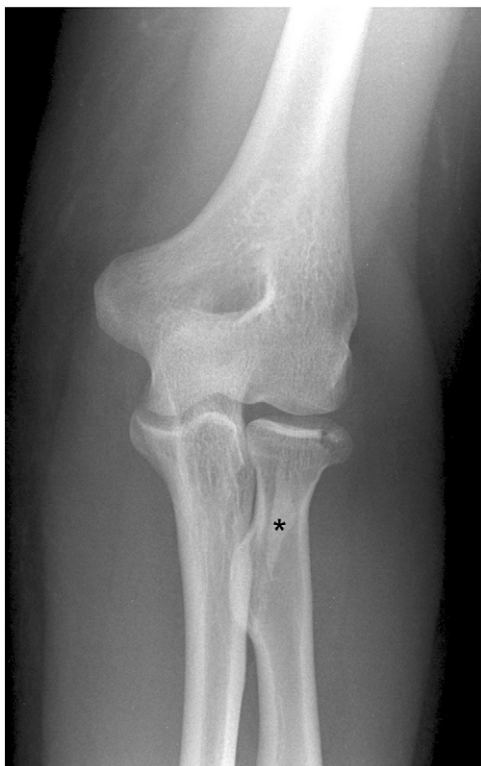
Fig. E-3A

Figs. E-3A through E-3D A patient who sustained a radial head fracture and a displaced crista supinatoris fracture in a fall from a standing height. **Figs. E-3A and E-3B** Anteroposterior and lateral radiographs of the elbow, depicting a minimally displaced radial head fracture and a displaced crista supinatoris fracture that is difficult to visualize (asterisk).

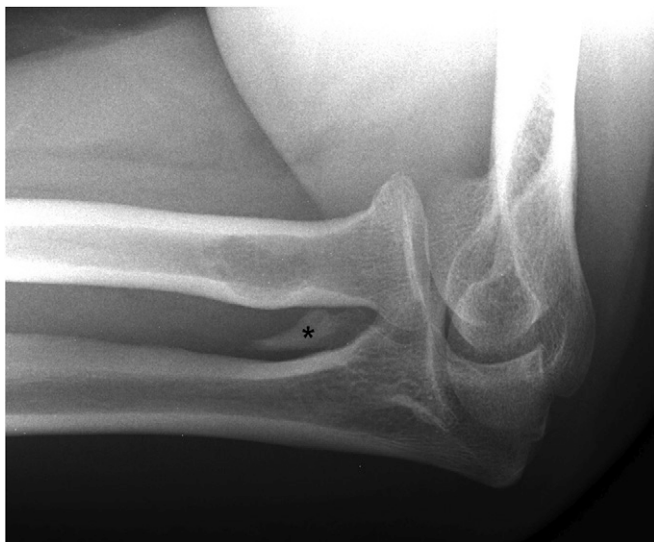
Fig. E-3C An external oblique radiographic view of the elbow appropriately visualizes the crista fracture (asterisk). **Fig. E-3D** A three-dimensional CT scan also shows the crista fracture.
