Figs. E1-A through E1-F Case 16. Anteroposterior (**Fig. E1-A**) and lateral (**Fig. E1-B**) elbow radiographs showing suspicious early loosening of the humeral component two years after primary total elbow arthroplasty.

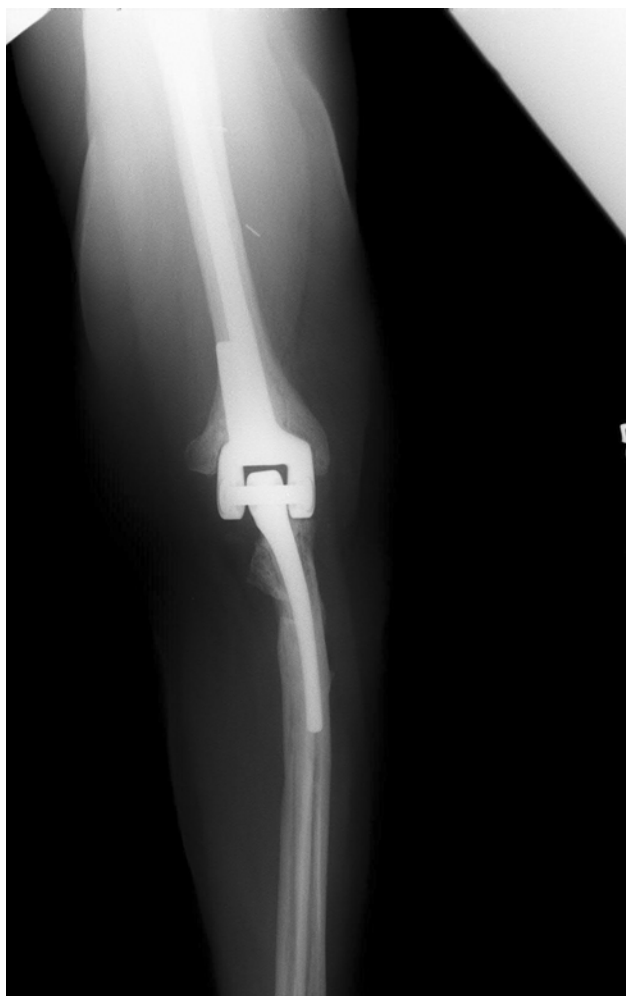
Fig. E1-C

Anteroposterior (**Fig. E1-C**) and lateral (**Fig. E1-D**) postoperative elbow radiographs made after index revision of the humeral component. Intraoperative culture yielded an unexpected growth of *Staphylococcus epidermidis*.

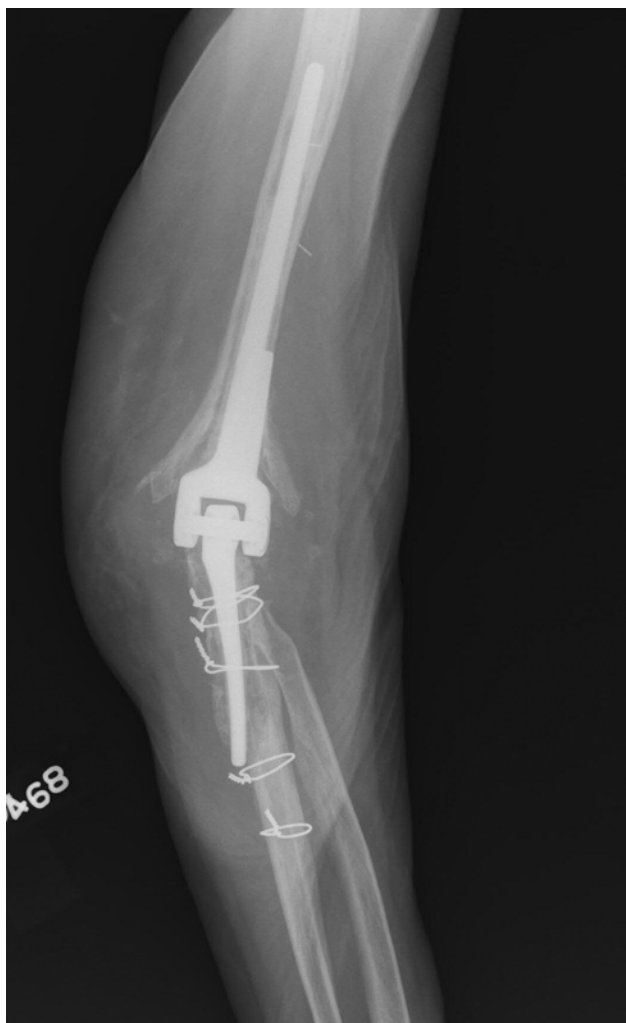
Fig. E1-E

Anteroposterior (**Fig. E1-E**) and lateral (**Fig. E1-F**) elbow radiographs made eight years after the index revision, showing repeat loosening of the pre-coated ulnar component. (The patient had a strut allograft fixation of the ulna to treat a periprosthetic fracture during the eight-year interim period.)
