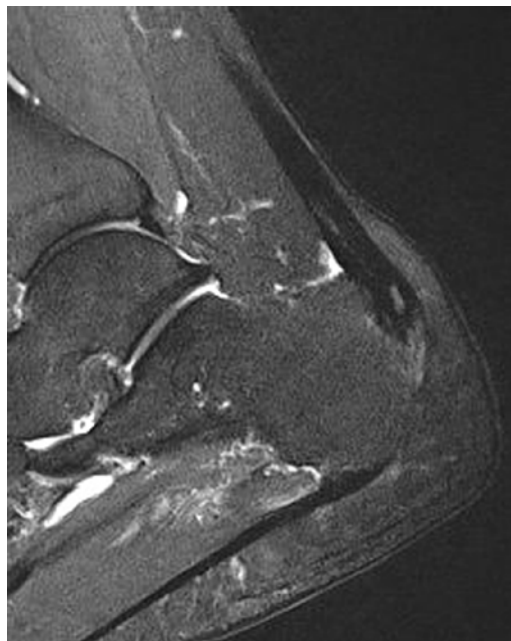
Fig. E-1

Sagittal magnetic resonance image showing a large insertional exostosis, gross thickening of the Achilles tendon, and intrasubstance degeneration involving the distal 3 cm of the tendon.

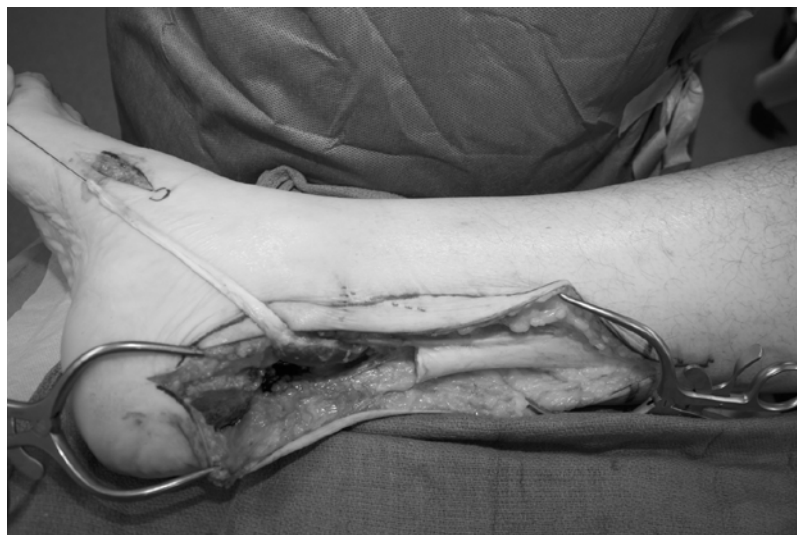
Fig. E-2

Photograph showing that the flexor hallucis longus has been harvested from the midfoot in preparation for transfer. An area of severe distal Achilles tendinosis has been resected.

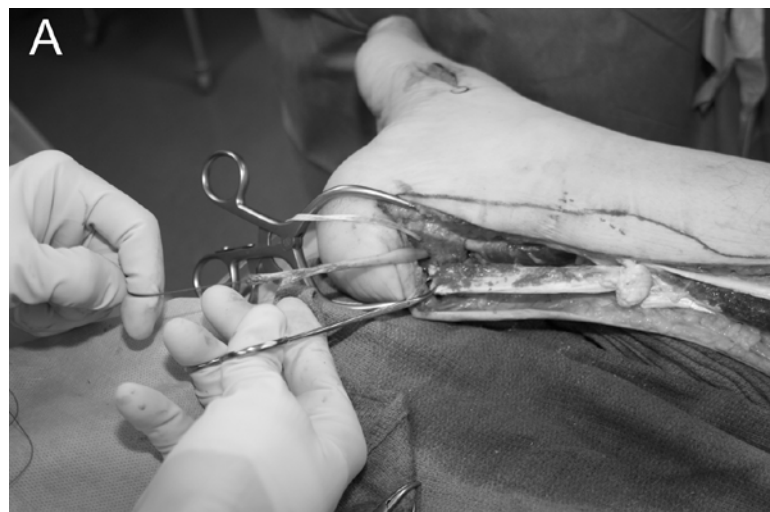
Fig. E-3A

Figs. E3-A through E3-C The Achilles tendon turndown procedure is performed in conjunction with flexor hallucis longus transfer. **Fig. E3-A** A central one-third Achilles tendon turndown has been done to span the Achilles tendon defect. The flexor hallucis longus has been passed through convergent bone tunnels in the posterior calcaneus.

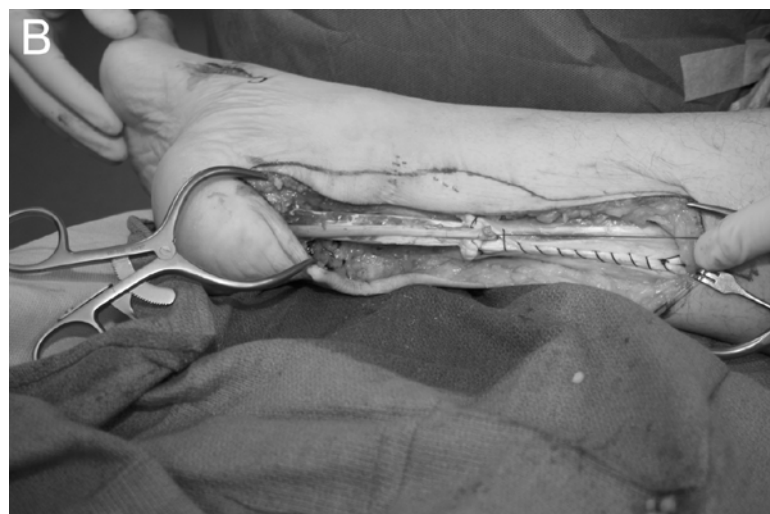
Fig. E3-B

The turned-down segment of the Achilles tendon has been fixed to the calcaneus with use of suture anchors. The flexor hallucis longus is shown coursing back proximally out of the calcaneal bone tunnel.

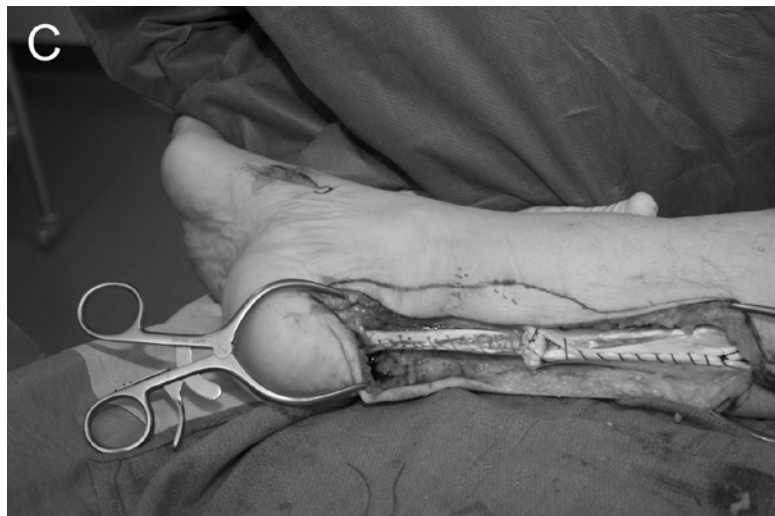
Fig. E3-C

The turned-down segment of the Achilles tendon has been tubularized around the flexor hallucis longus tendon.
