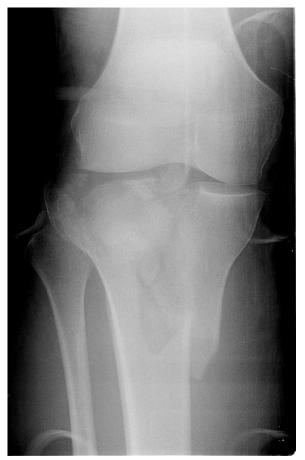
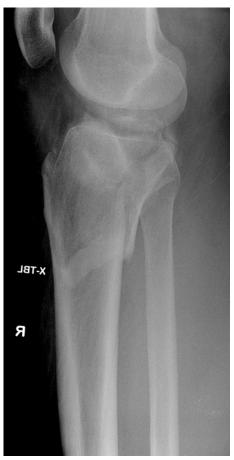
Fig. E-1A Fig. E-1B

Anteroposterior and lateral injury radiographs of an AO/OTA type-41-C3 bicondylar tibial plateau fracture sustained in a motor-vehicle collision. The patient had multiple other injuries.

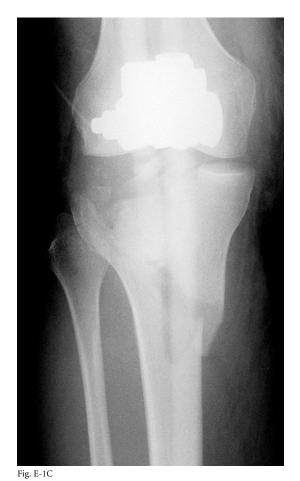
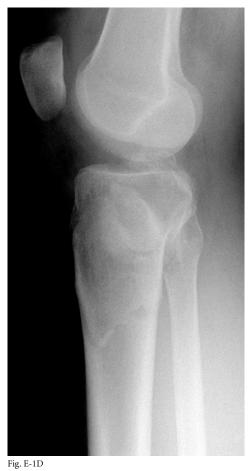
The tibial plateau fracture was acutely treated with the application of a temporary spanning external fixator to facilitate the management of more severe, life-threatening injuries.

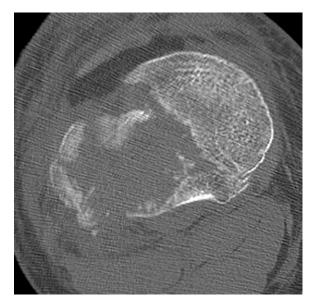
Fig. E-1E

Computerized tomographic scans were acquired after application of the temporary spanning external fixator. Axial images with coronal and sagittal reformations demonstrate substantial depression of the articular surface of the lateral tibial plateau without involvement of the medial articular surface.

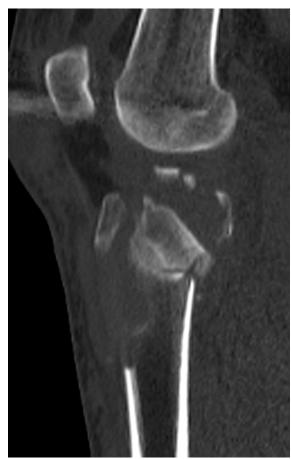
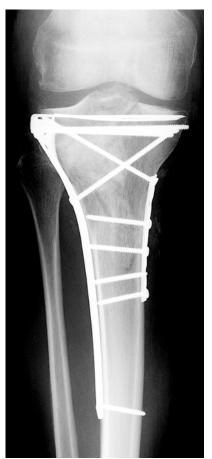
Fig. E-1H Fig. E-1I

Anteroposterior and lateral radiographs made immediately after open reduction and internal fixation with use of combined anterolateral and posteromedial surgical exposures and medial and lateral plate fixation.

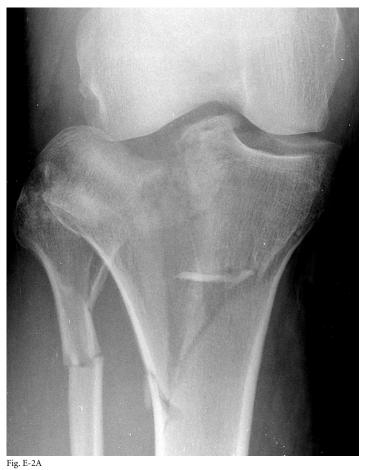
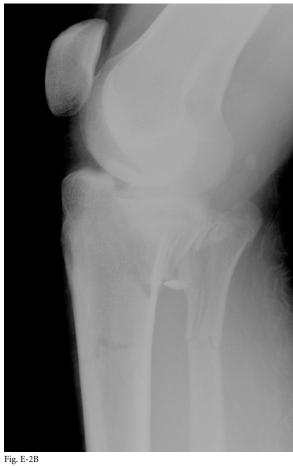
Anteroposterior and lateral injury radiographs of an AO/OTA type-41-C3 bicondylar tibial plateau fracture sustained in a fall from a ladder. Note the double density at the medial articular surface, which is suggestive of a coronal plane injury pattern of the medial plateau.

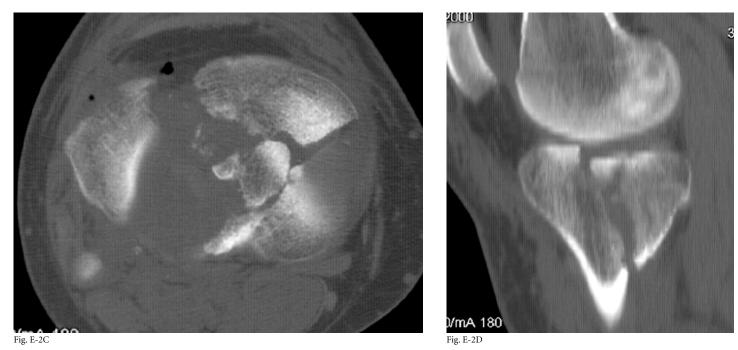
Axial computed tomography imaging with sagittal reformation corroborates the coronal plane injury pattern of the medial articular surface.

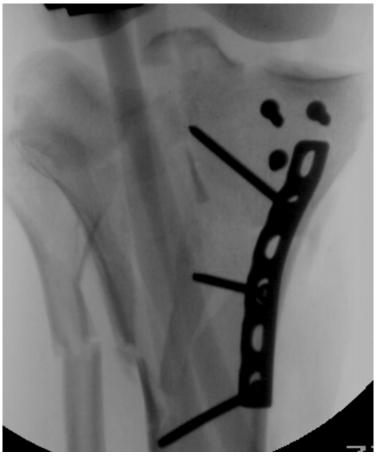
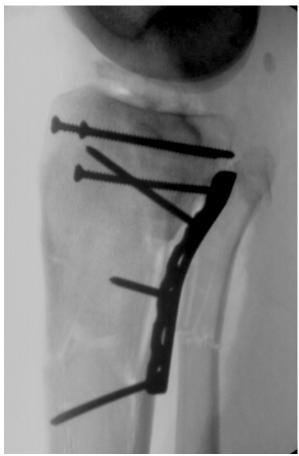
Fig. E-2E Fig. E-2F

Anteroposterior and lateral fluoroscopic imaging after open reduction and internal fixation of the medial articular surface with a posteromedial surgical exposure. The posteromedial fragment has been neutralized with a posteriorly applied compression plate and independent lag-screw fixation. Care was taken to avoid inadvertent fixation of unreduced lateral fragments.

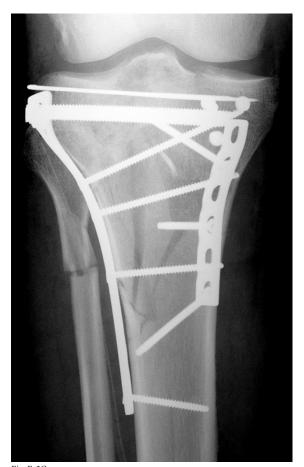
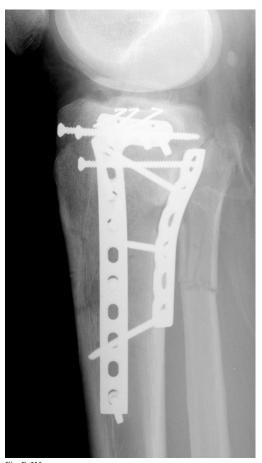
Fig. E-2G Fig. E-2H

Anteroposterior and lateral radiographs made immediately after open reduction and internal fixation of the lateral injury components.
