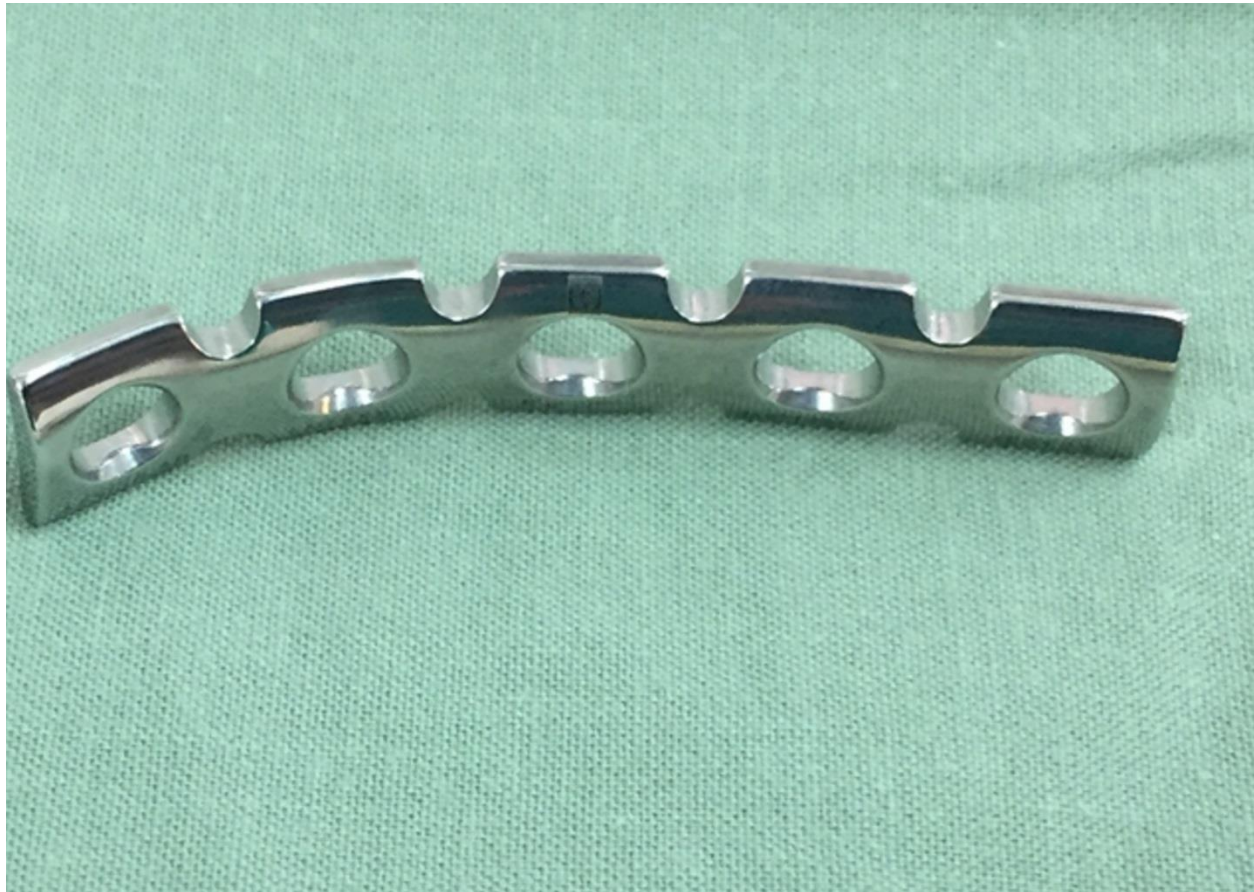
**Fig. E-1:** Reconstruction plate contoured for the anatomic curve of the quadrilateral plate.

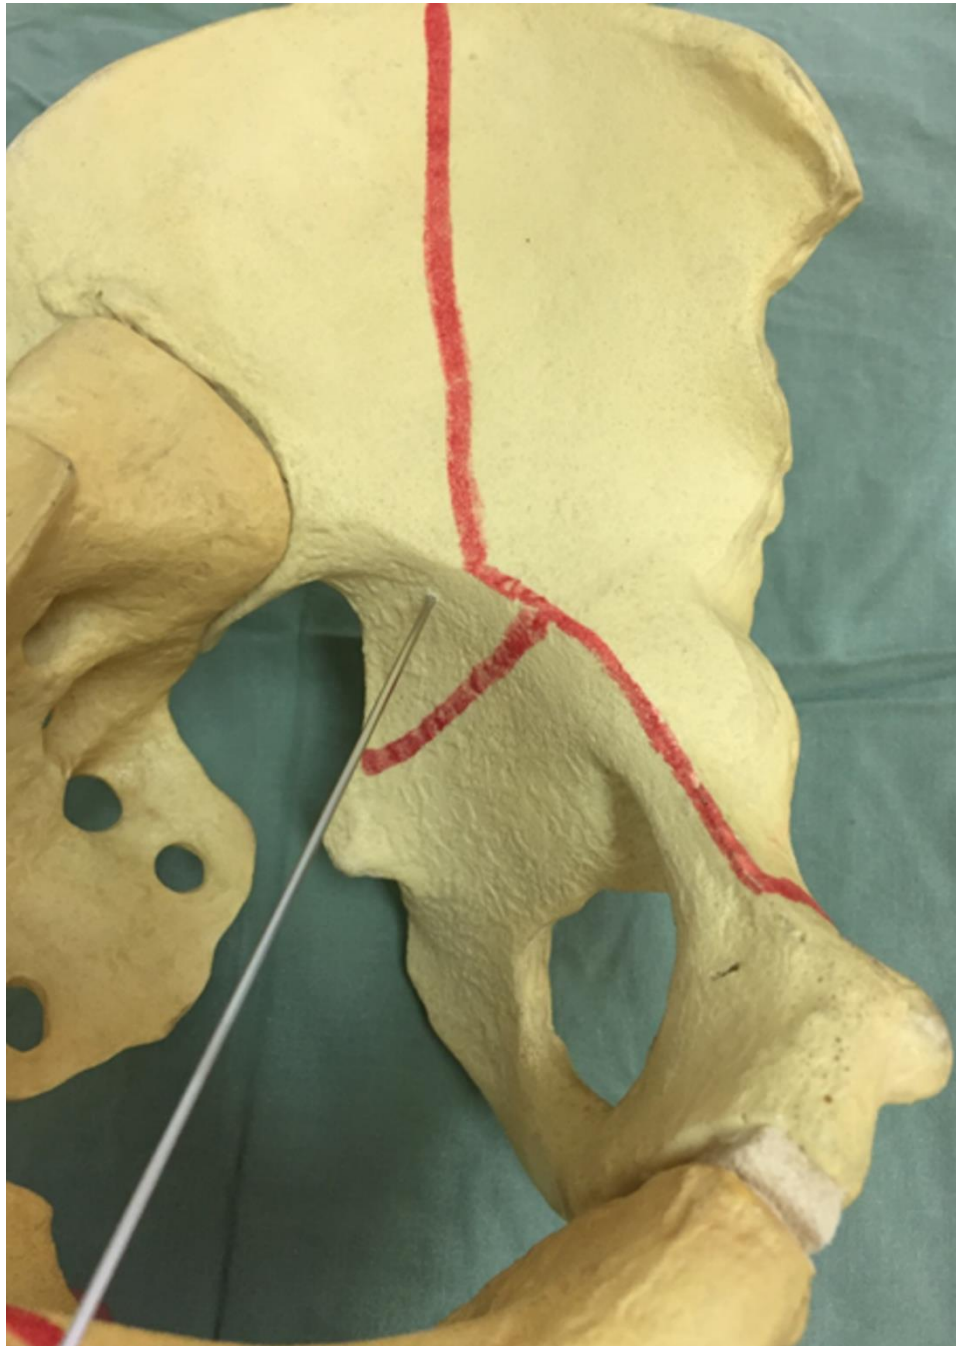
**Fig. E-2:** The fracture demonstrated is a superomedial displacement vector subtype 1, which starts from the iliac crest. The fracture of the pelvic brim goes along the pelvic brim. Note that the quadrilateral plate fracture is perpendicular to the pelvic brim. After the exposure of the quadrilateral plate, a 2-mm Kirschner wire or size-2 Steinmann pin is inserted into the stable part of the quadrilateral plate.

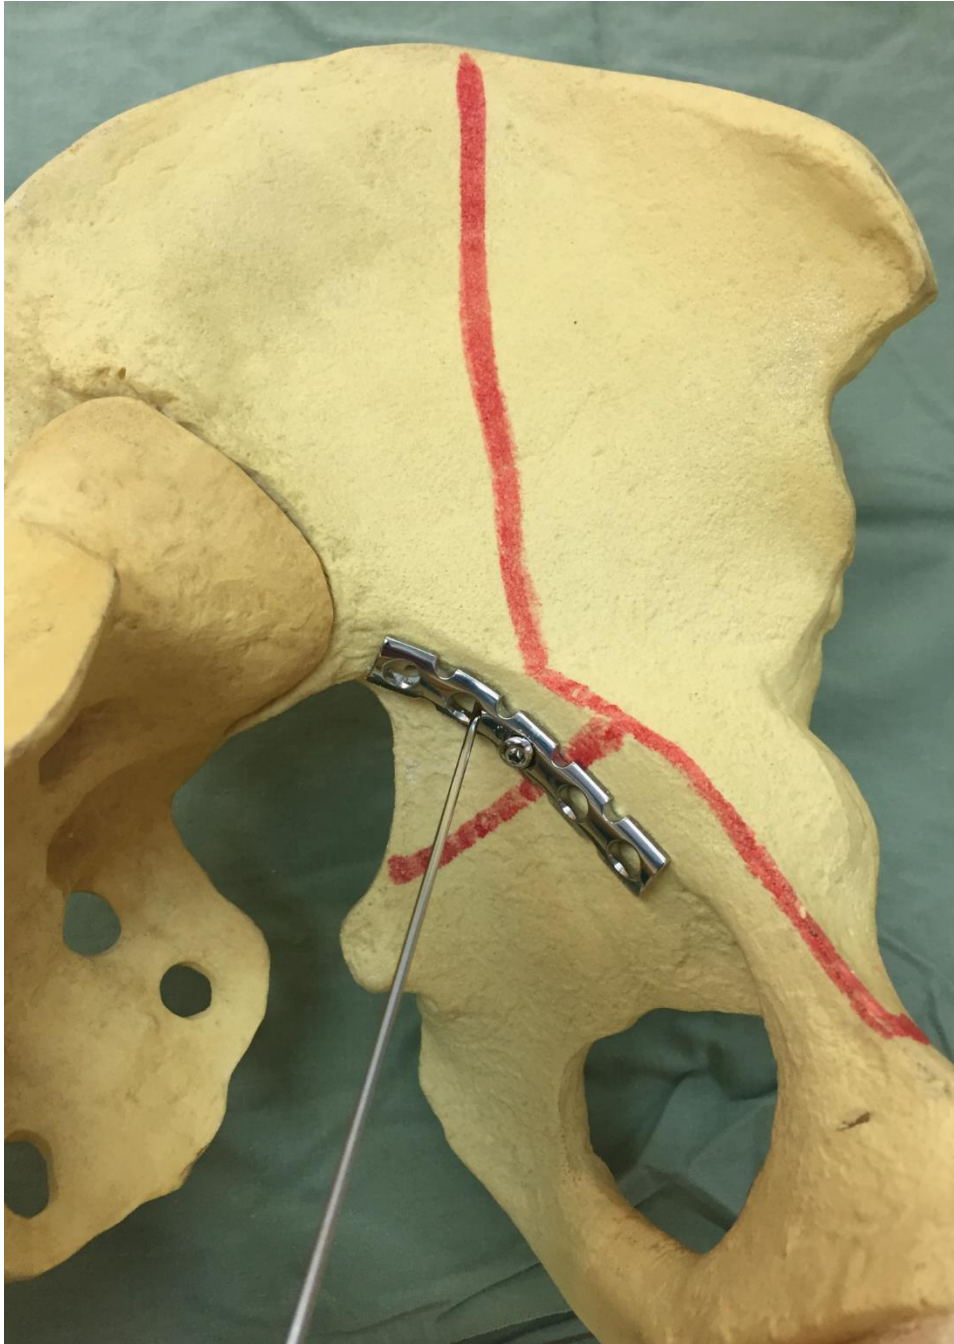
**Fig. E-3:** The pre-contoured reconstruction plate is then inserted on the wire (so that it does not get lost in the pelvis). The first screw (closest to the fracture line) is then inserted while using a ball-spike to push the quadrilateral plate laterally into reduction.

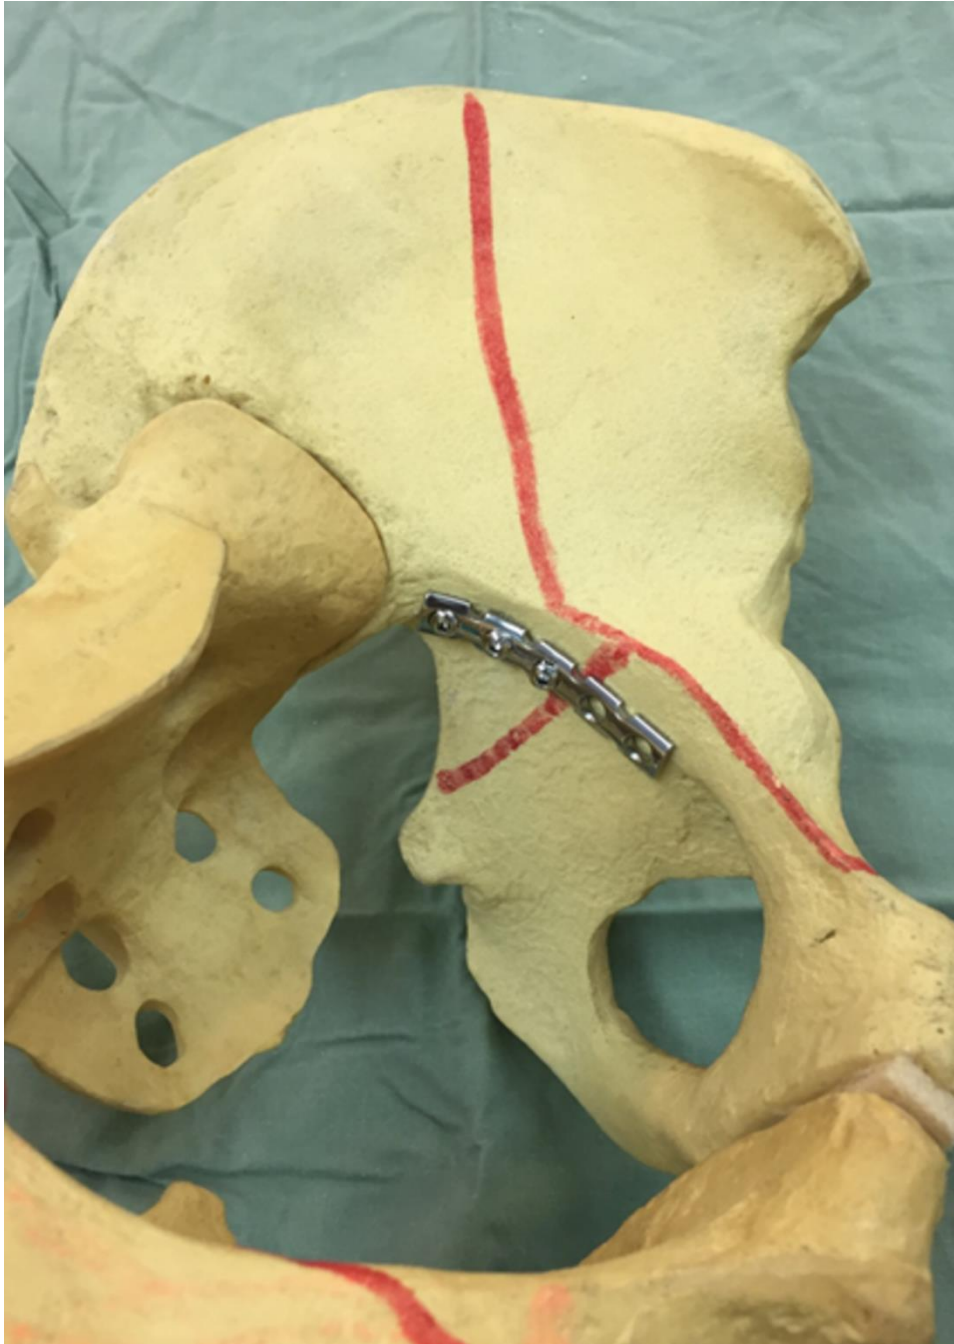
**Fig. E-4:** The wire is then retracted and the other screws are inserted. Depending on the angle of the wire, it can sometimes prevent the buttress plate from fully reducing onto the fracture. In that case, the wire needs to be removed and the first screw needs to be further tightened.

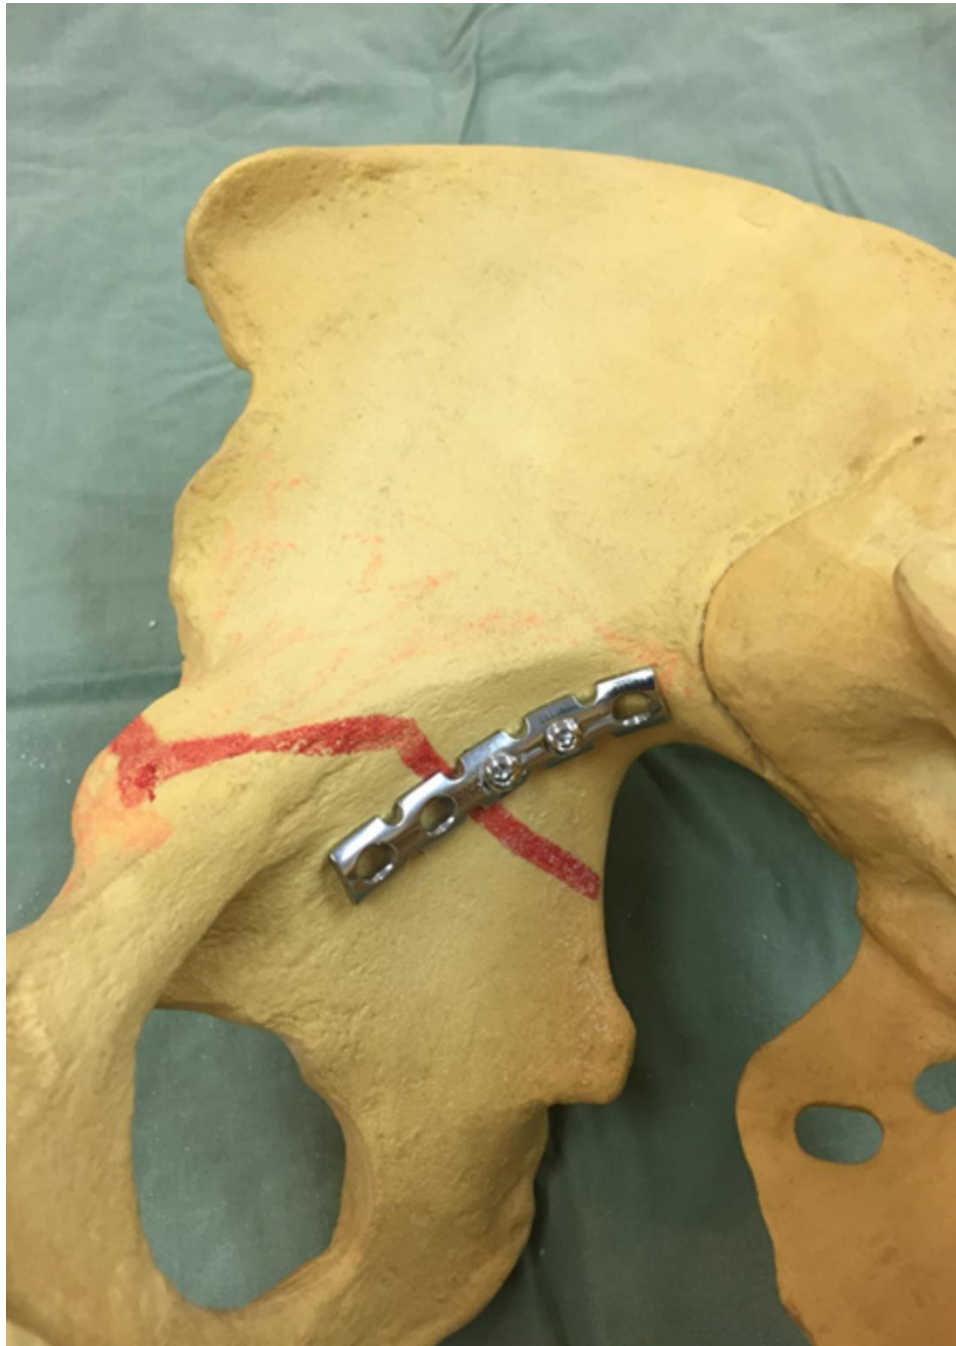
**Fig. E-5:** A similar technique of inserting a quadrilateral buttress plate can be used for reduction and fixation of the quadrilateral plate in a superomedial displacement vector subtype-2 fracture, which does not include the iliac wing. Note here that the pelvic-brim fracture crosses the brim. Again, the quadrilateral plate fracture is perpendicular to the pelvic brim.

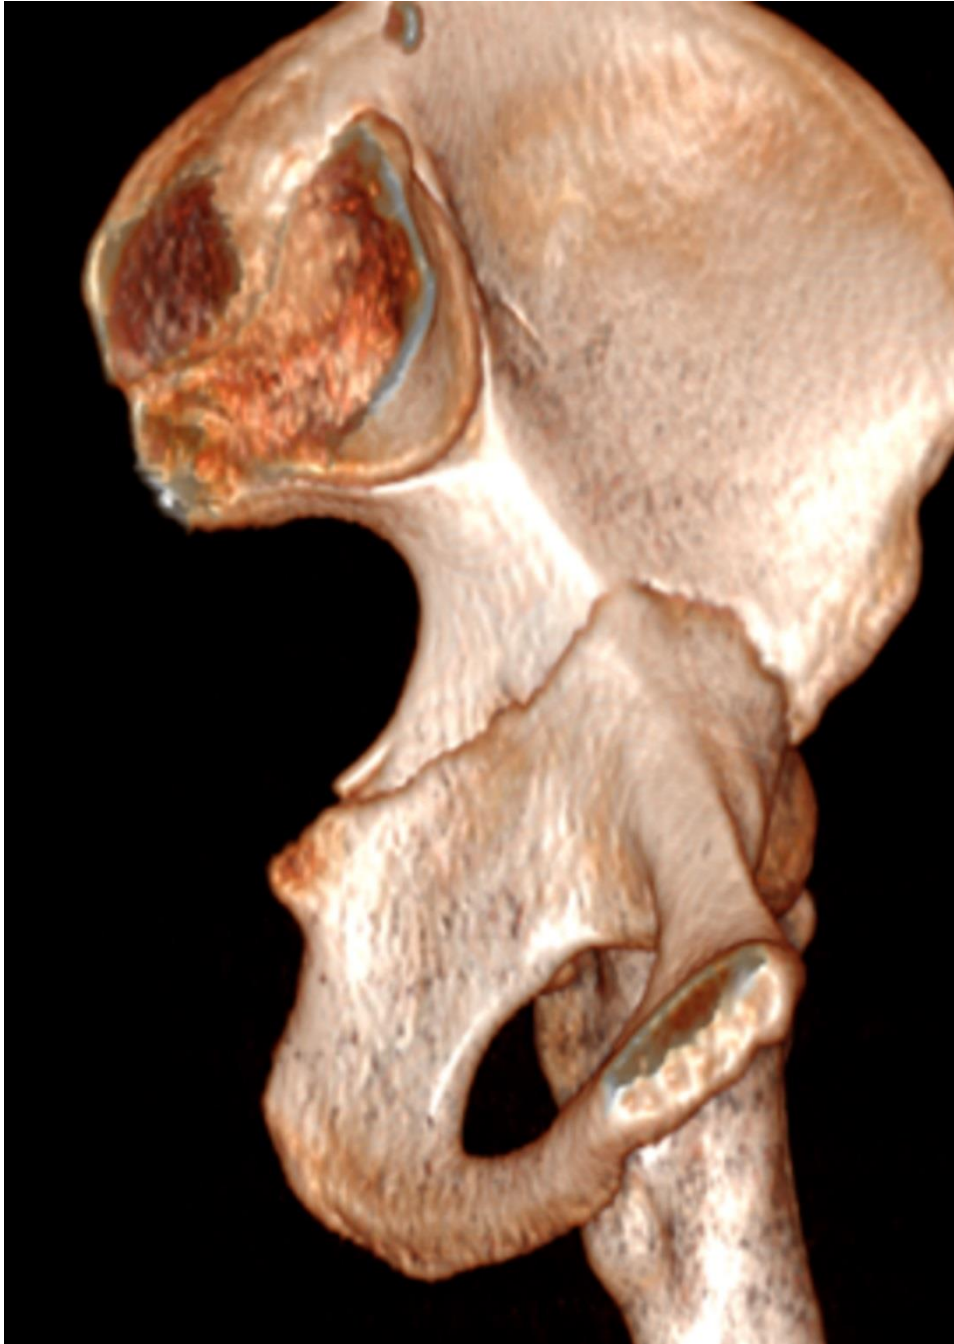
**Figs. E-6A and E-6B:** Three-dimensional CT scans of a 24-year-old man injured in a motor vehicle accident, fracture group classified as combined displacement vector subtype 2 (transverse and posterior wall). **Fig. E-6A:** A 3-dimensional CT scan of the medial aspect of the hemipelvis.

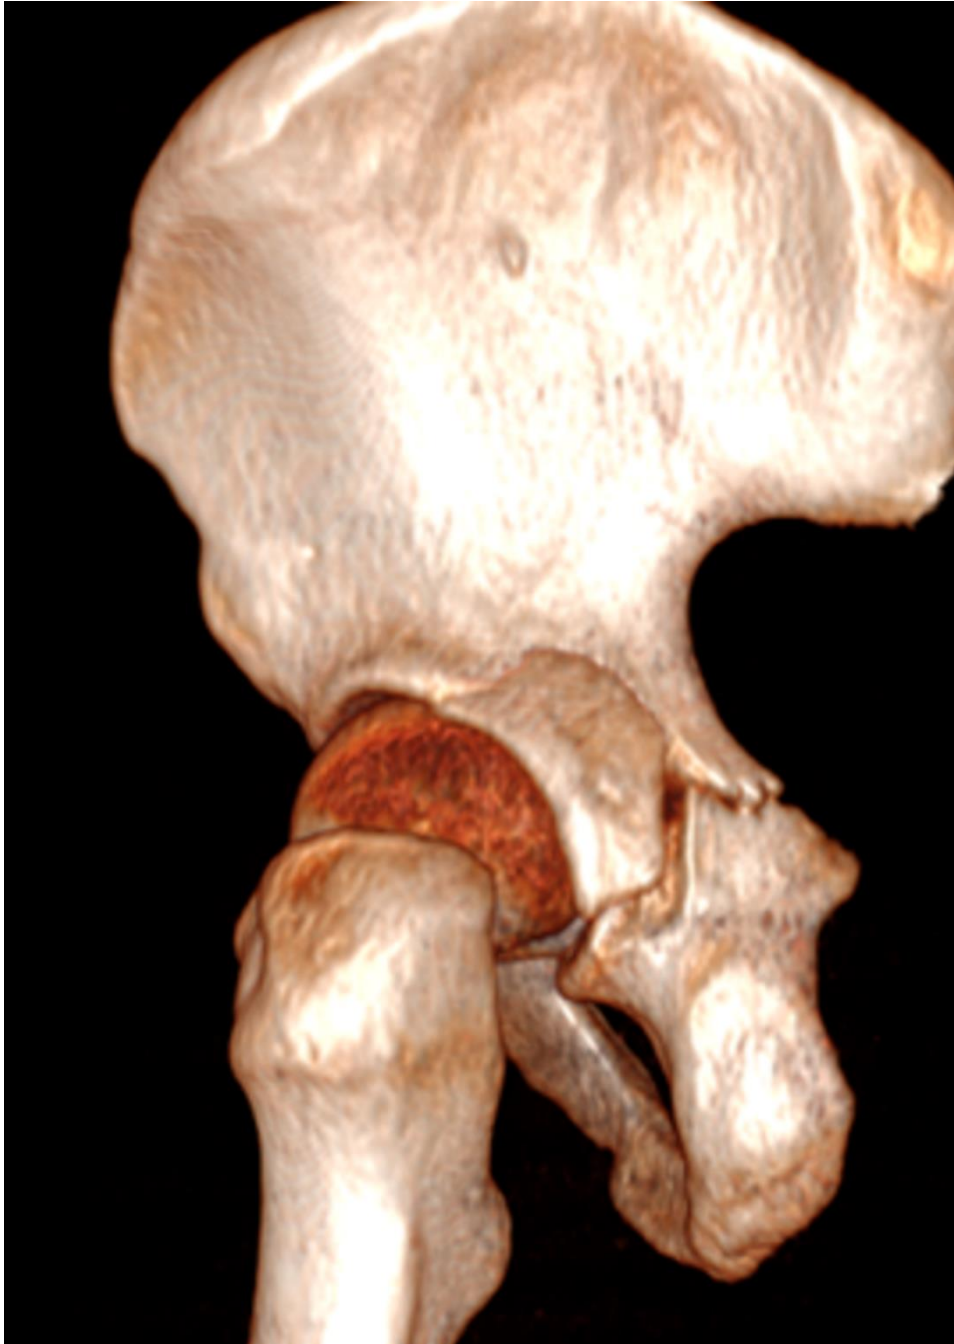
**Fig. E-6B:** A 3-dimensional CT scan of the posterior wall. The characteristics of the subtype-2 fracture can be seen; it does not include the iliac wing, the quadrilateral plate is fractured perpendicular to the pelvic brim, and the pelvic brim fracture is across the pelvic brim. The posterior wall is also broken.

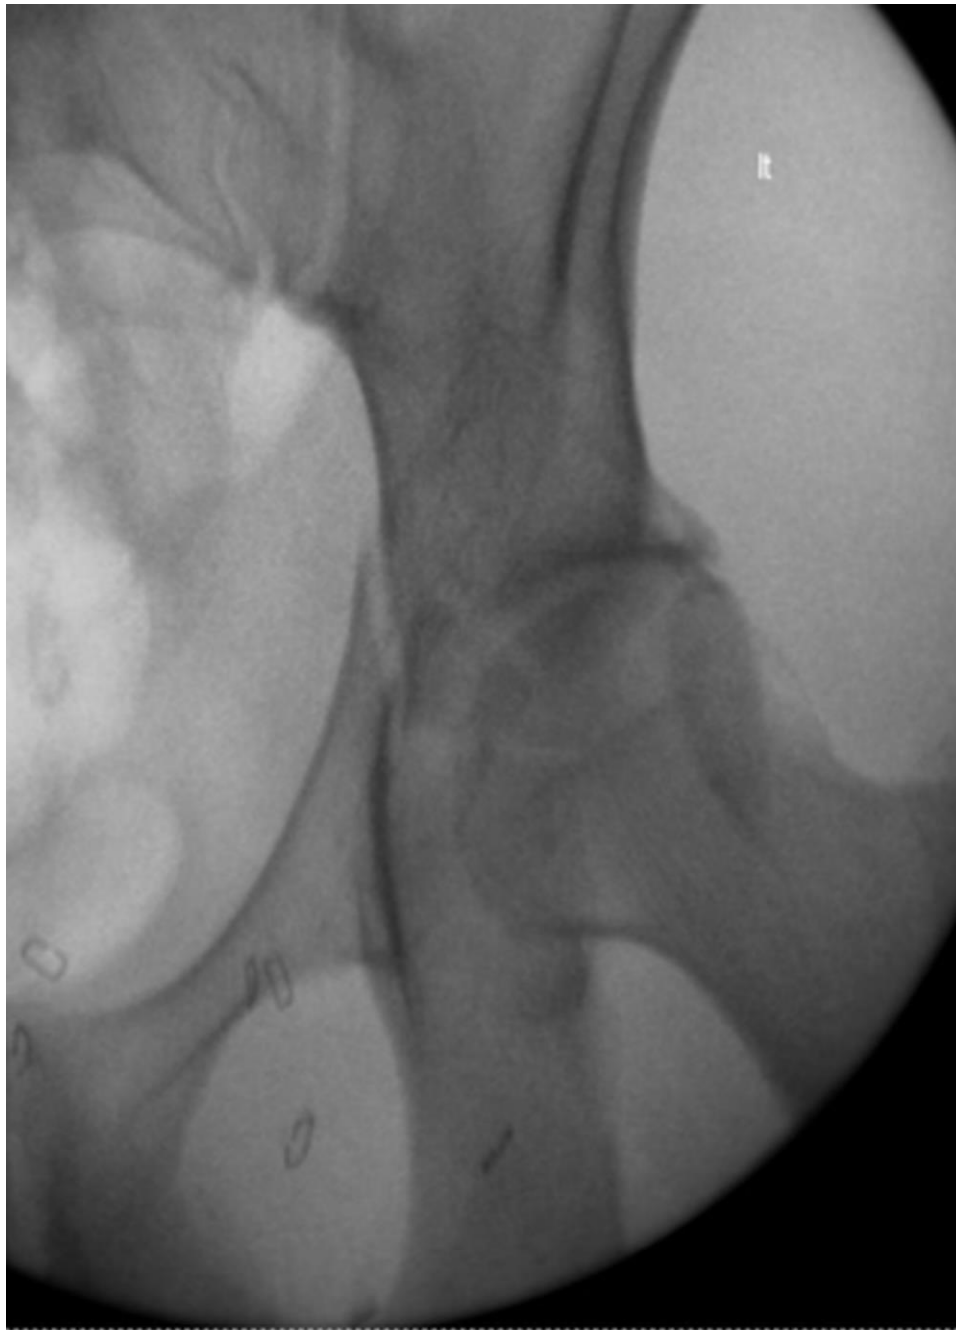
**Figs. E-7A through E-7E:** Fluoroscopic images during the anterior intrapelvic surgical approach. **Figs. E-7A:** Iliac oblique during surgery shows the displacement in the quadrilateral plate.

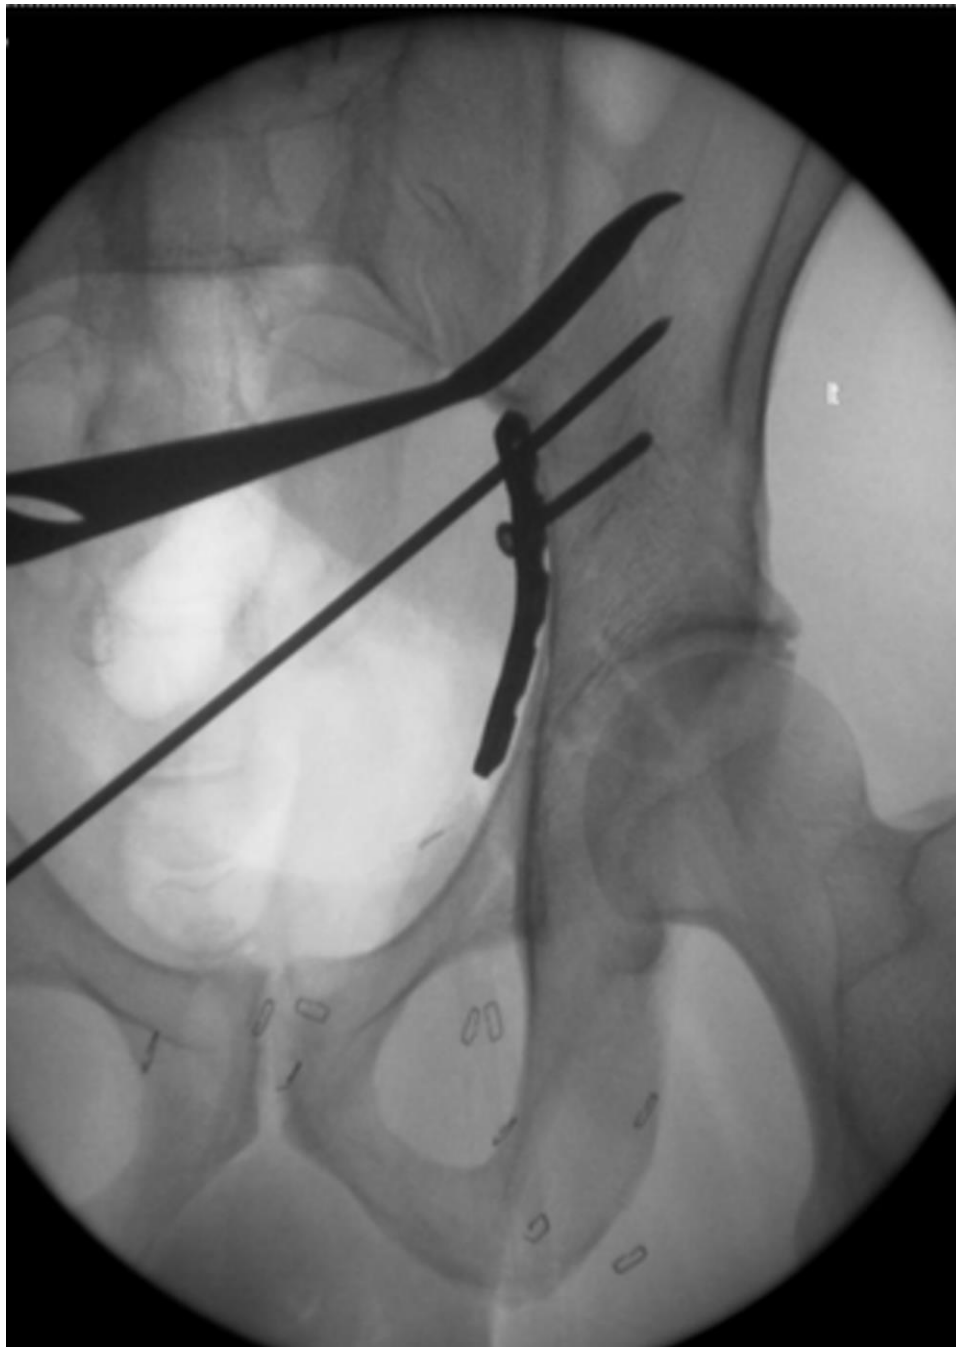
**Fig. E-7B:** Insertion of a 2-mm Kirschner wire; a pre-contoured reconstruction plate is inserted on it for fracture fixation.

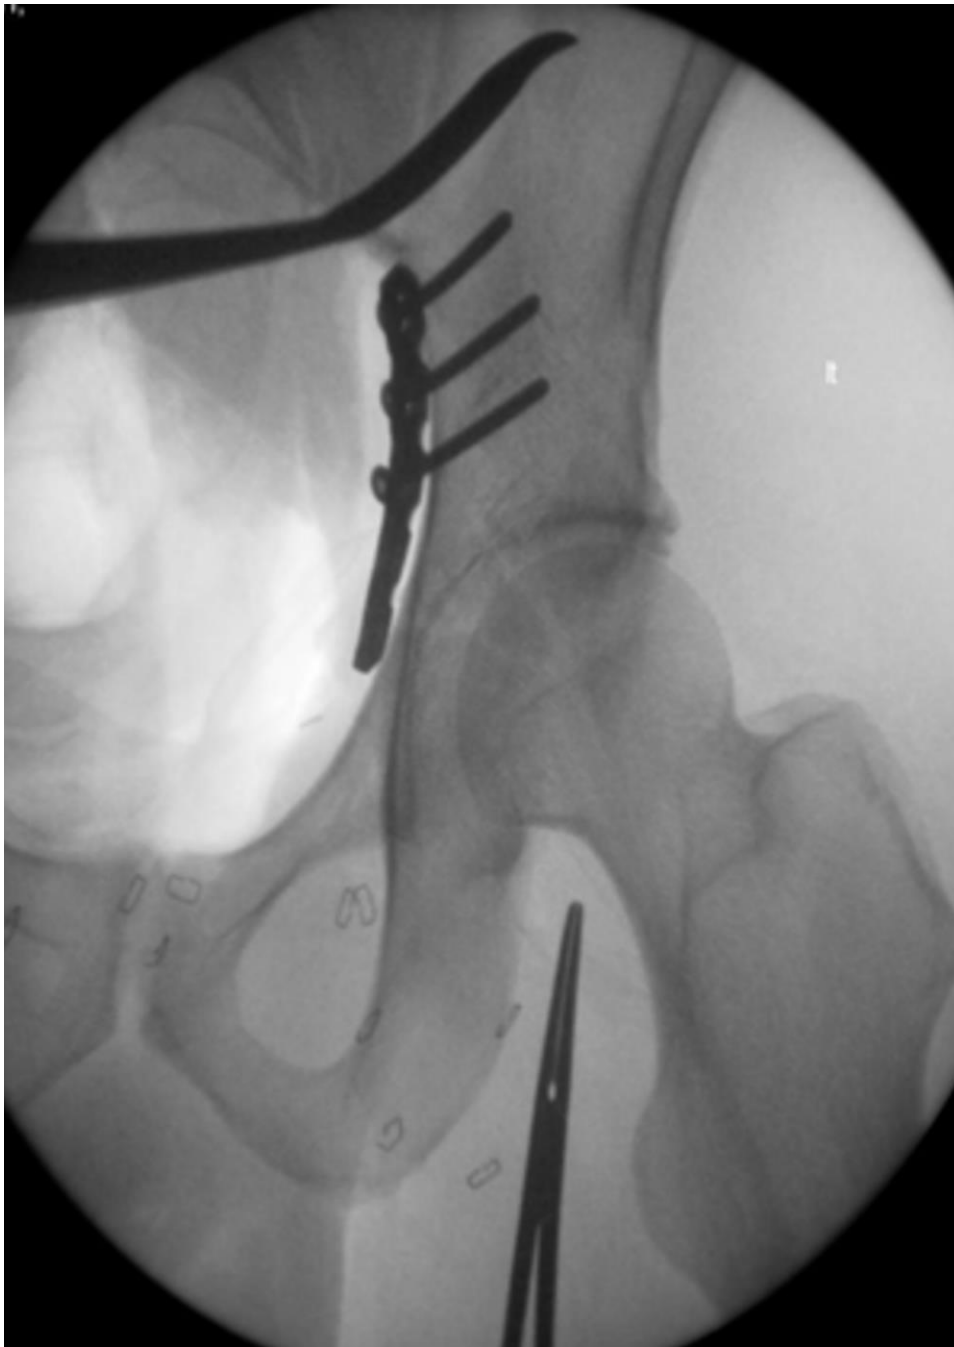
**Fig. E-7C:** The quadrilateral plate is reduced and fixed with a buttress plate.

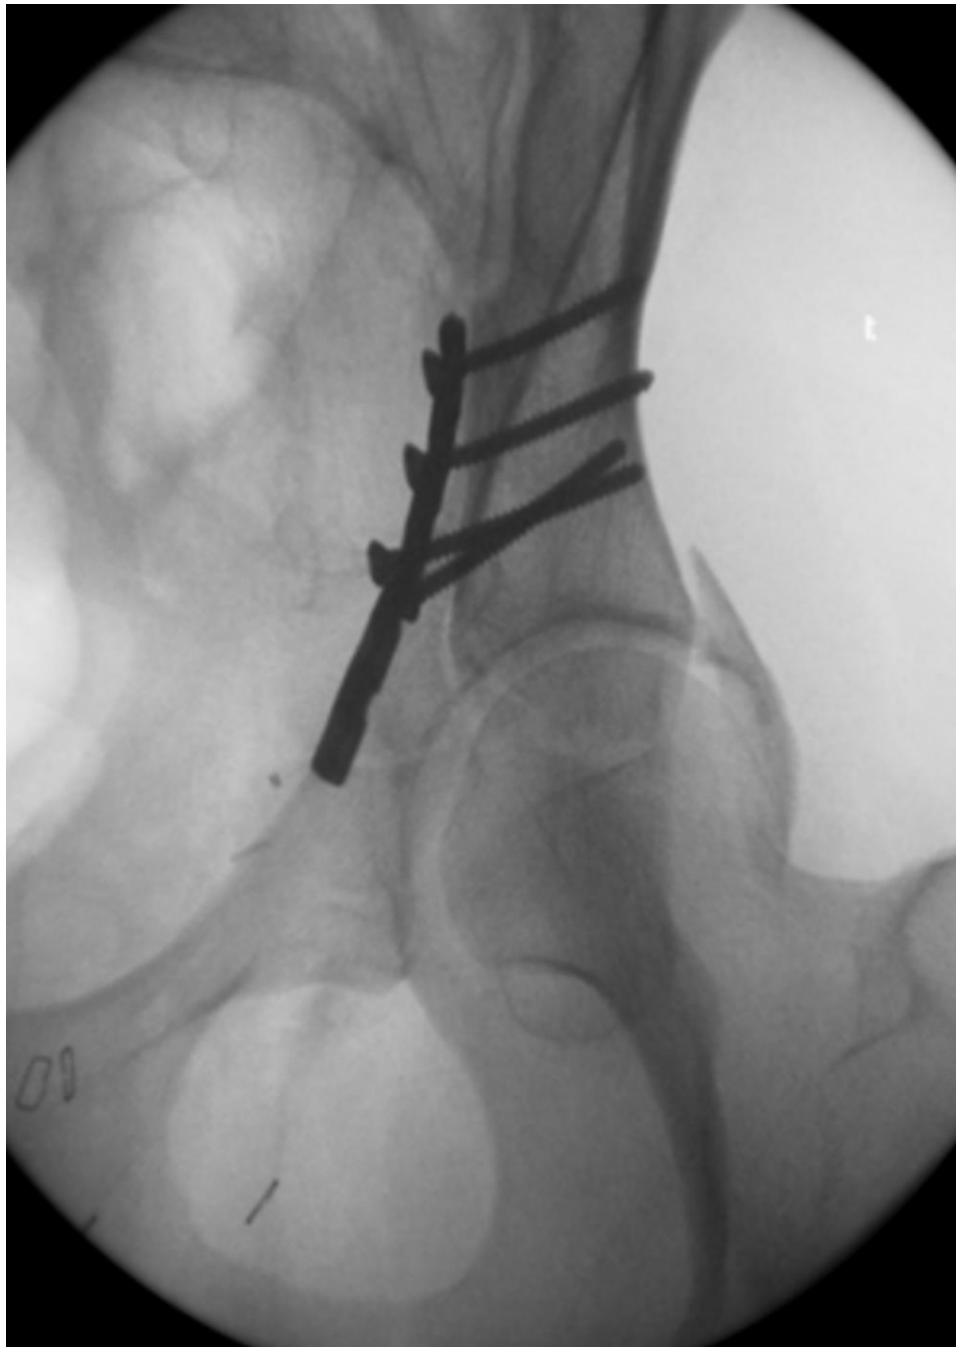
**Fig. E-7D:** The pelvic brim fracture is then reduced and fixed with interfragmentary positional screws. The posterior wall fracture can also be seen.

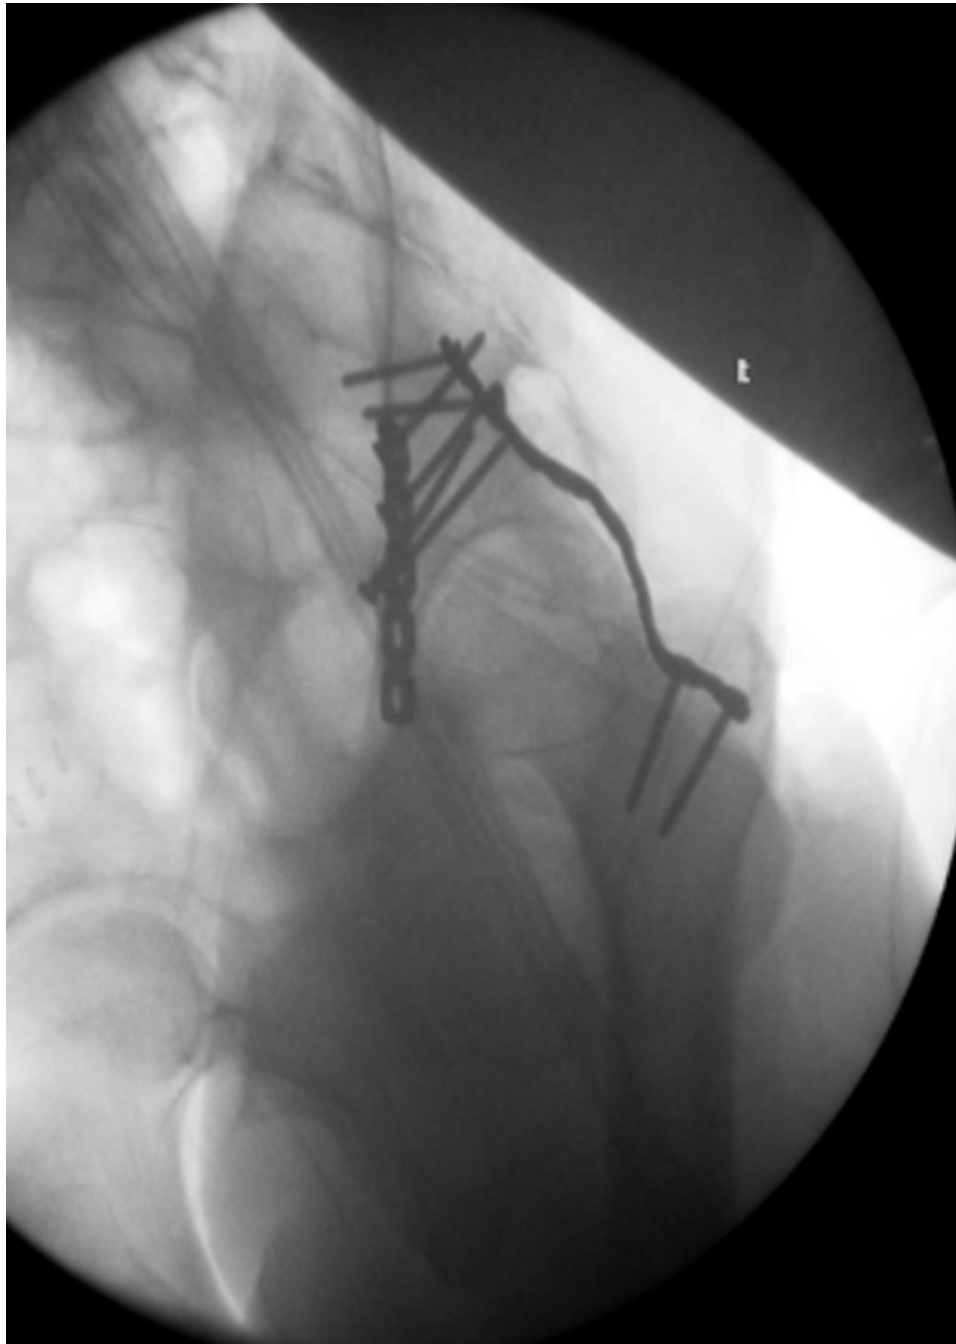
**Fig. E-7E:** The patient is then turned to the decubitus position and a Kocher-Langenbeck surgical approach is used for fixation of the posterior wall.
