A patient sustained a comminuted transverse plus posterior wall fracture as shown on the preoperative post-reduction AP radiograph

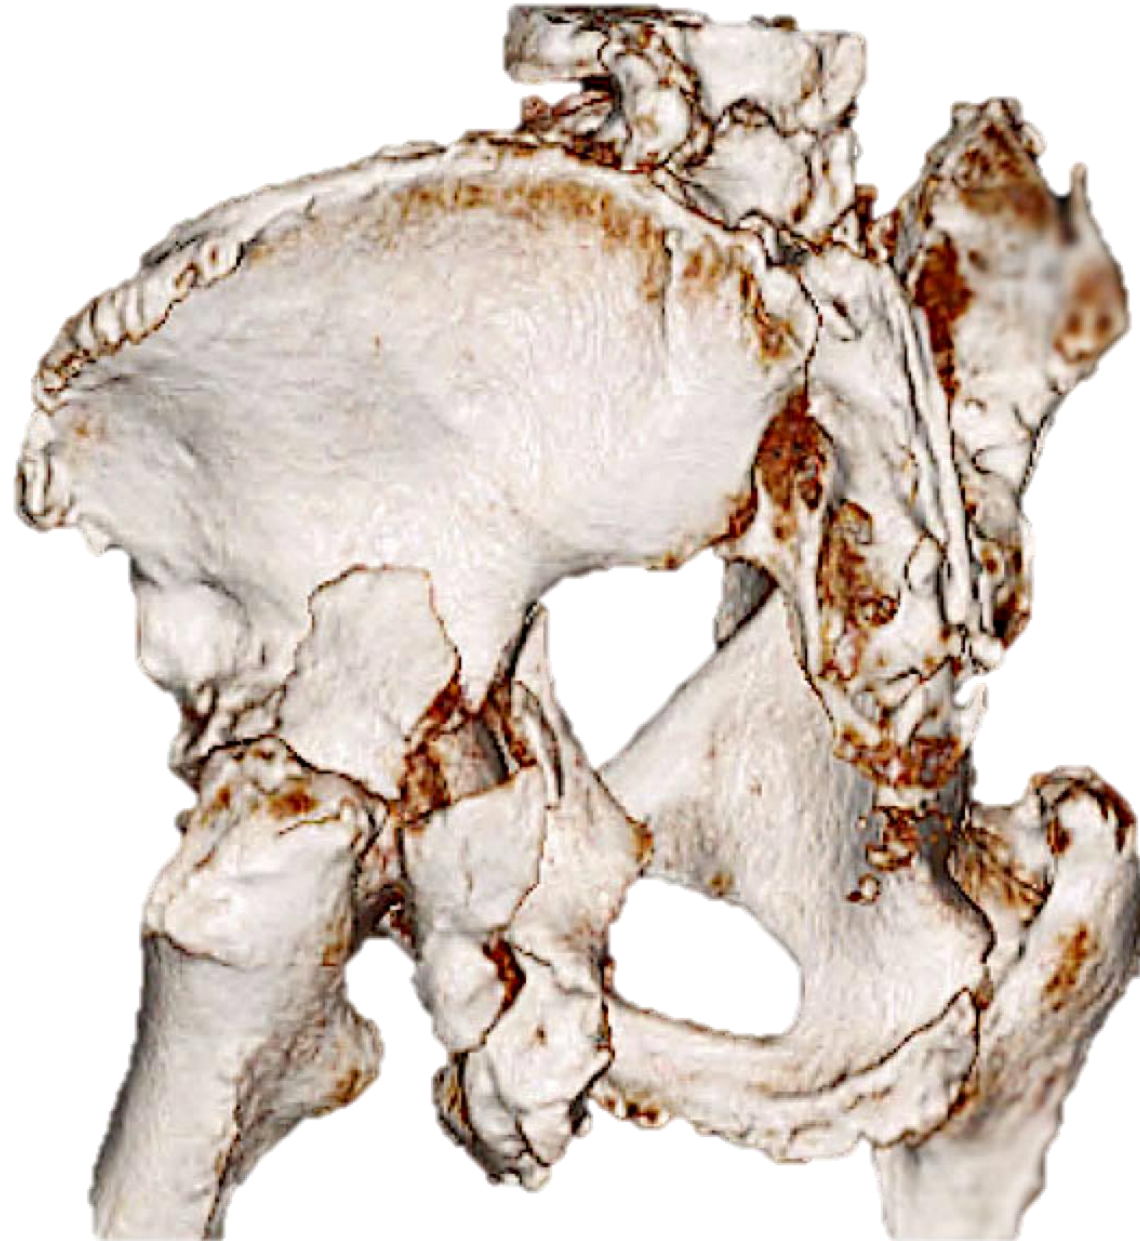
# Preoperative 3D CT Reconstruction

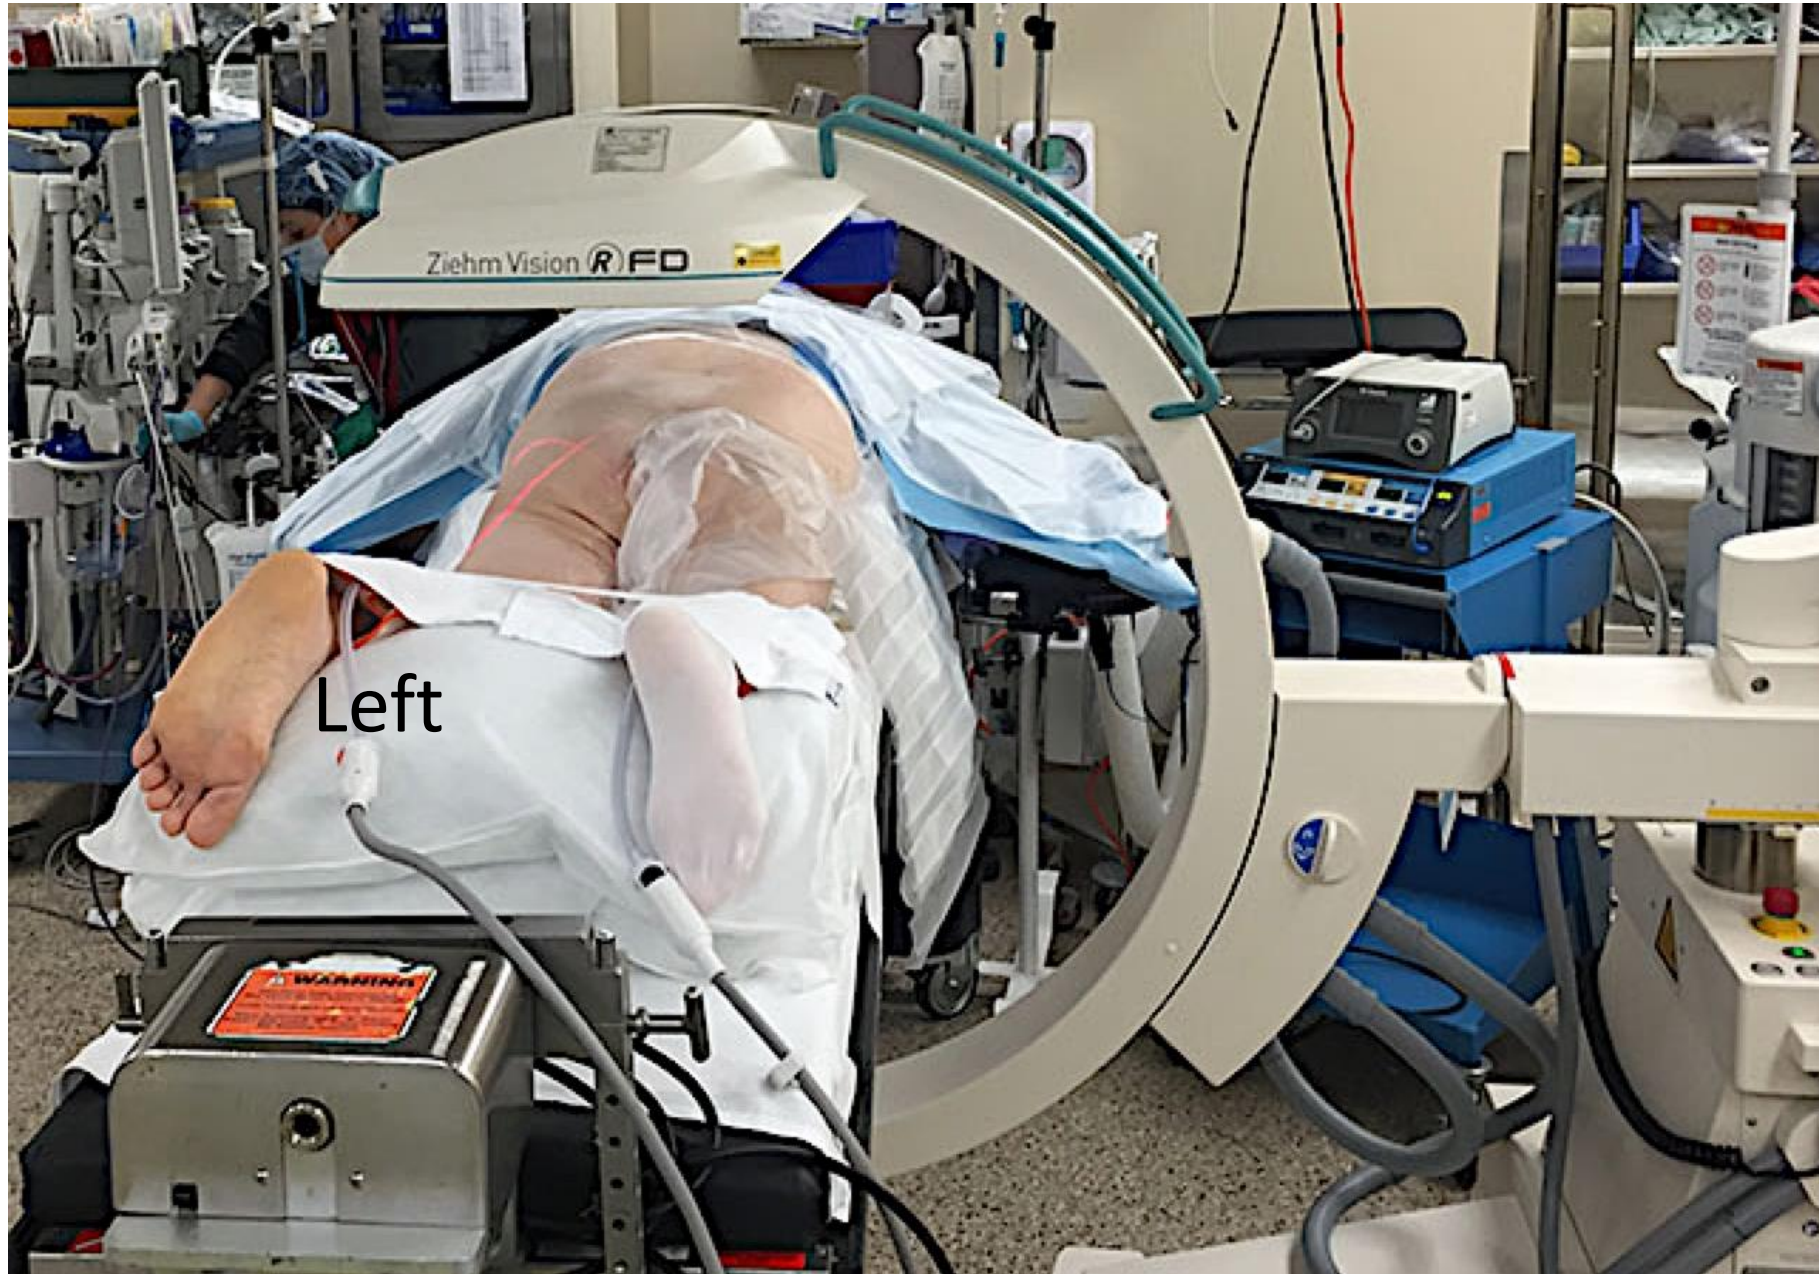
In the operating room, the patient was placed prone and the Ziehm RFD 3D C-arm unit was appropriately positioned

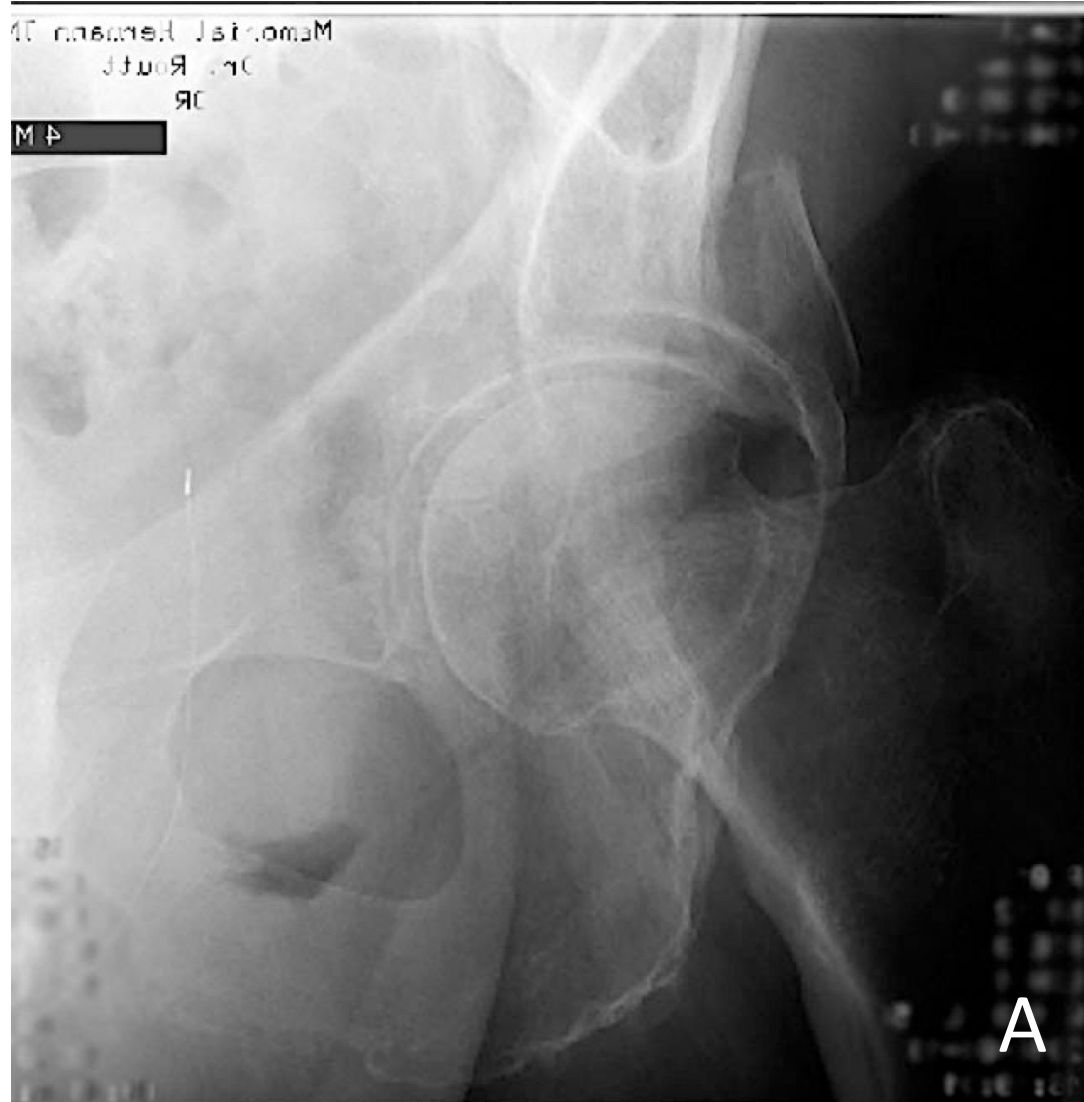
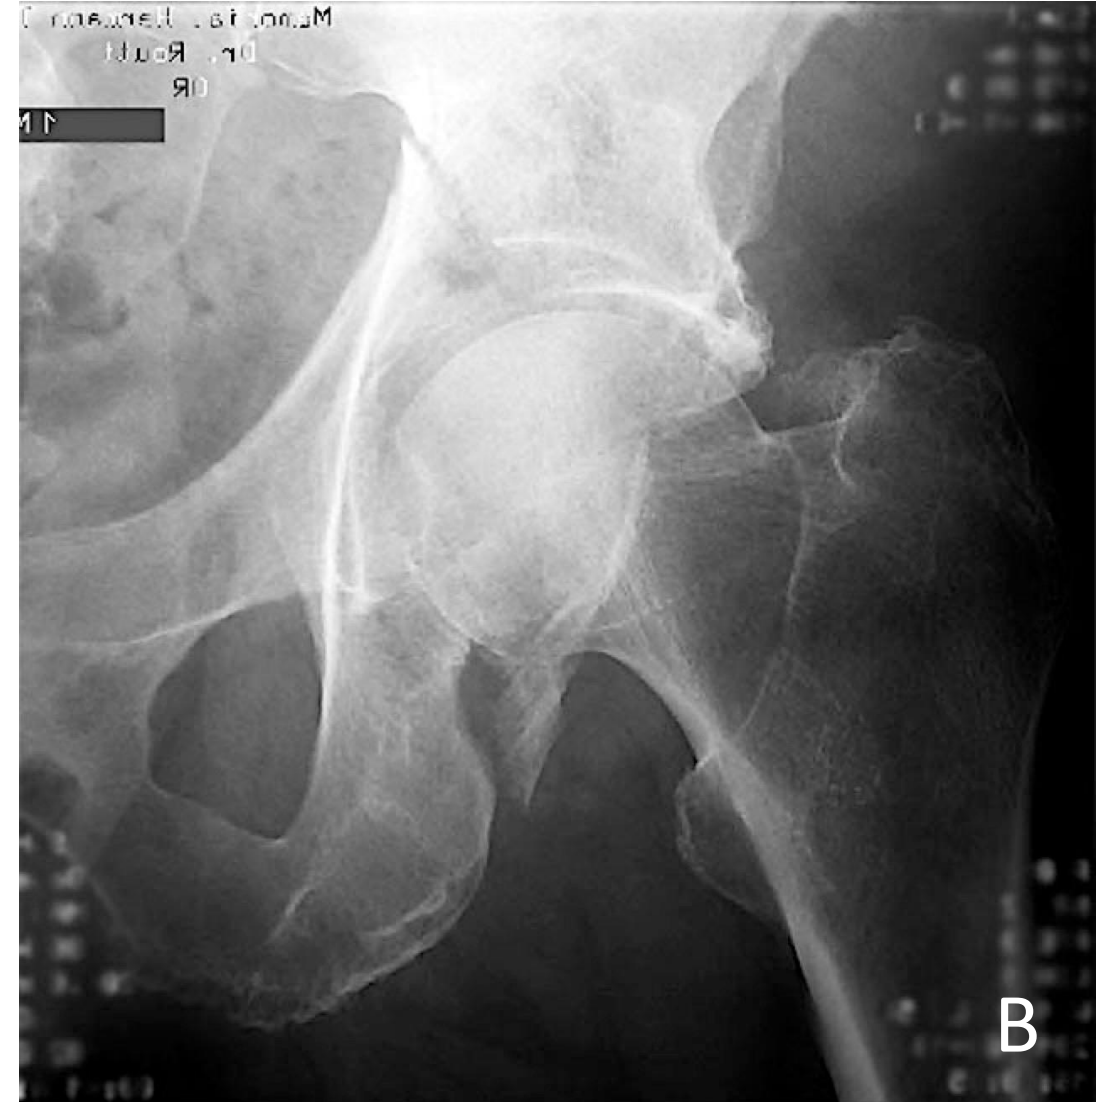
Standard fluoroscopic imaging was performed, including the AP (A) and obturator oblique (B) views, showing reduction
