Original AP Pelvis x-ray
in ER 35 yo female with
an 61C31.b injury

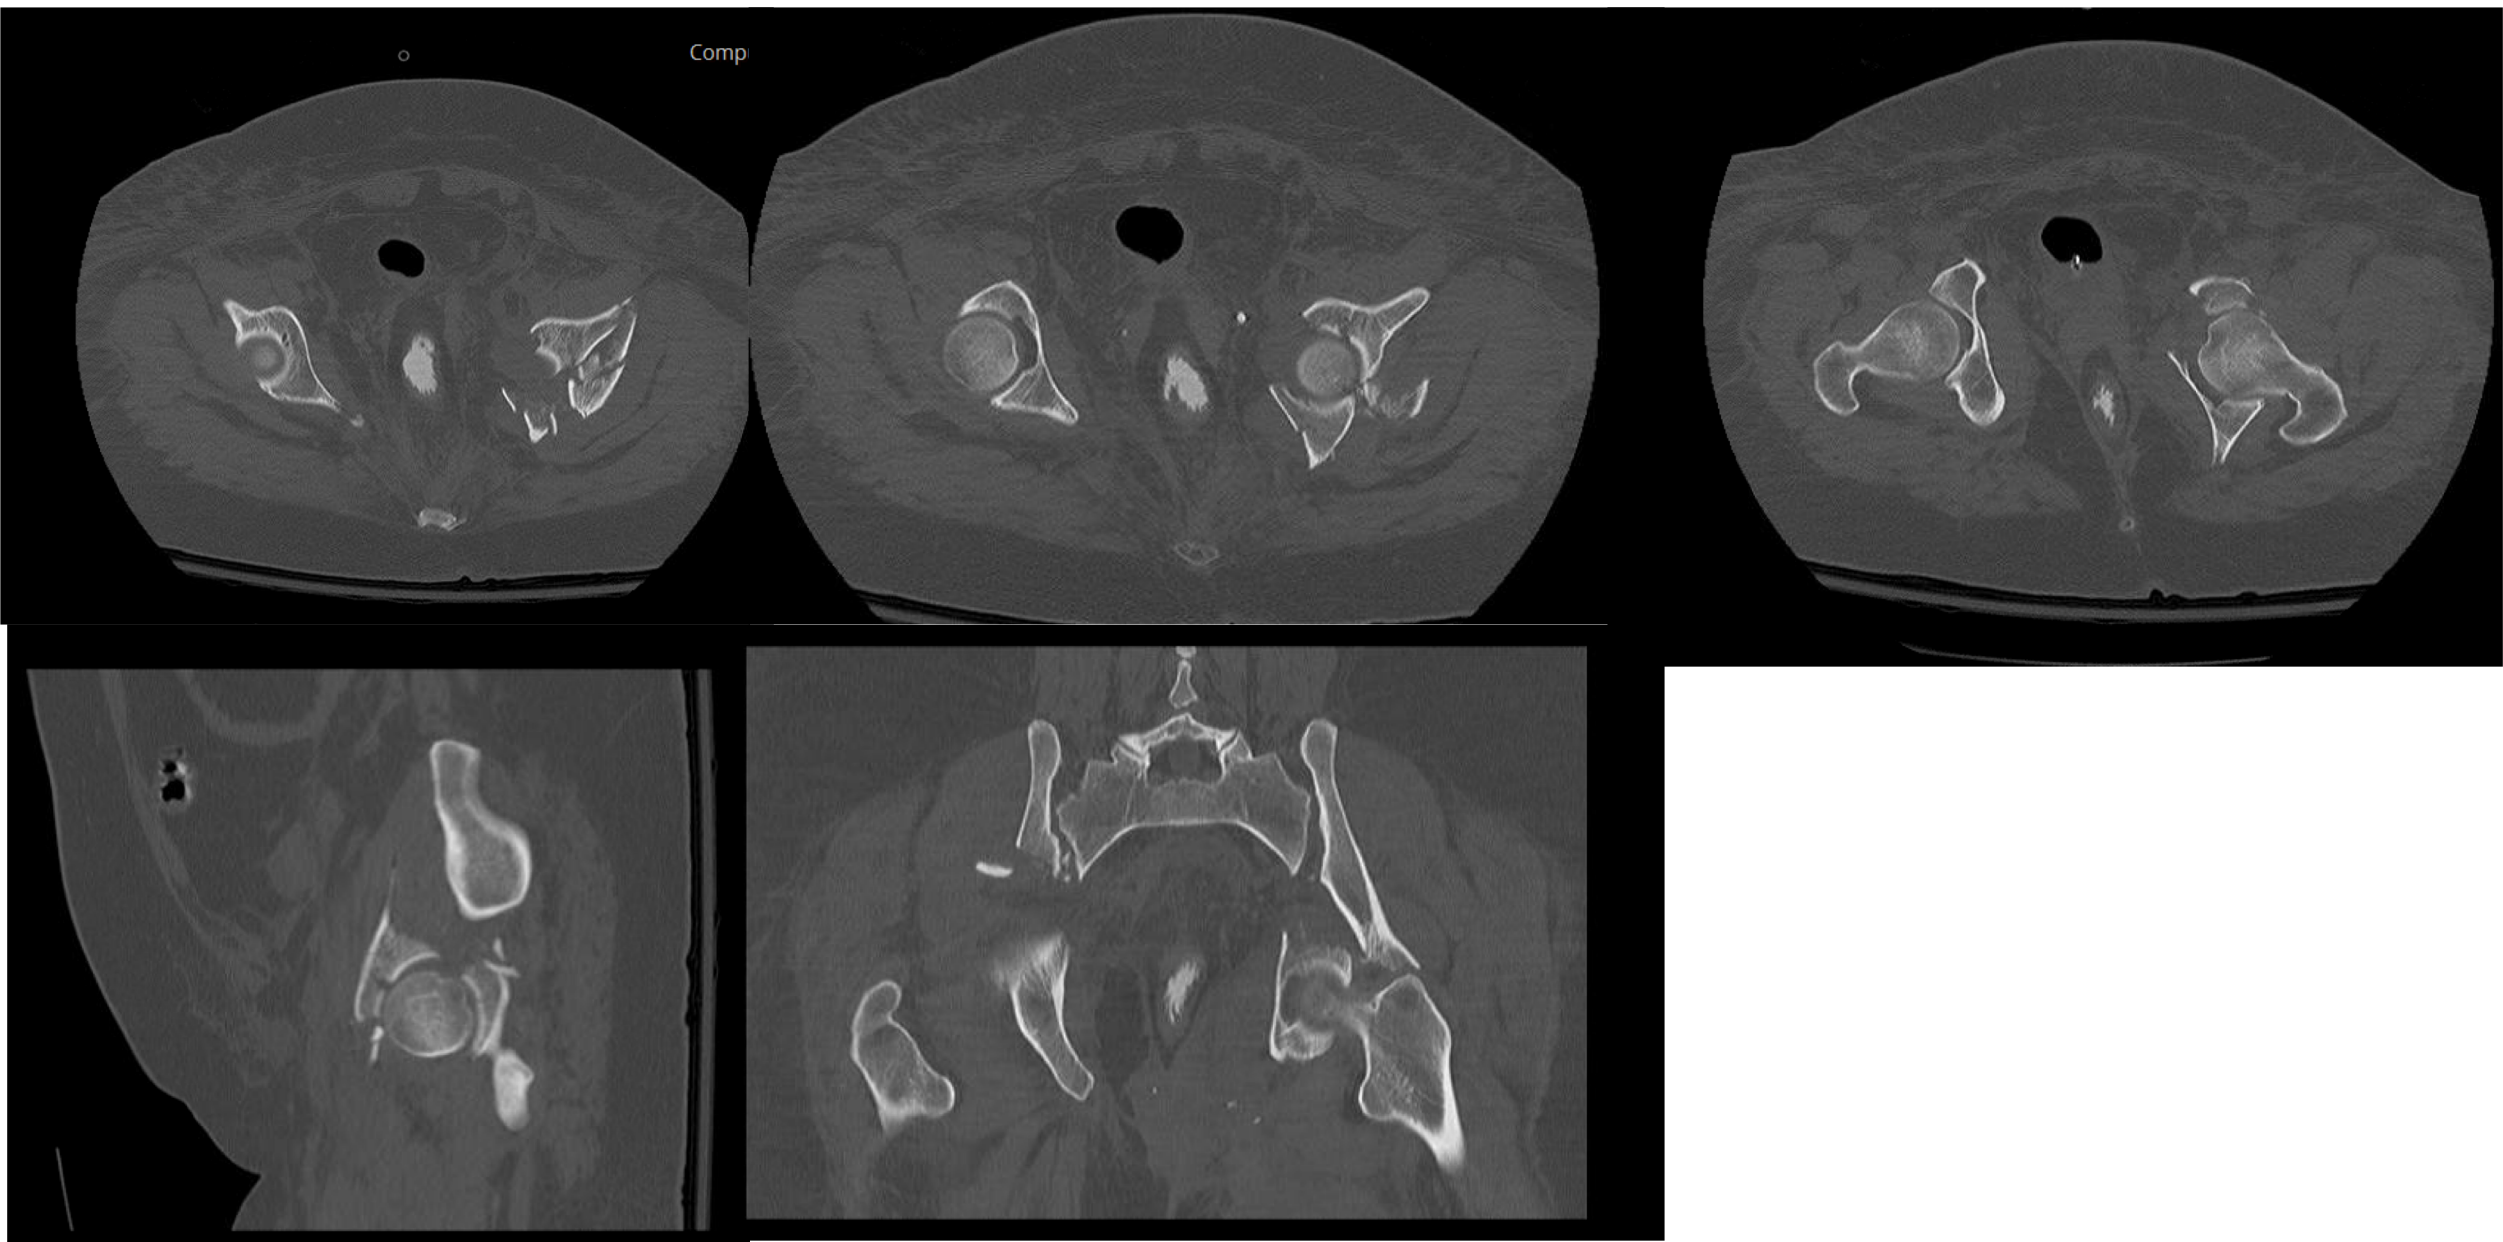
FIG 2 CT Scan

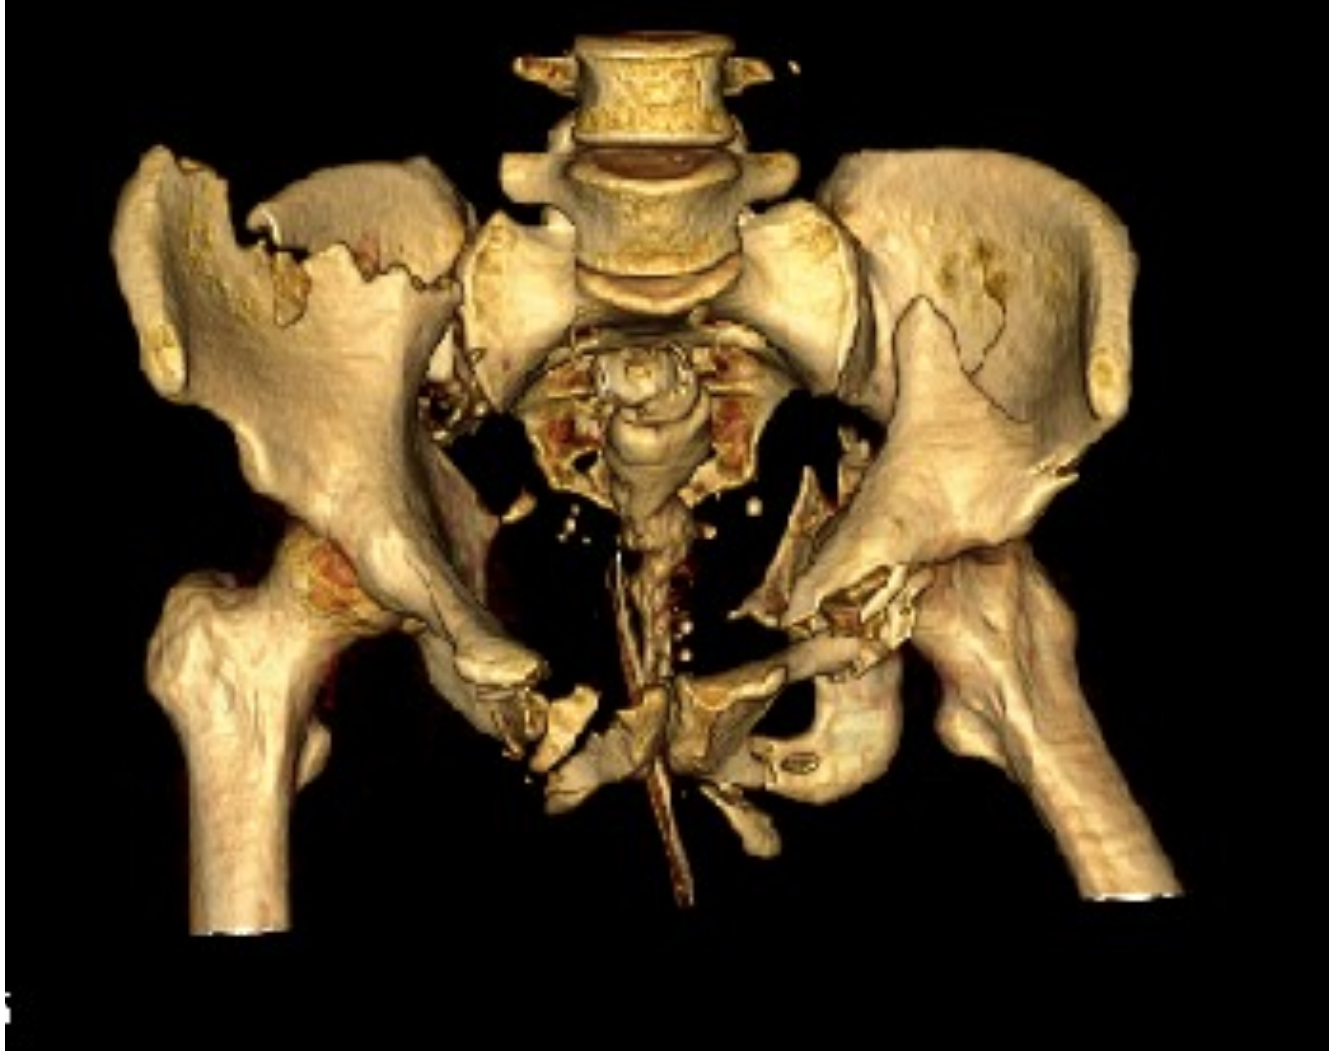
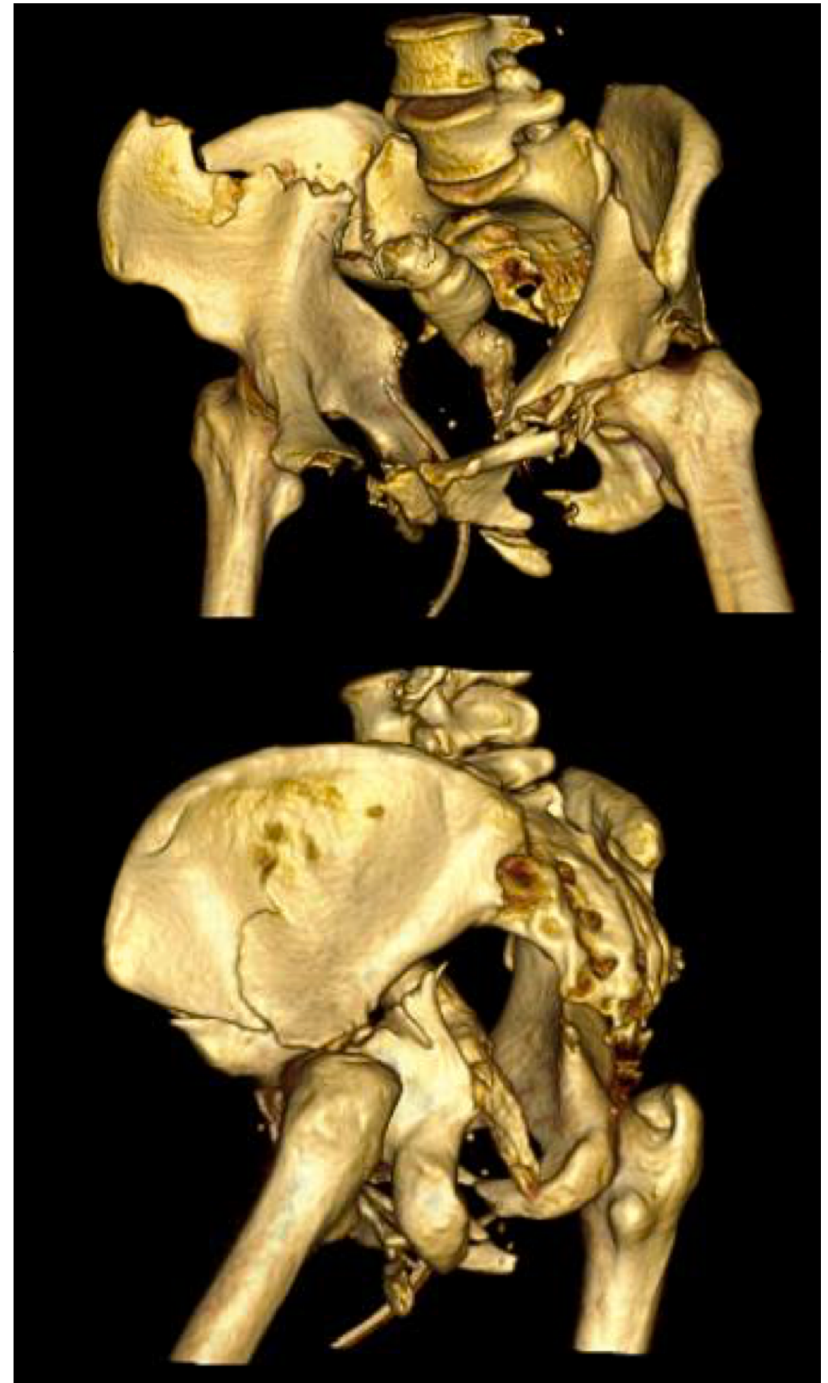
FIG 3 3D Reconstruction

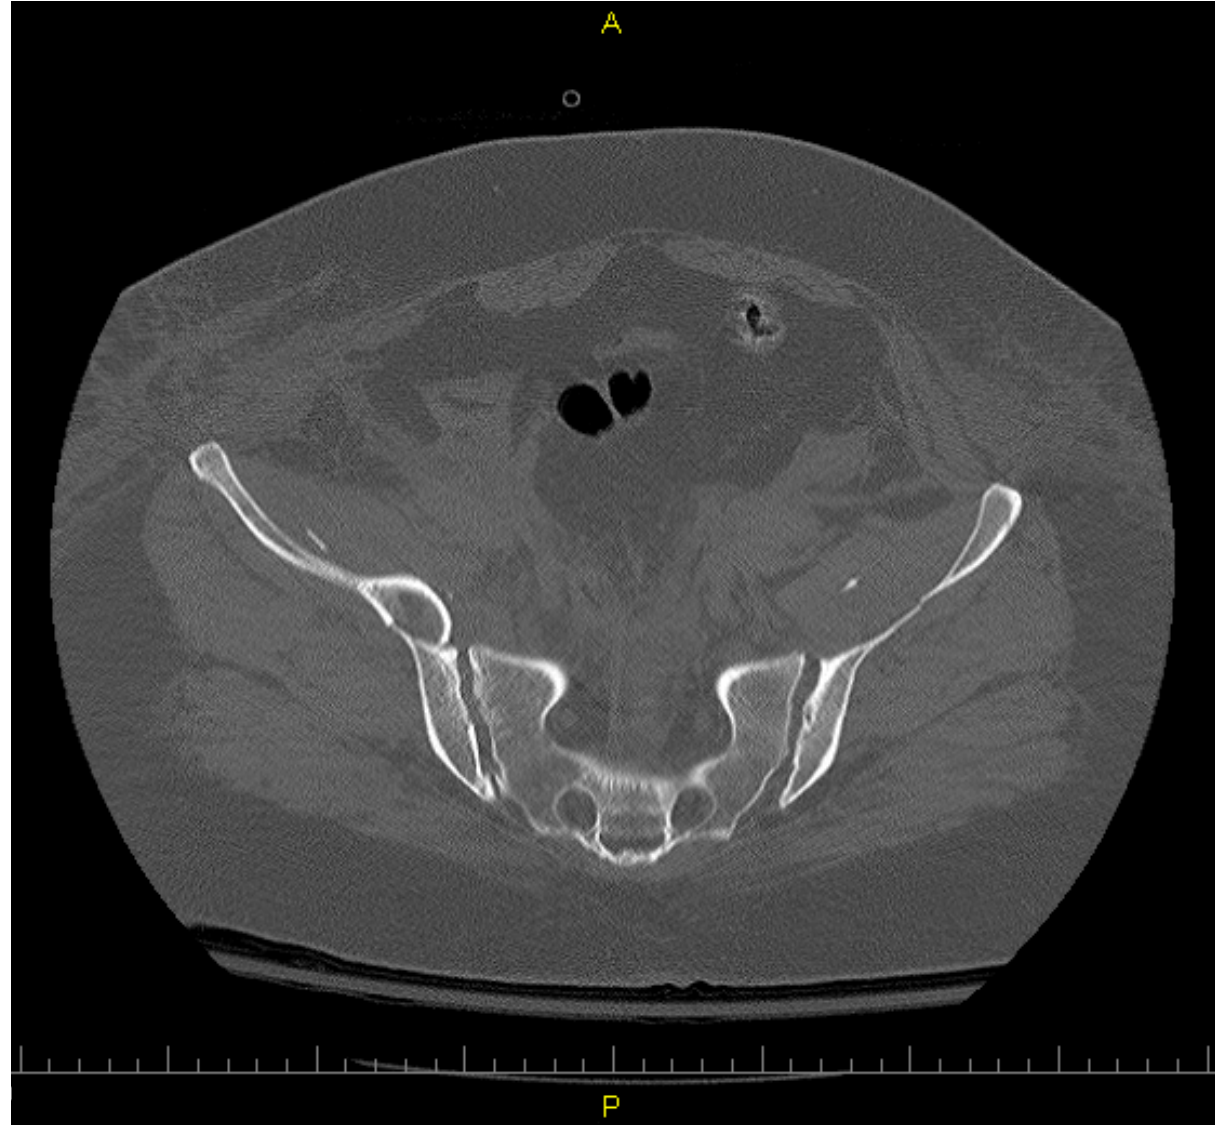
FIG 4 CT pelvis in a Binder

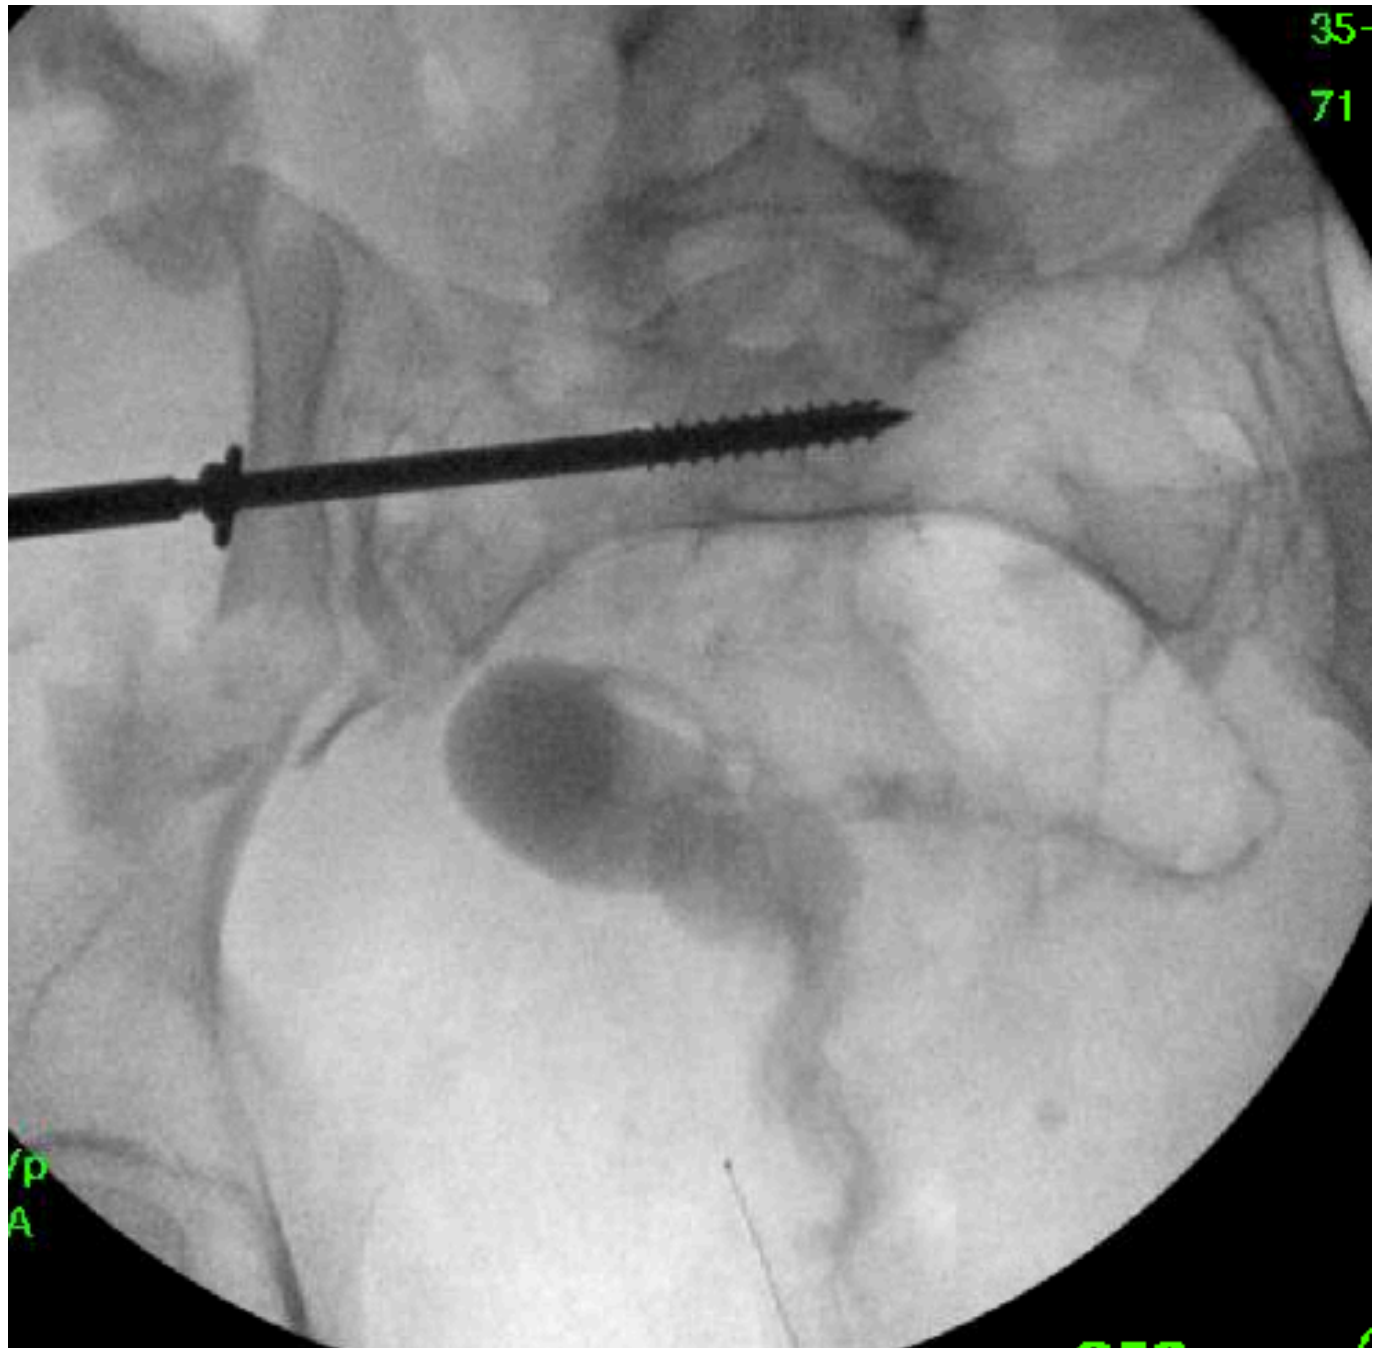
FIG 5

We started by
reducing the
posterior right
iliac fracture and
SI injury fixed
with an SI screw

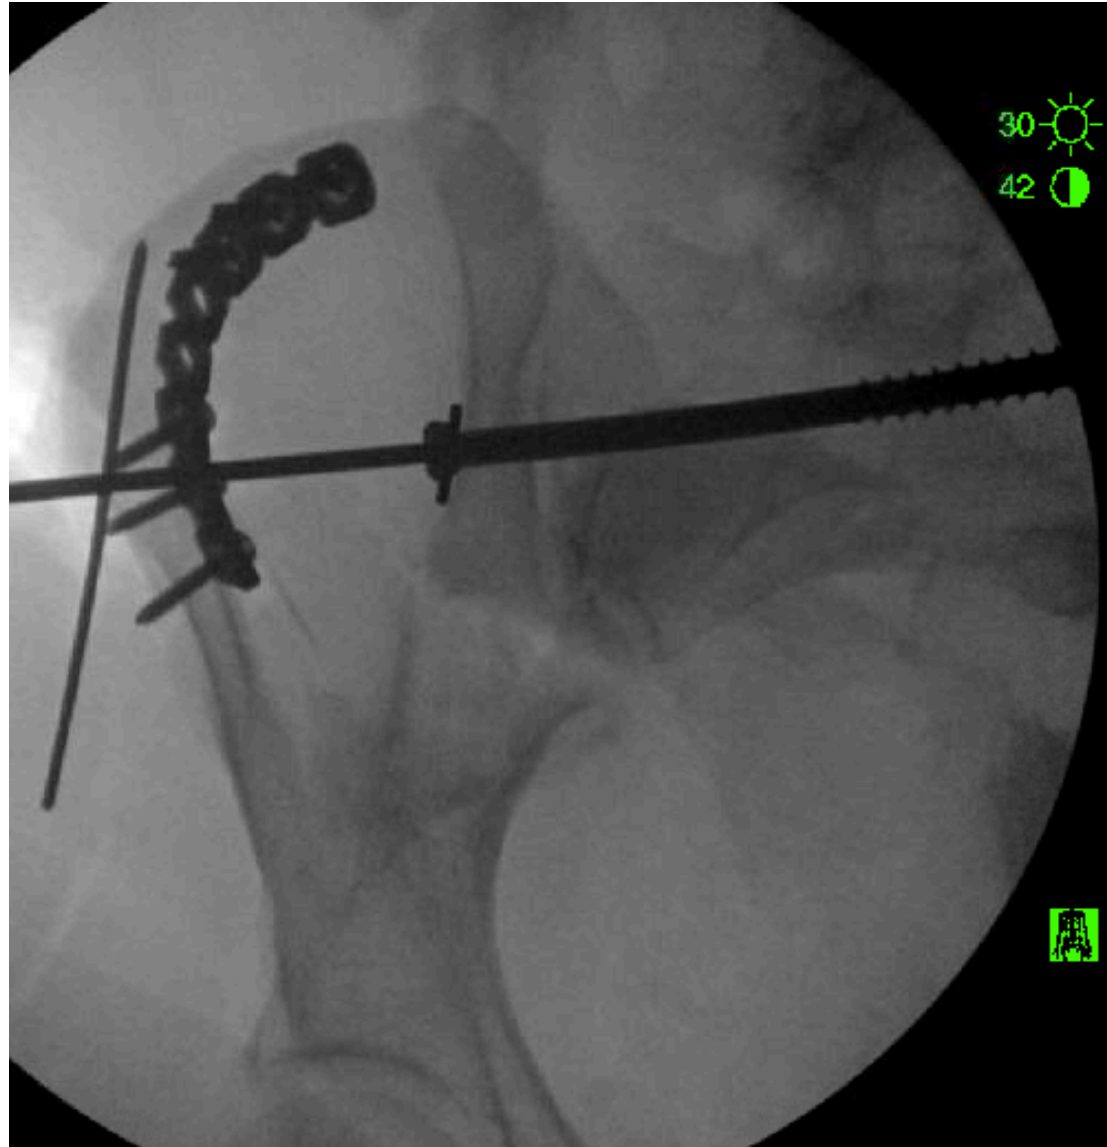
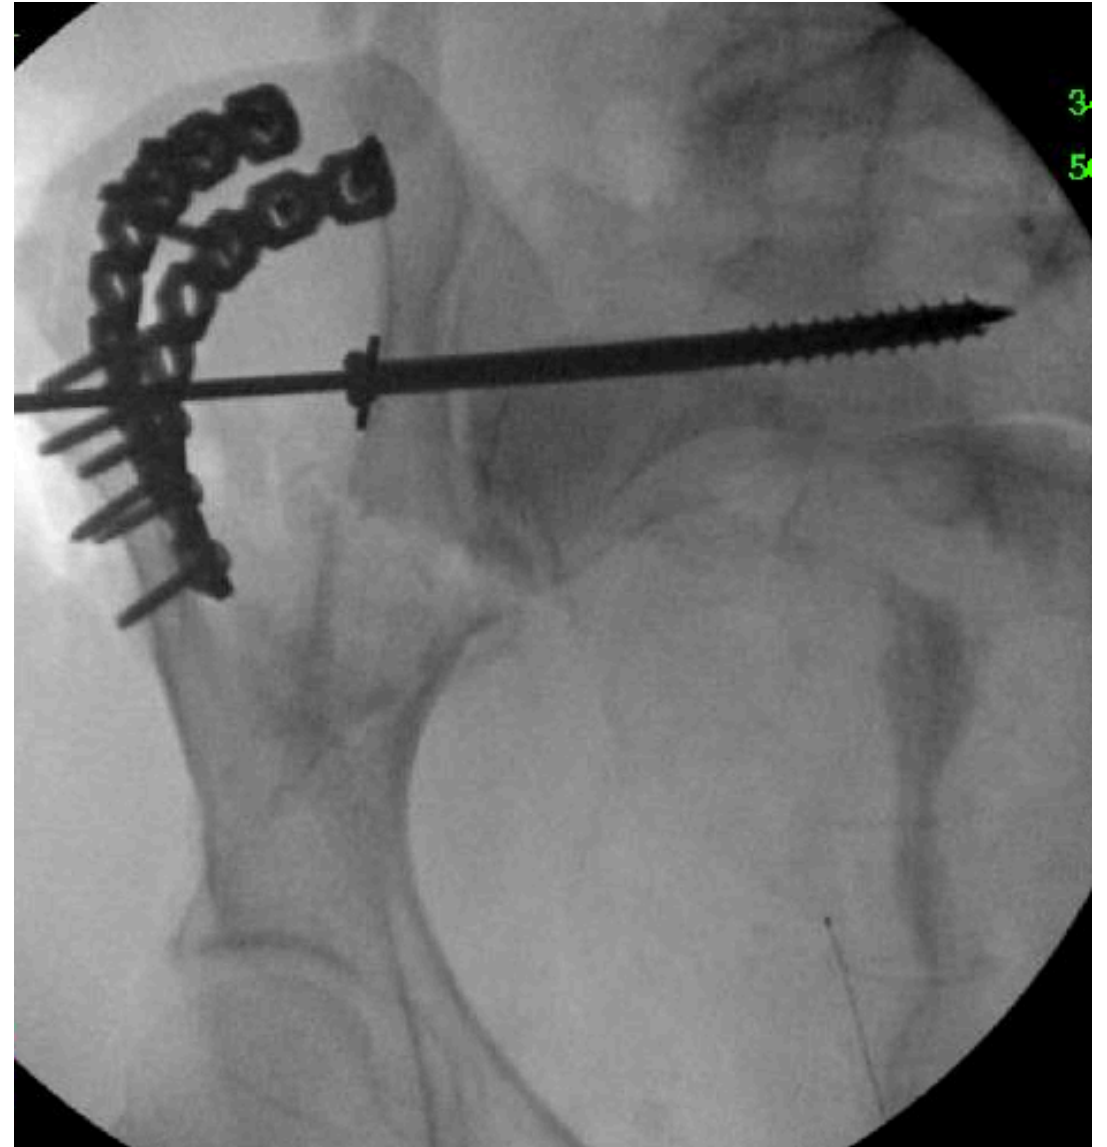
FIG 6 Iliac wing reduced and fixed at the brim and followed by an LC2 screw

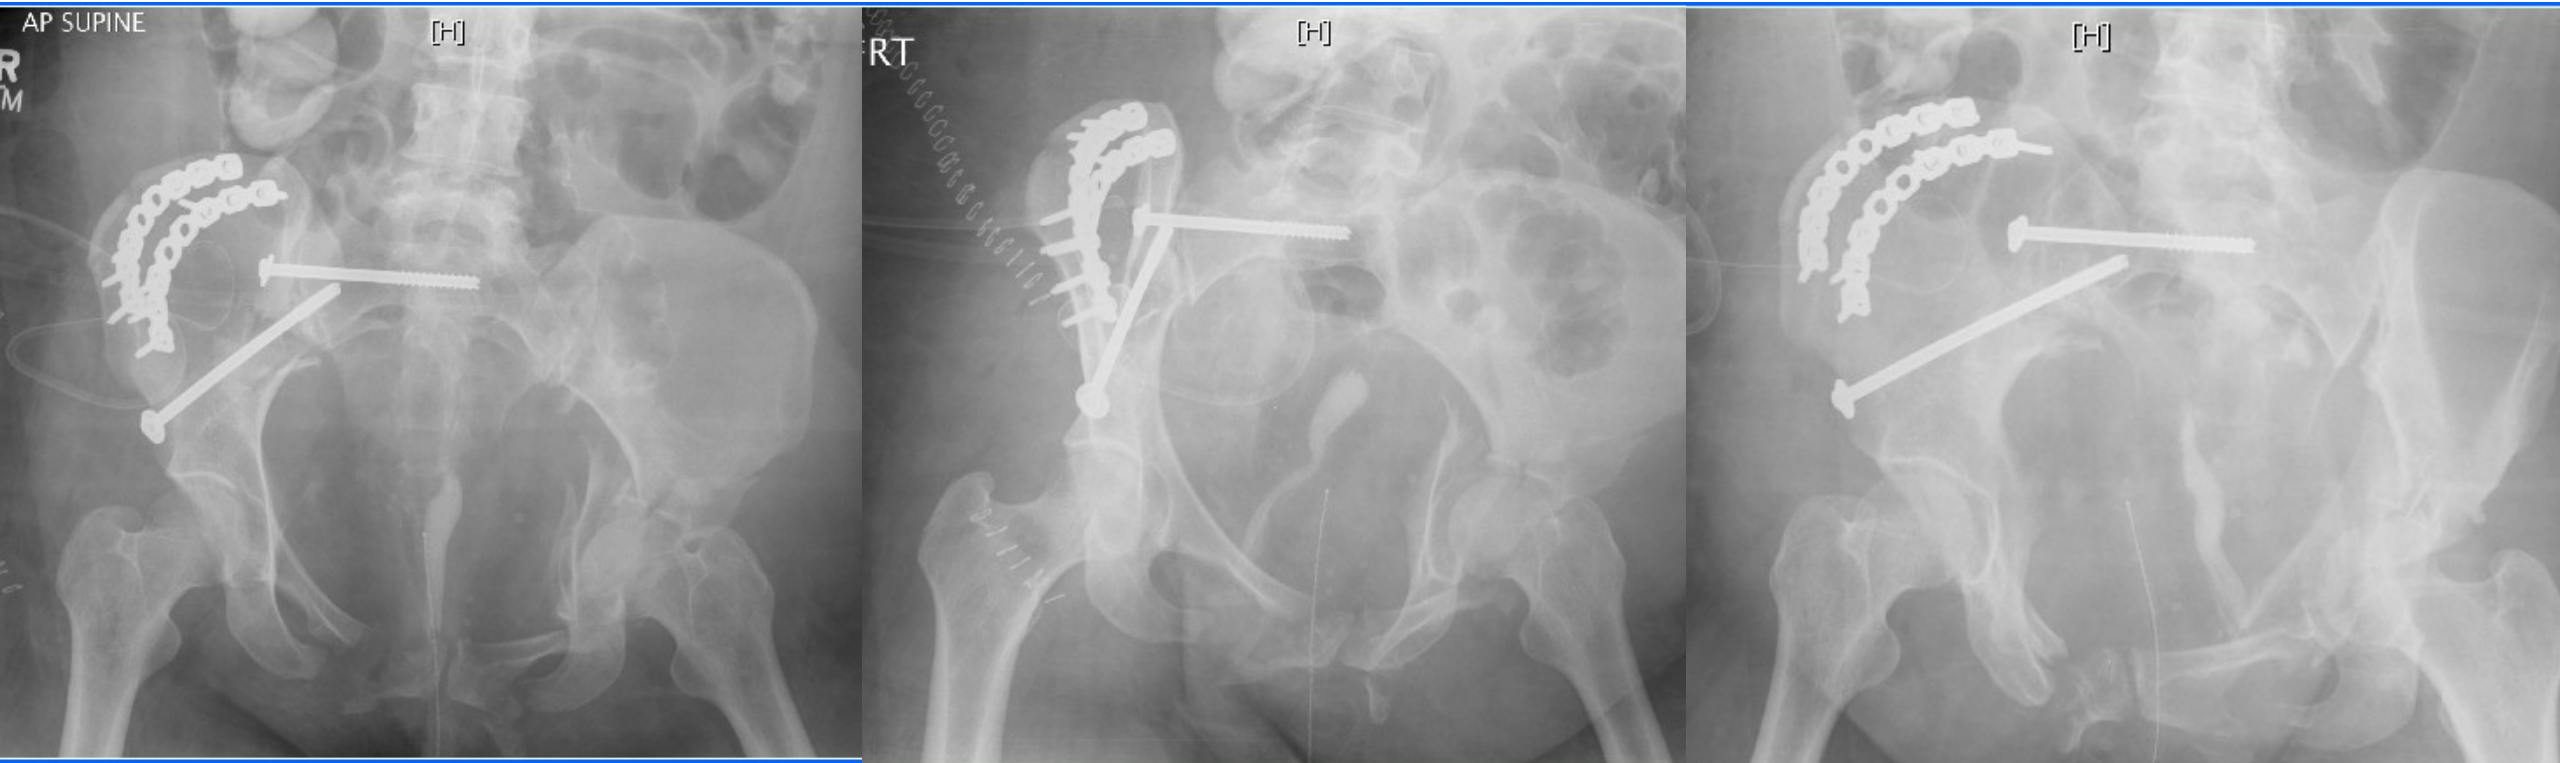
FIG 7. An LC2 screw was added AP
Obturator Oblique and Iliac Oblique views

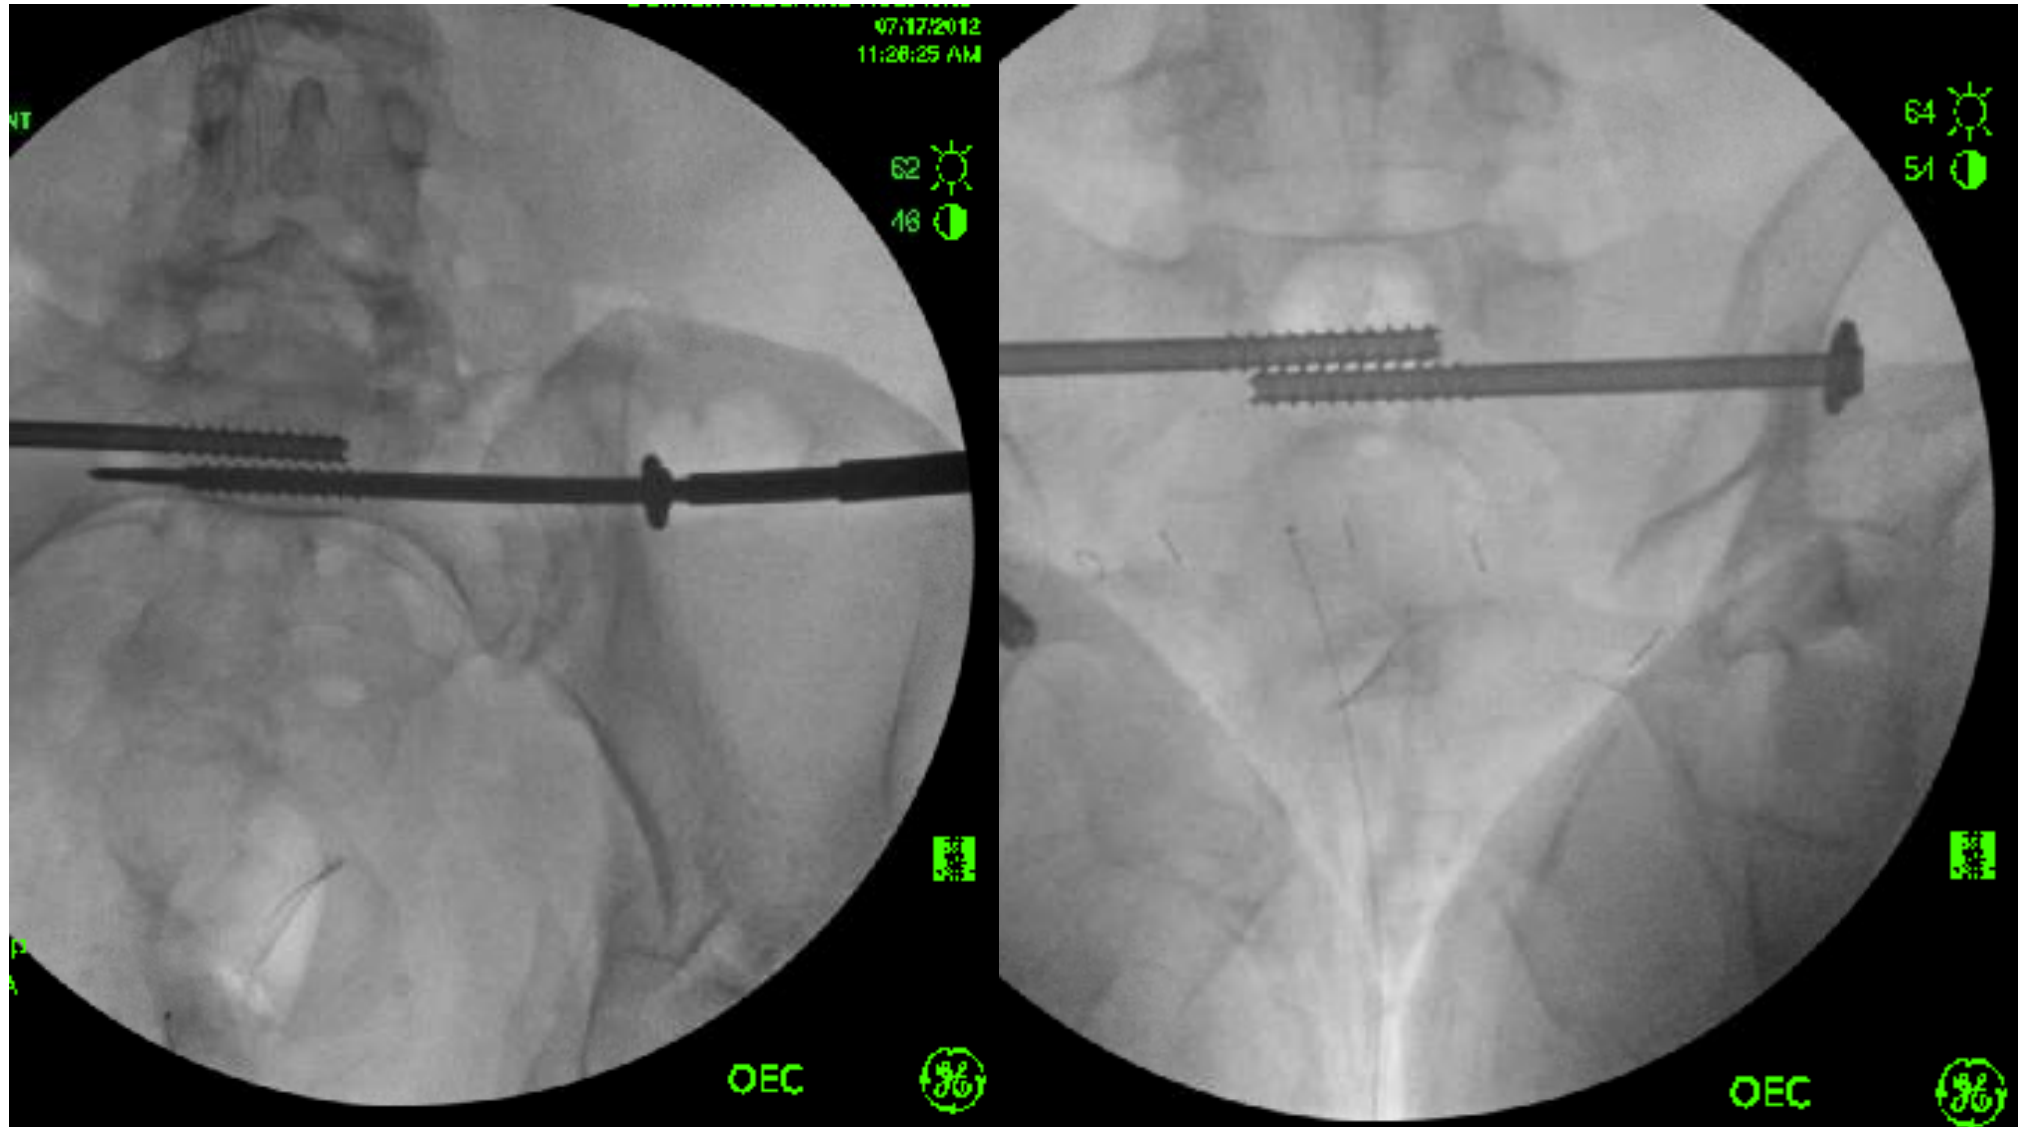
FIG 8 Left side fixed starting in the back by stabilizing the SI partial injury with an SI Screw

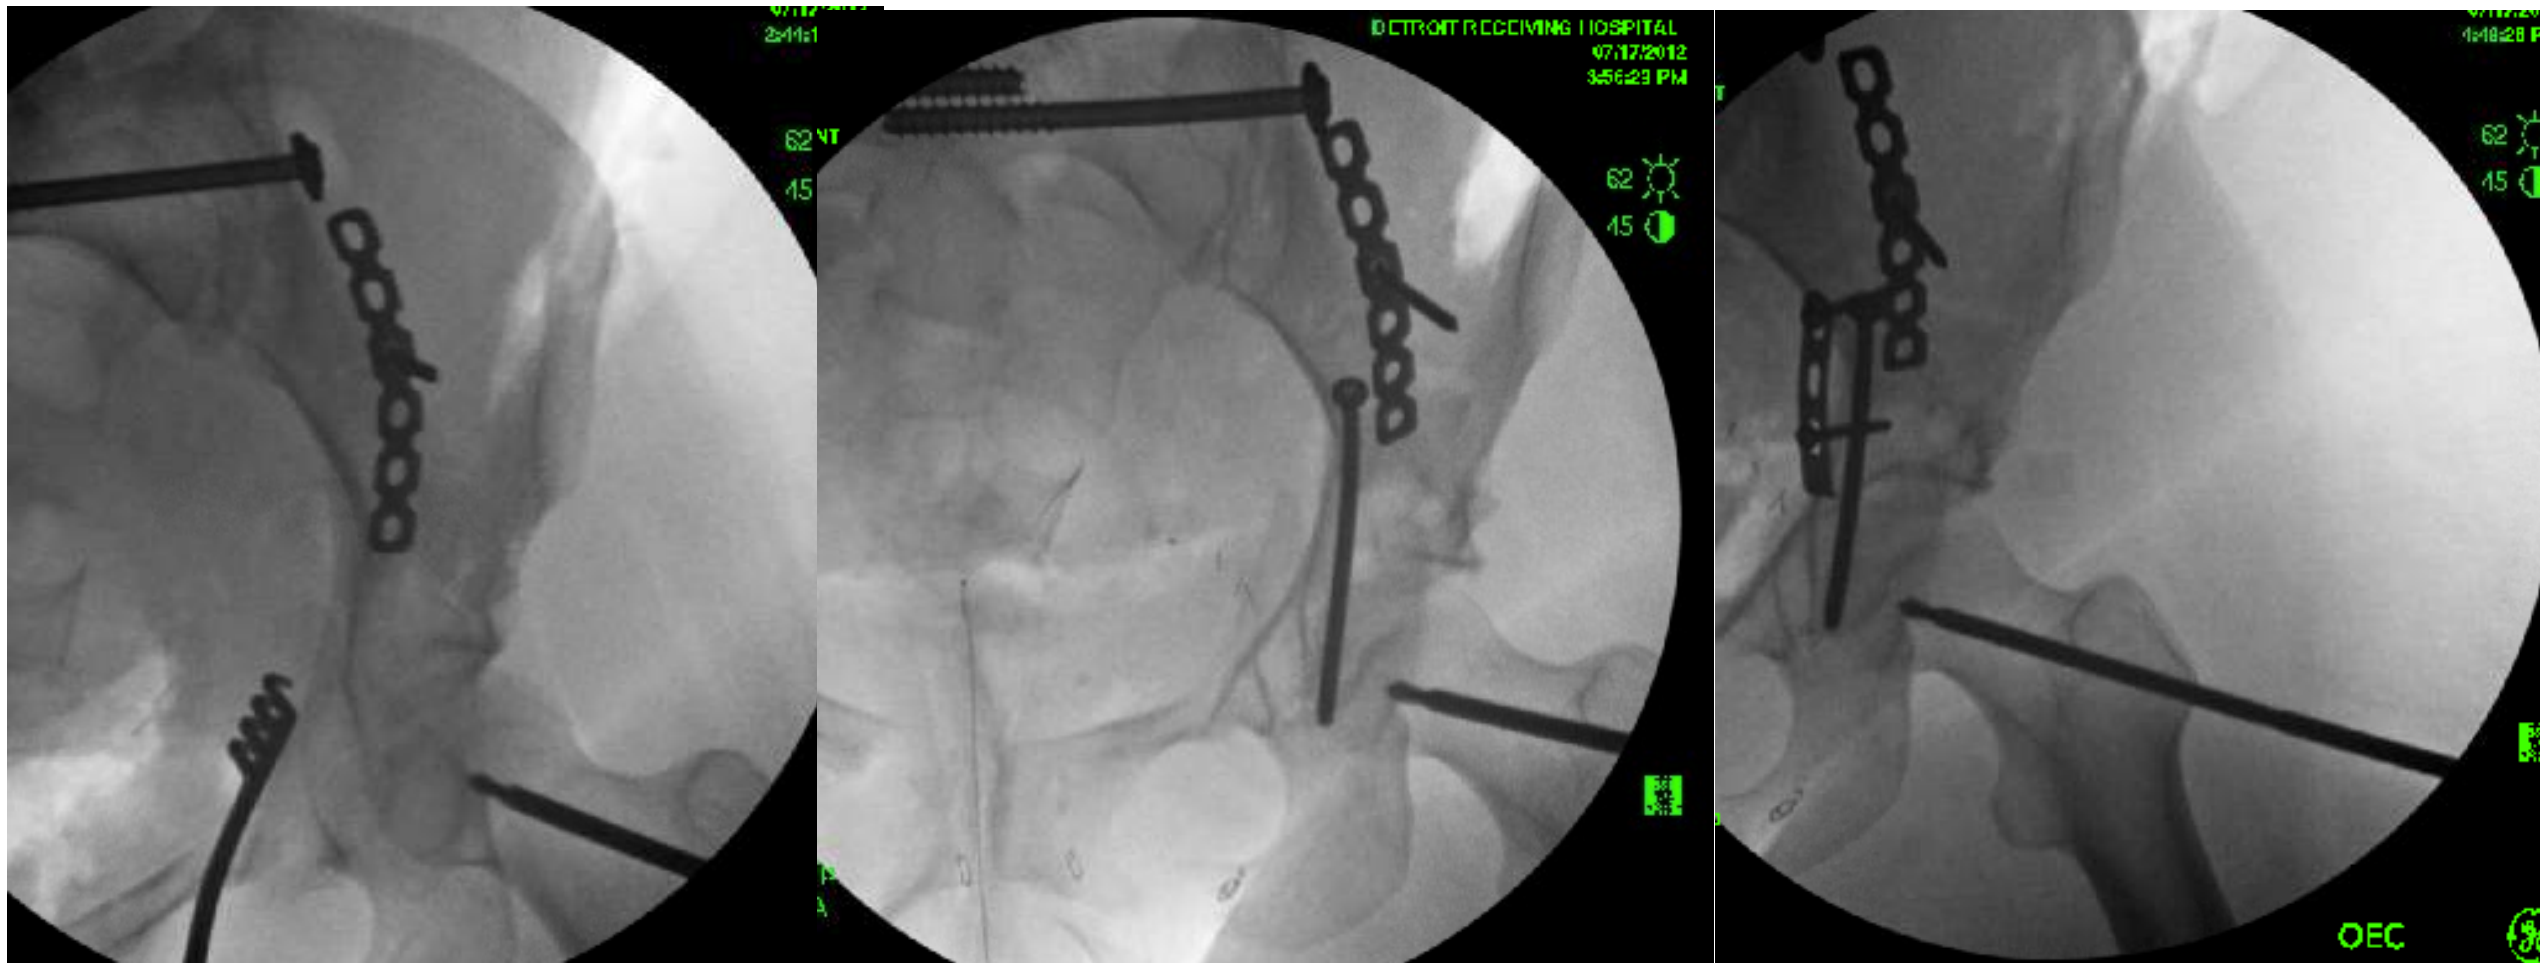
FIG 9 Reduction of iliac fracture, traction on the hip and acetabular dome

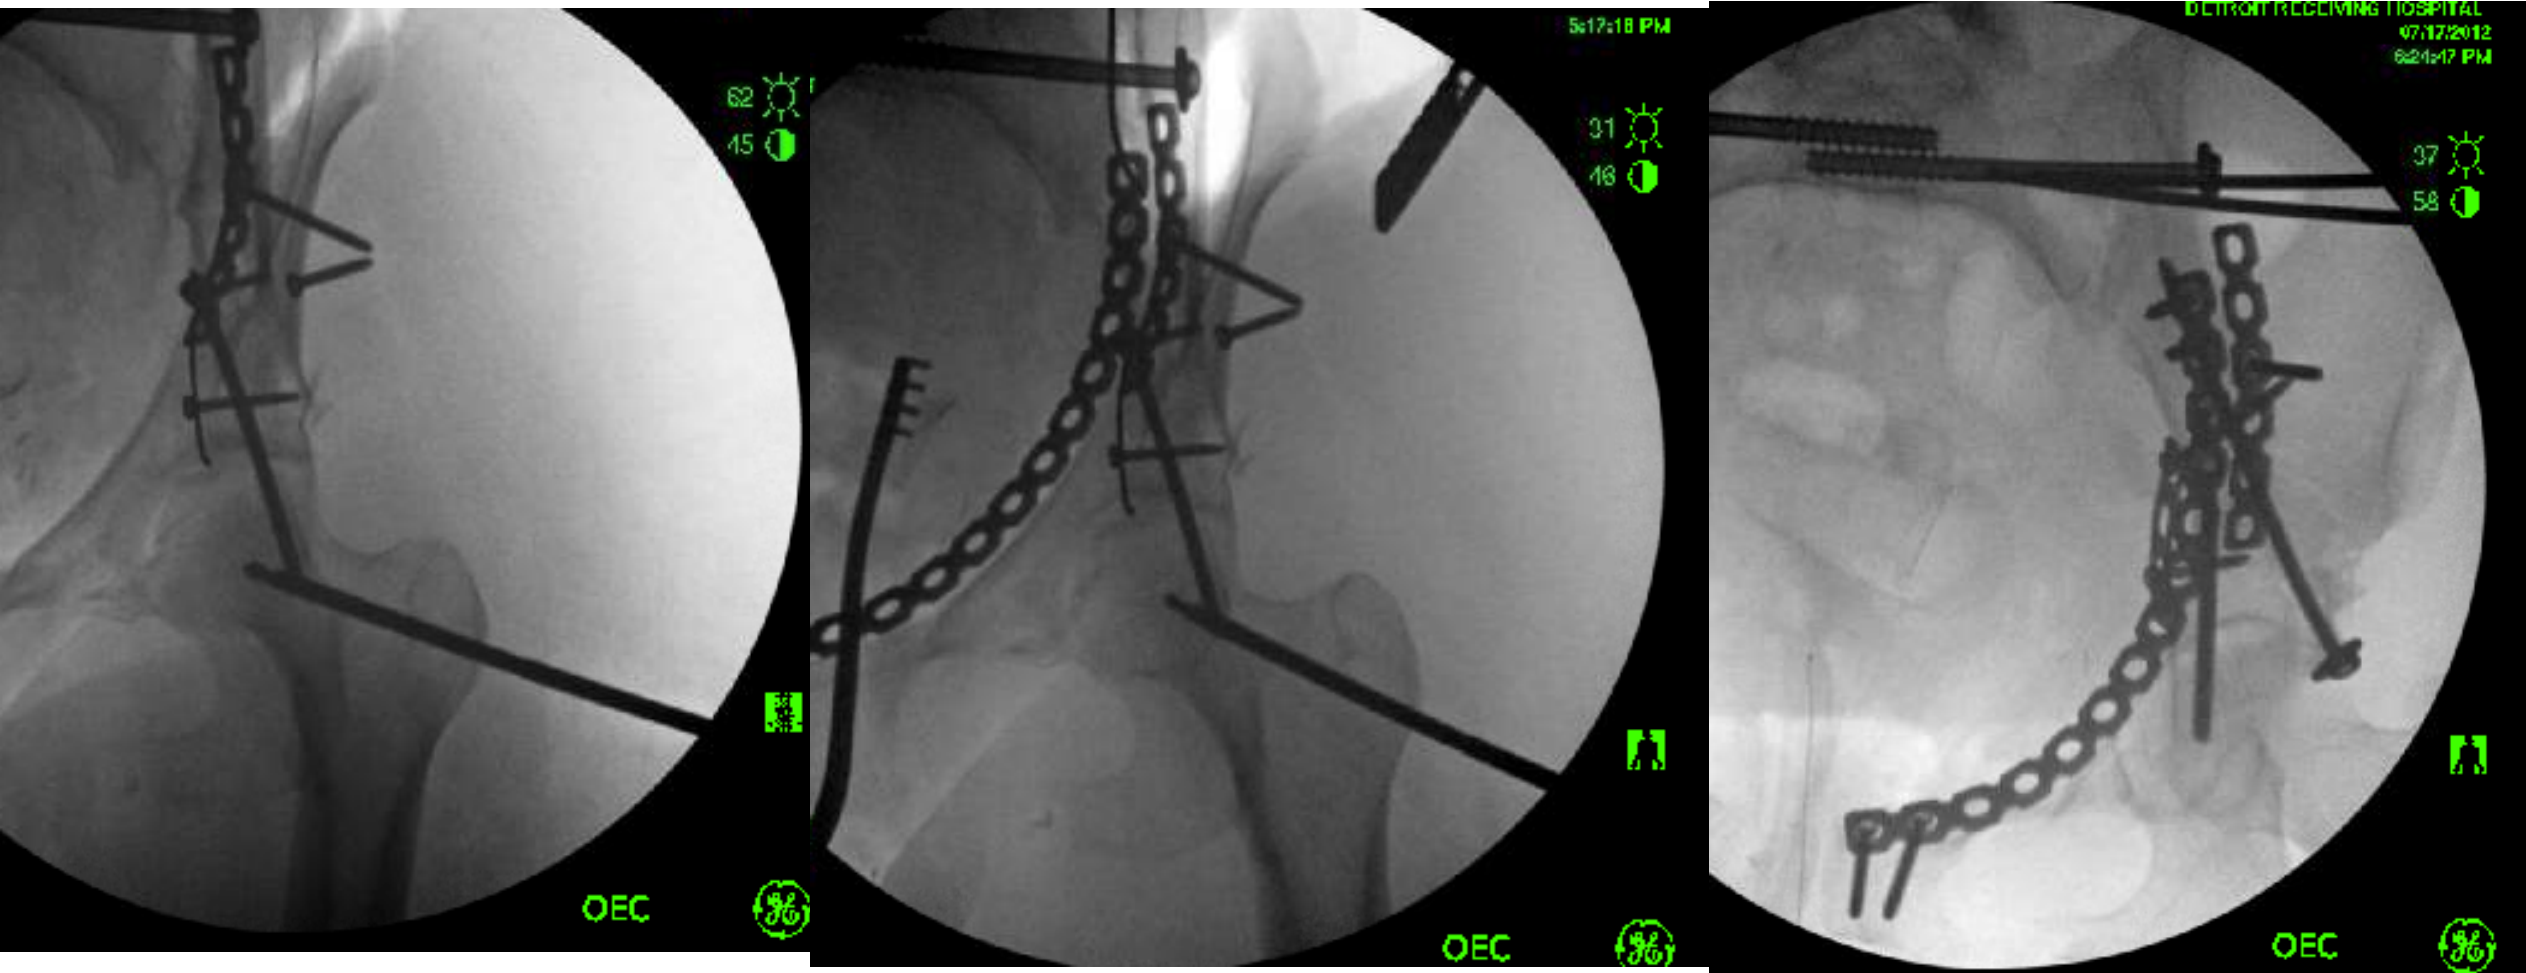
FIG 10 Anterior column and quadrilateral plate buttress and a front to back AILS toward PSIS screw to hold the low anterior column fragment

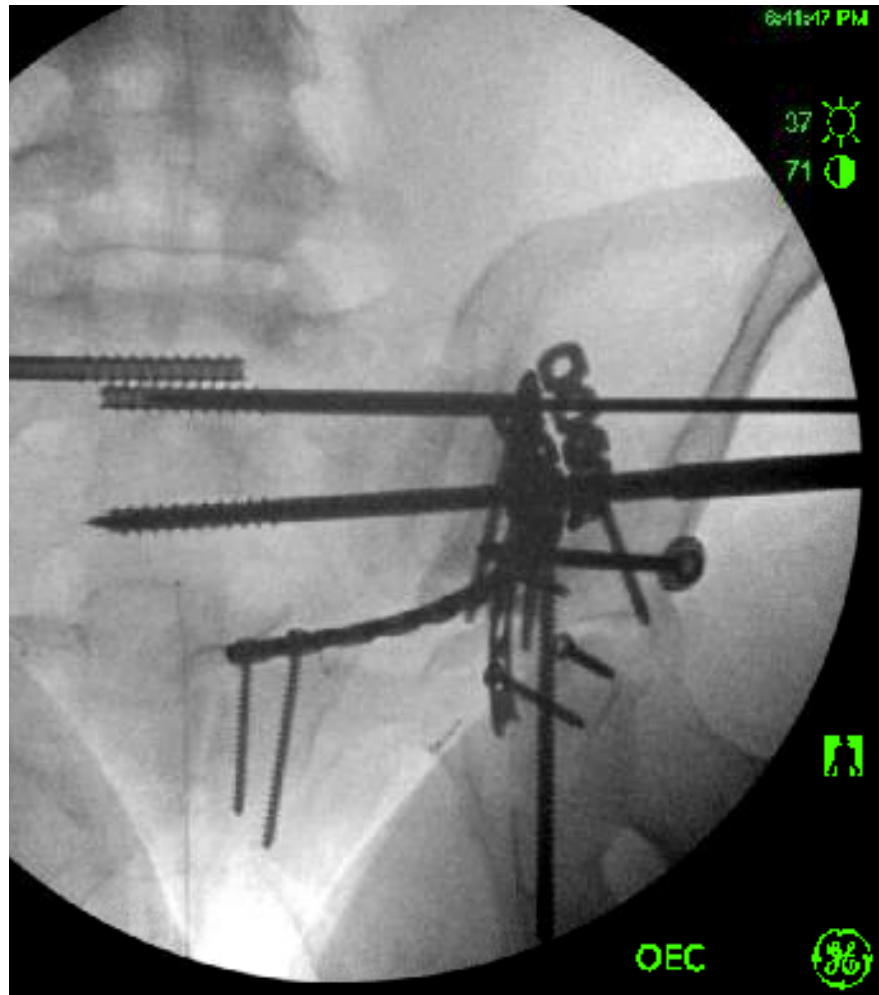
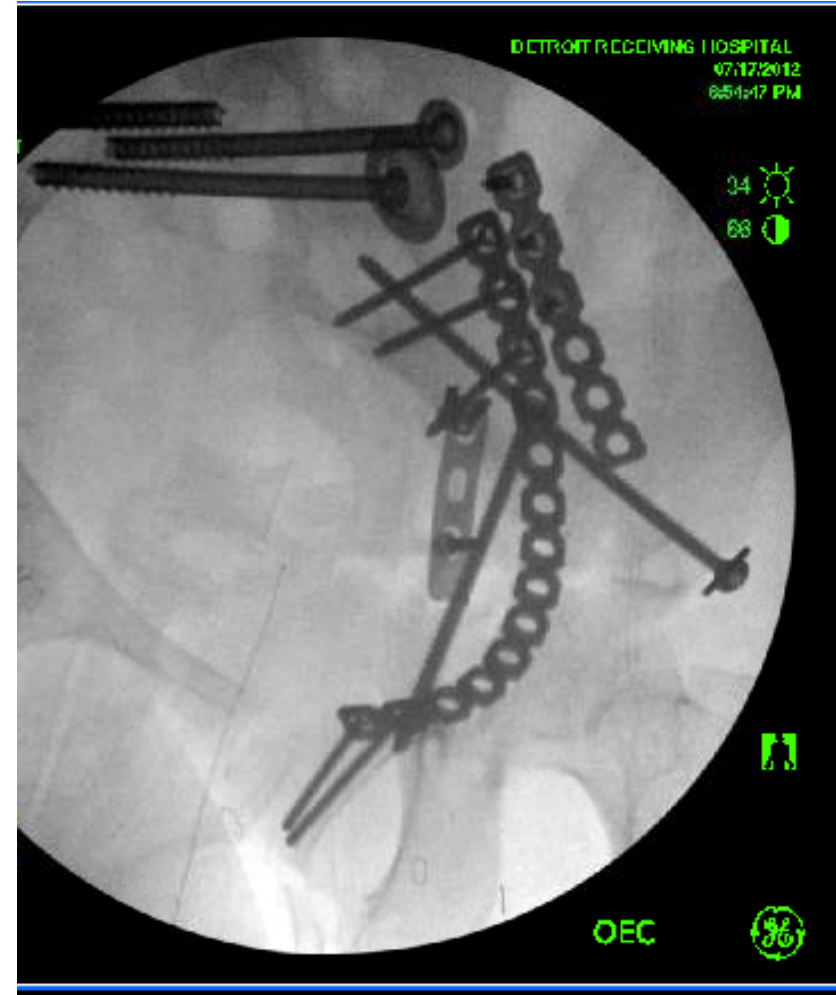
FIG 11 The patient started bleeding deep in the wound which had to be packed and the patient transfused. We stopped progression of the surgery
