Original AP Pelvis x-ray
in ER 35 yo female with
an 61C31.b injury

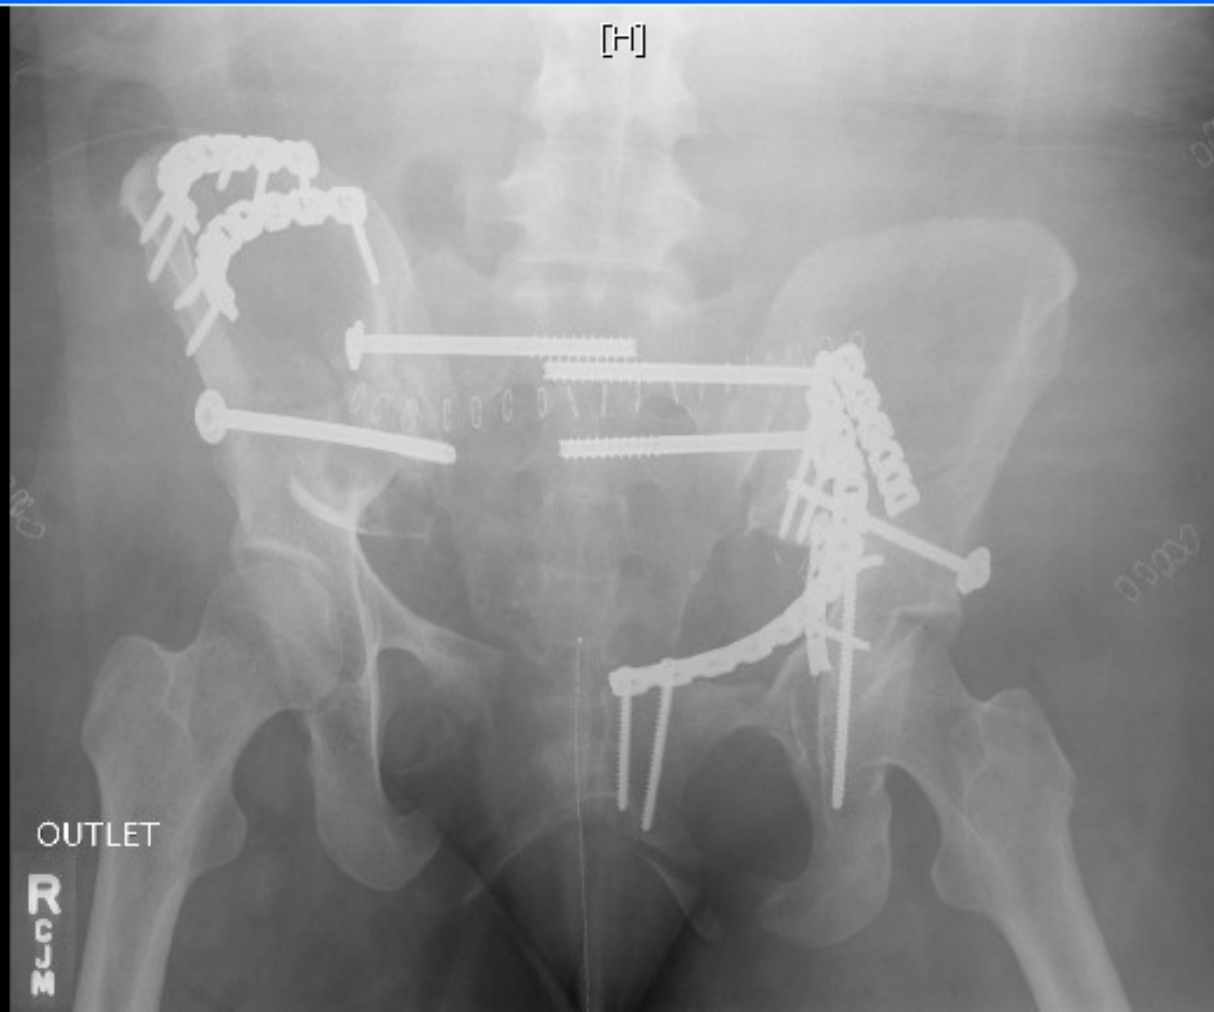
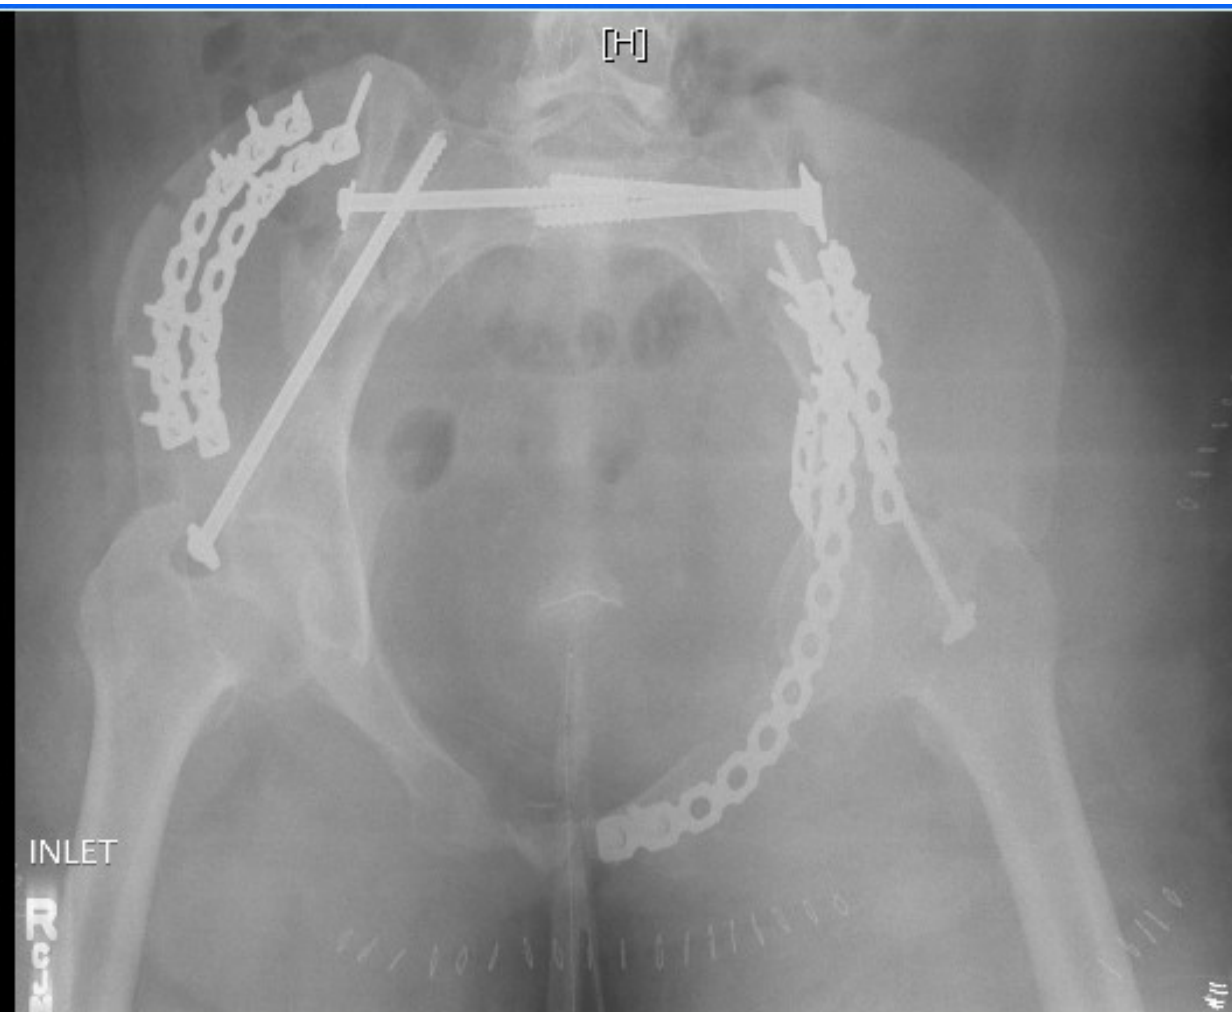
FIG 12 AP and INLET views

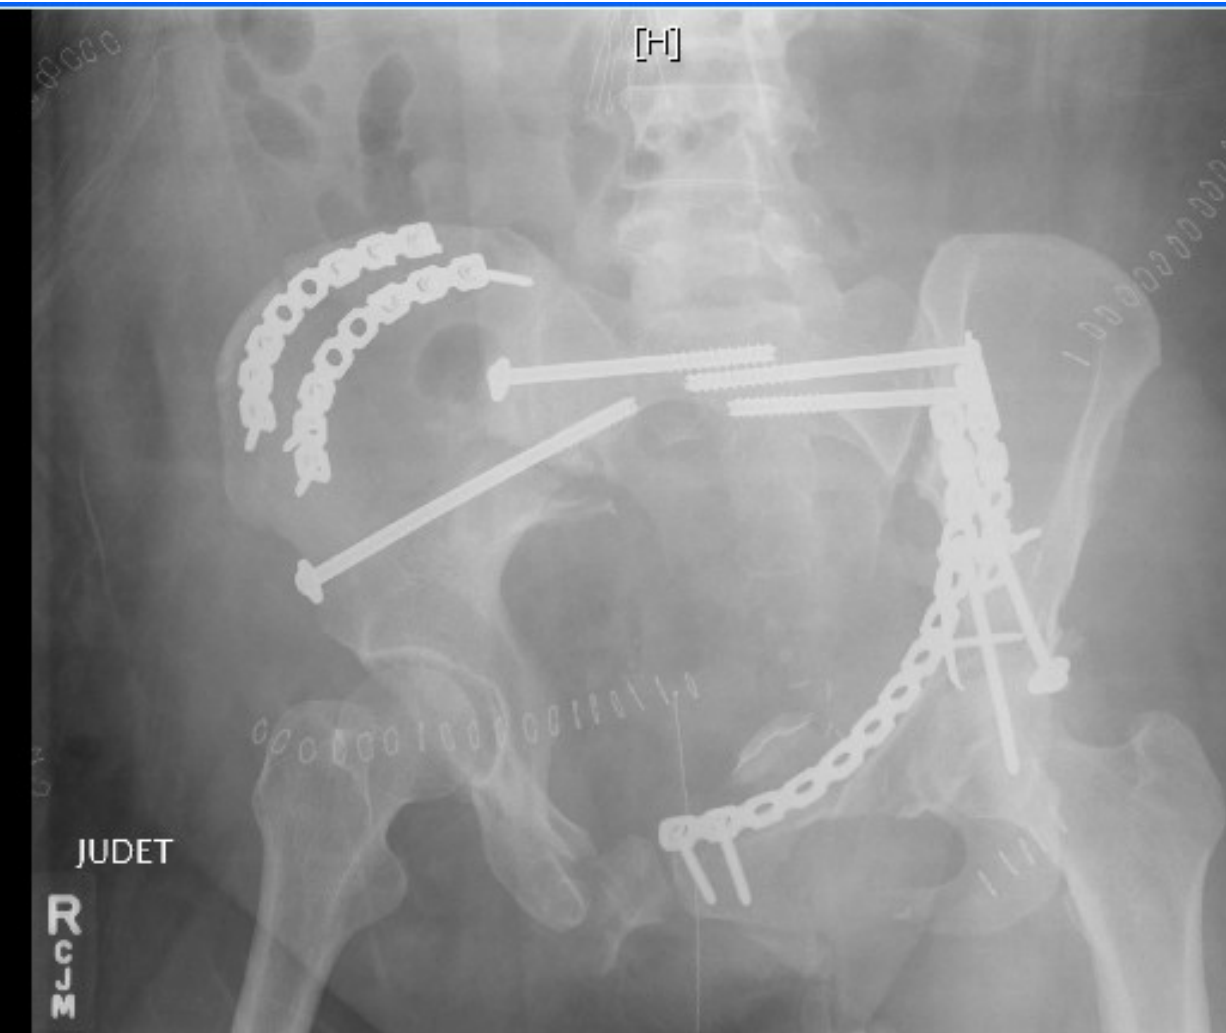
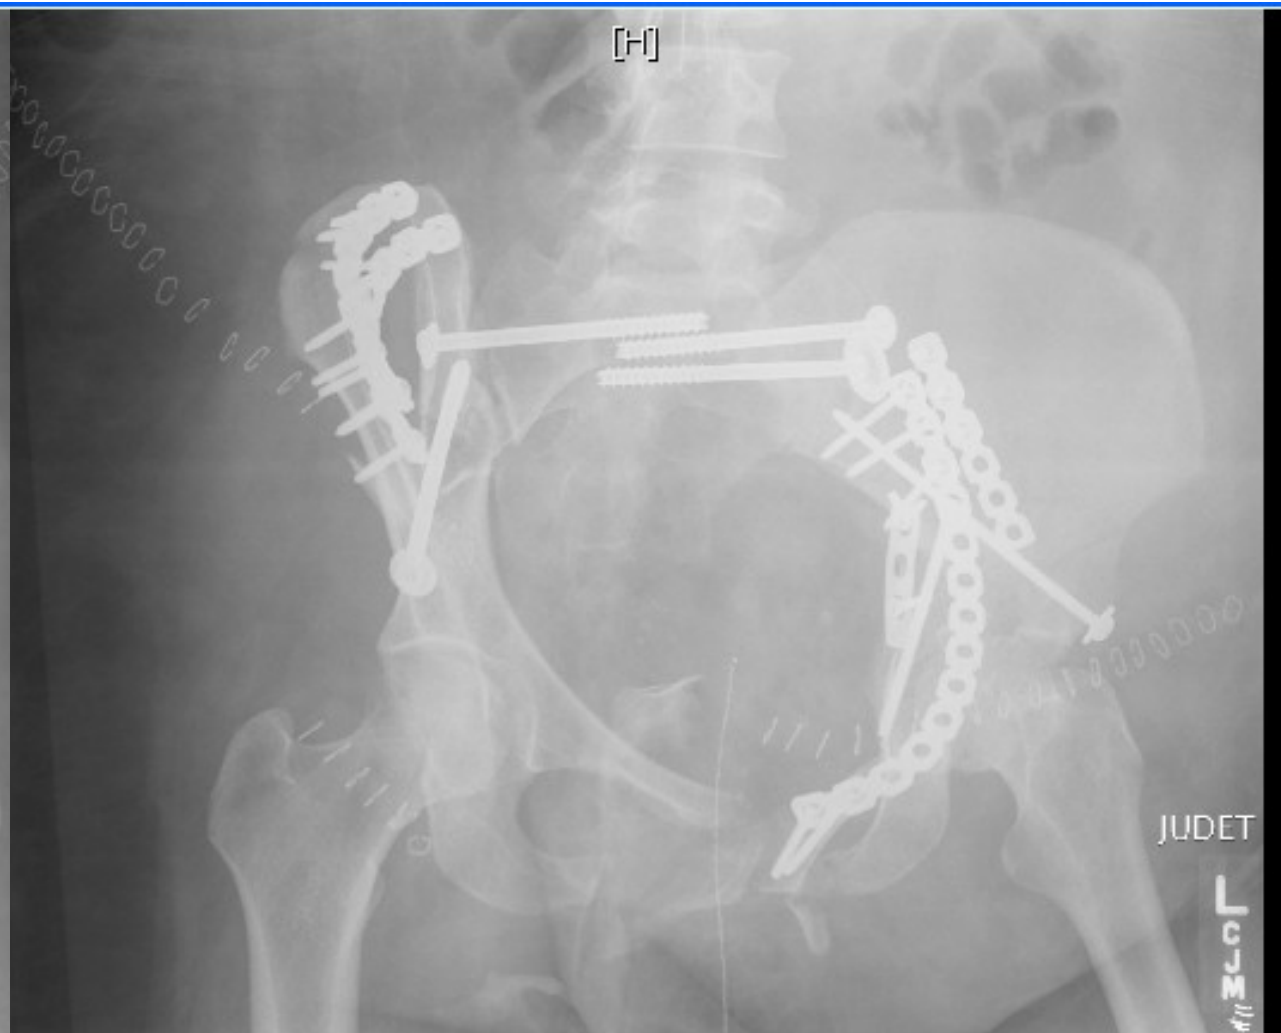
FIG 13 JUDET views

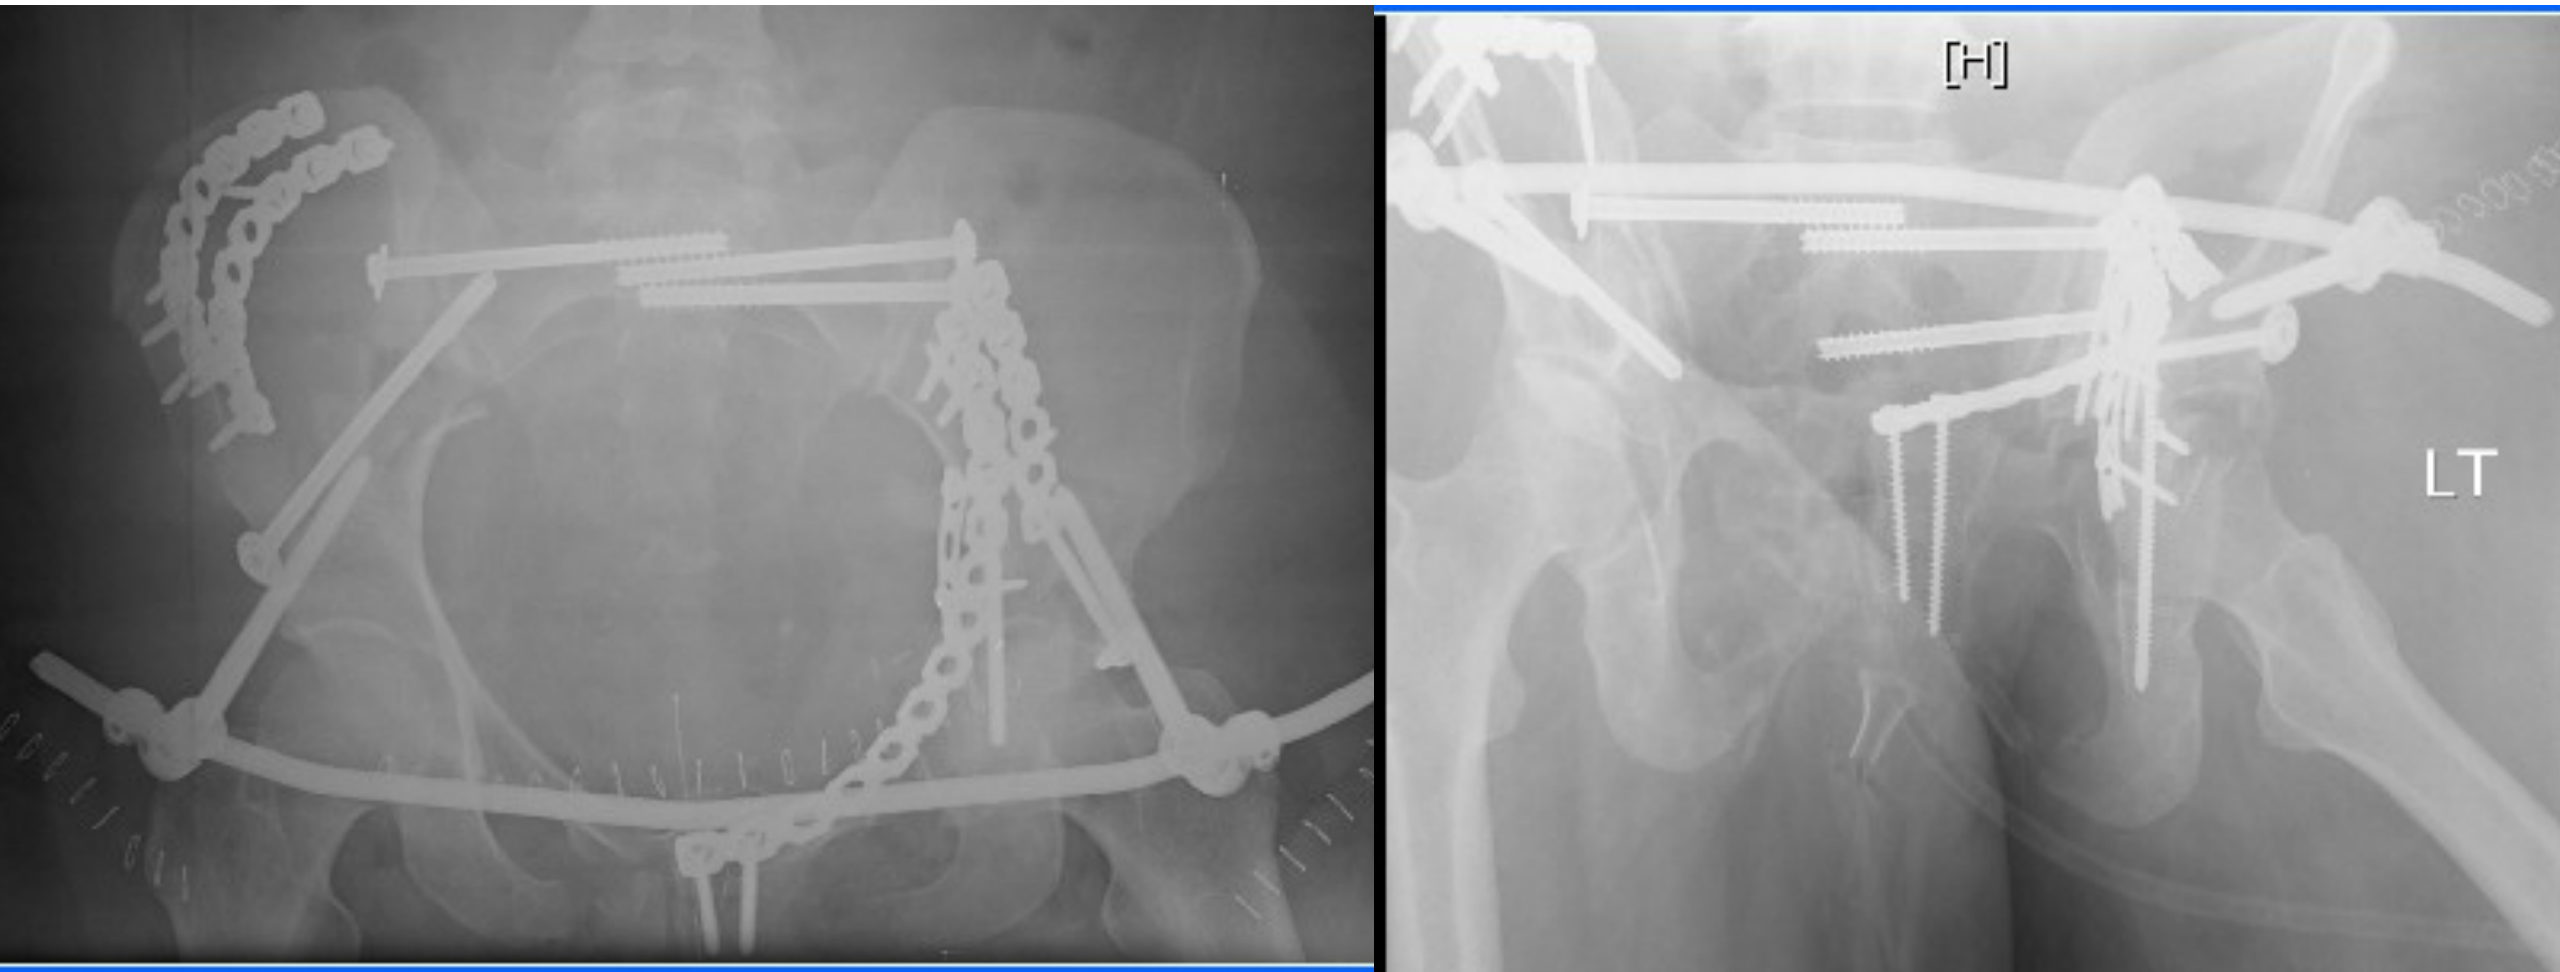
FIG 14 Subsequent bridging fixation with
INFIX 2 days later

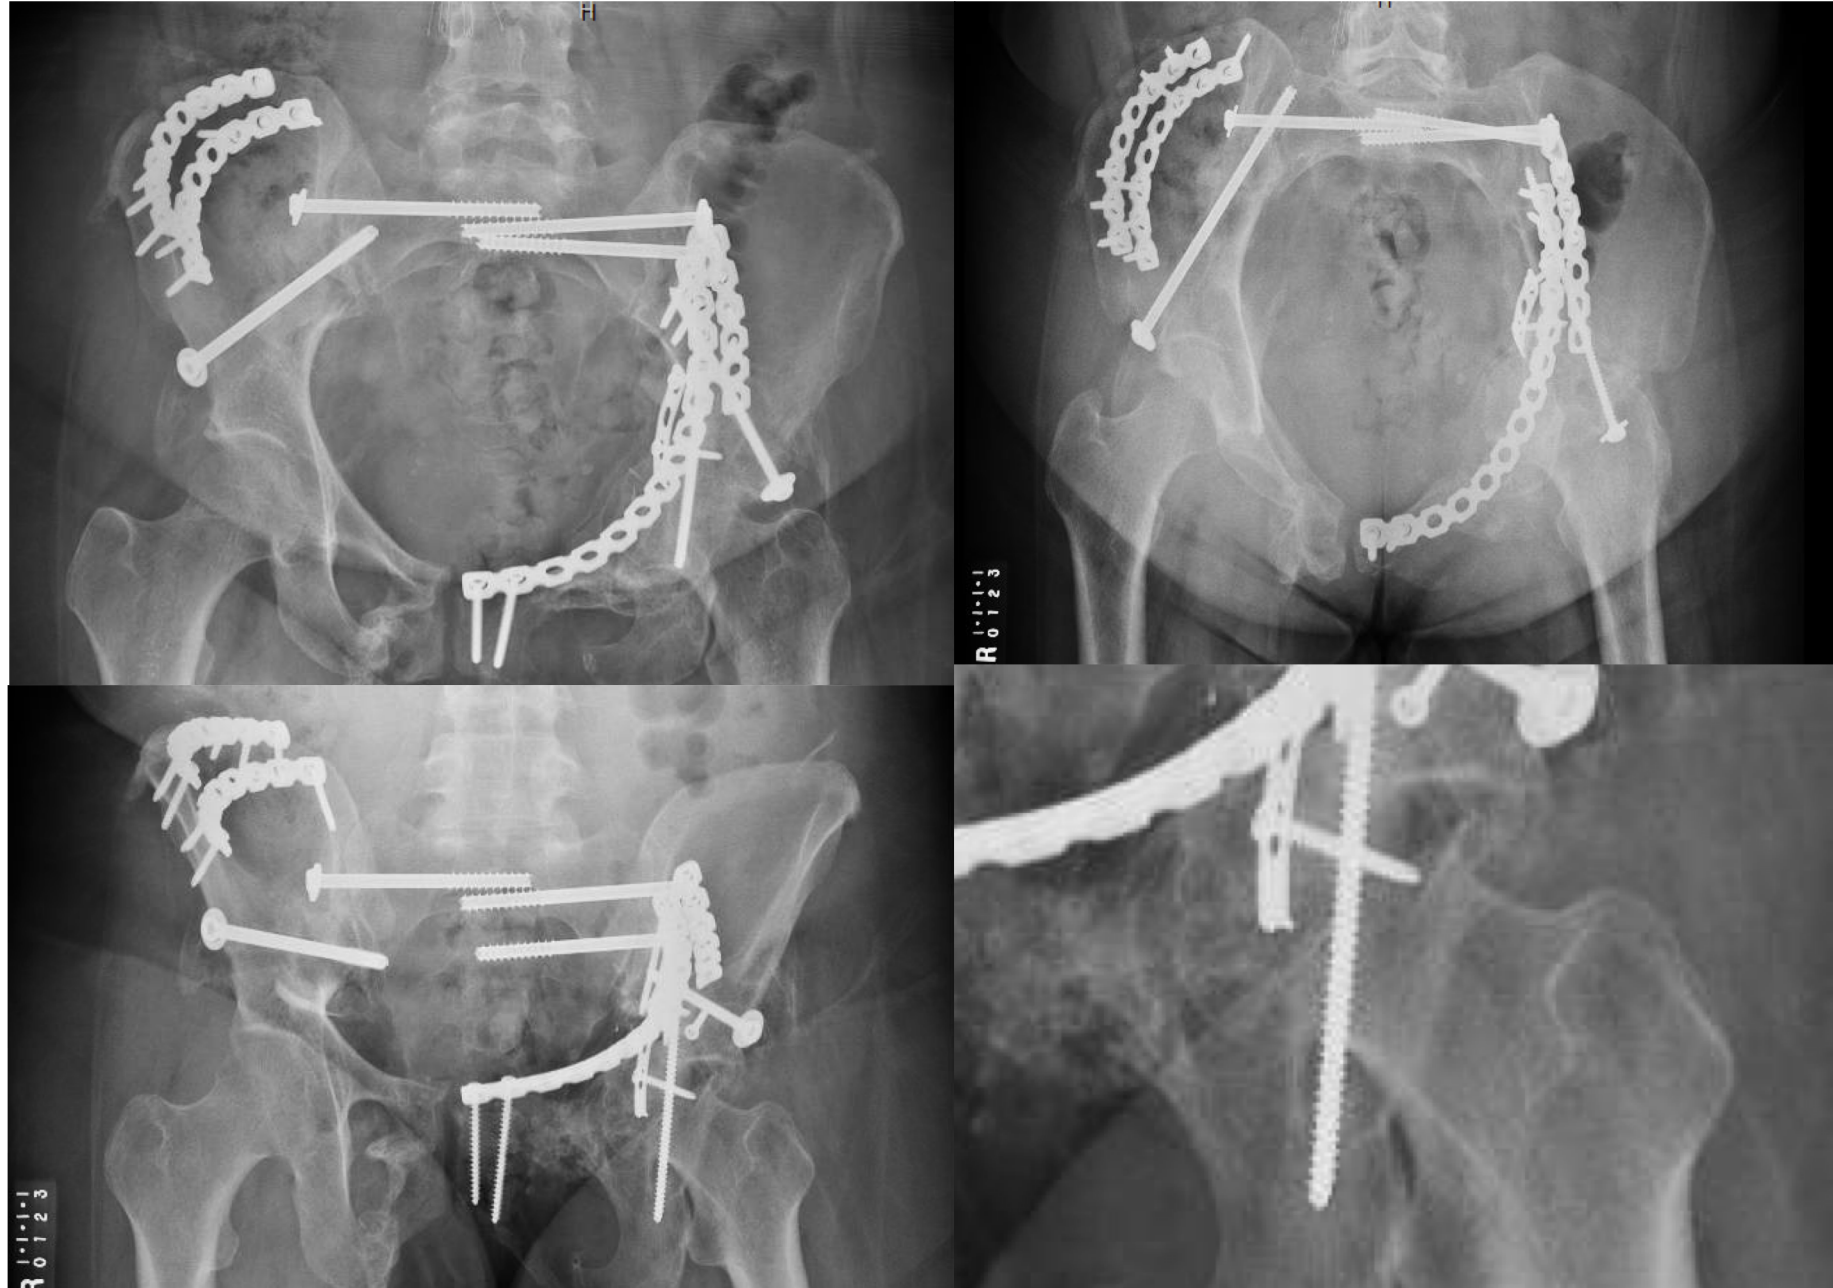
FIG 15
2 year FU
after INFIX
removal .
Patient goes
on to OA and
collapse of
the
acetabulum

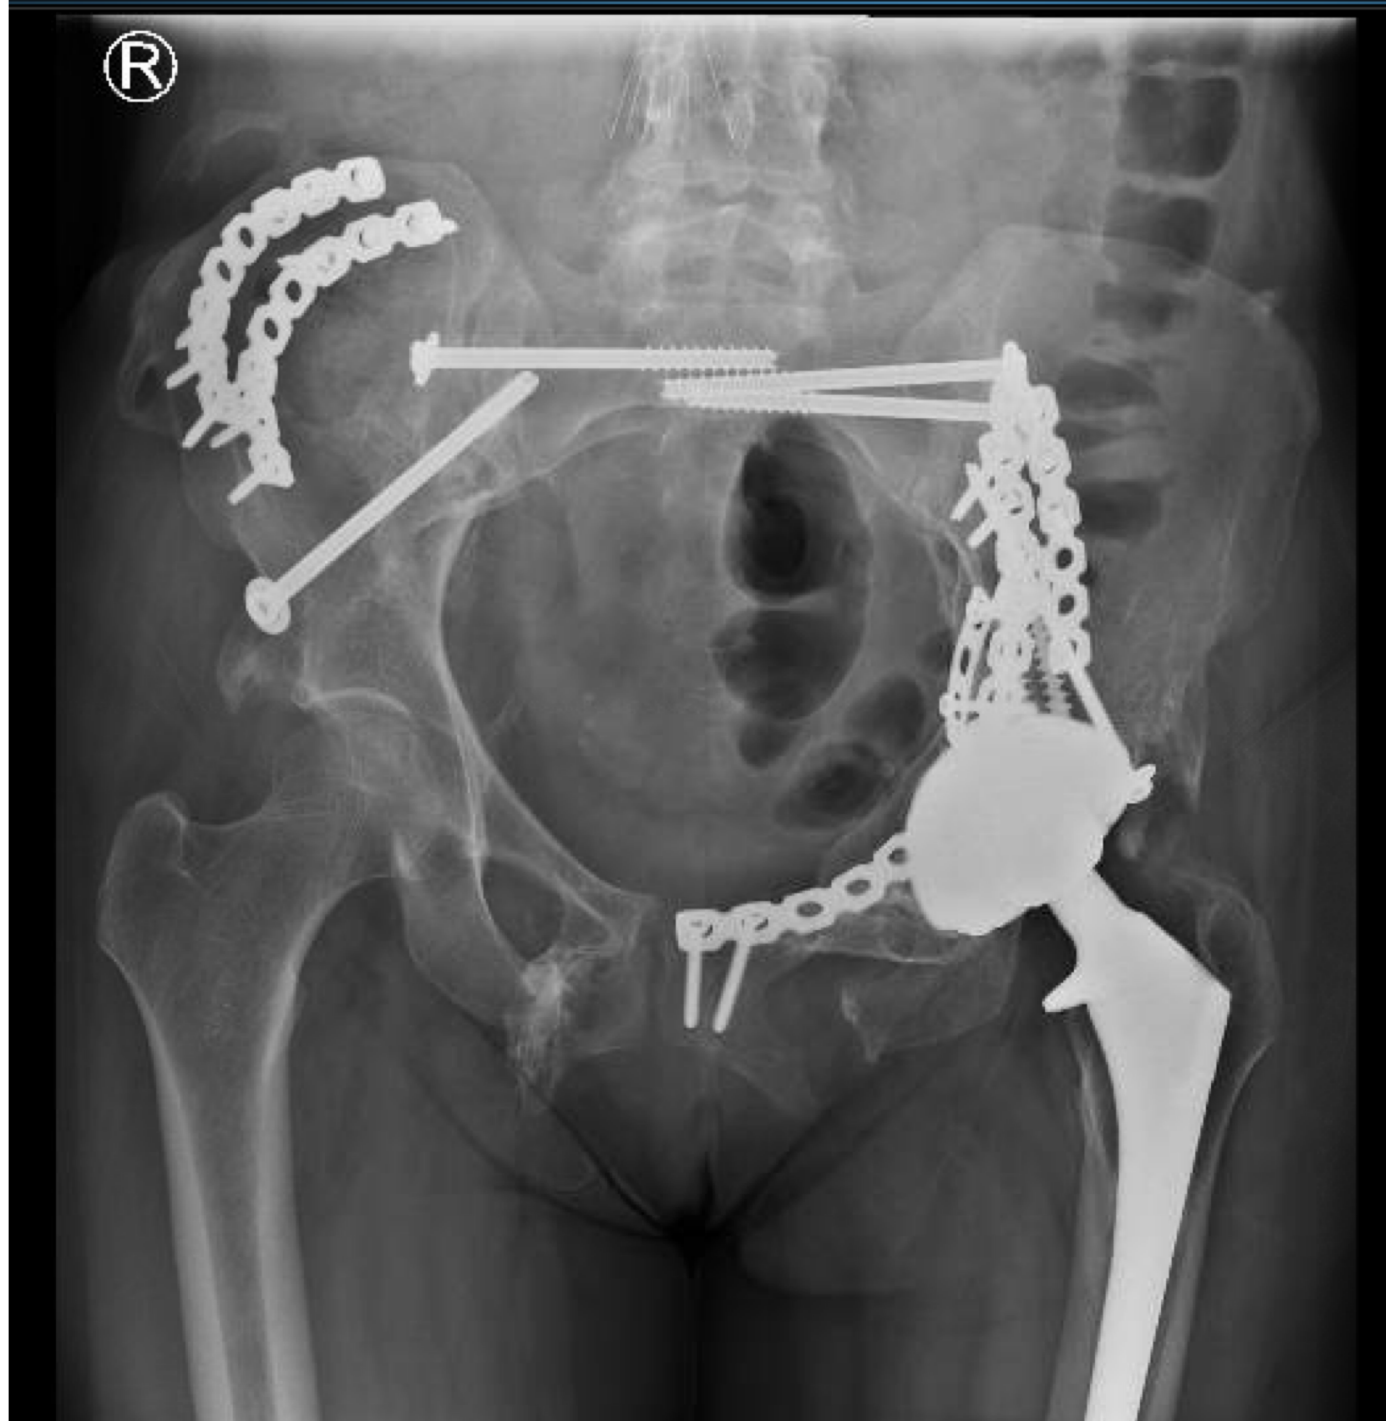
FIG 16
With subsequent
THA
