Yurteri-Kaplan LA and Park AJ. Surgical ergonomics and preventing work-related musculoskeletal disorders. *Obstet Gynecol* 2023;141.

The authors provided this information as a supplement to their article.

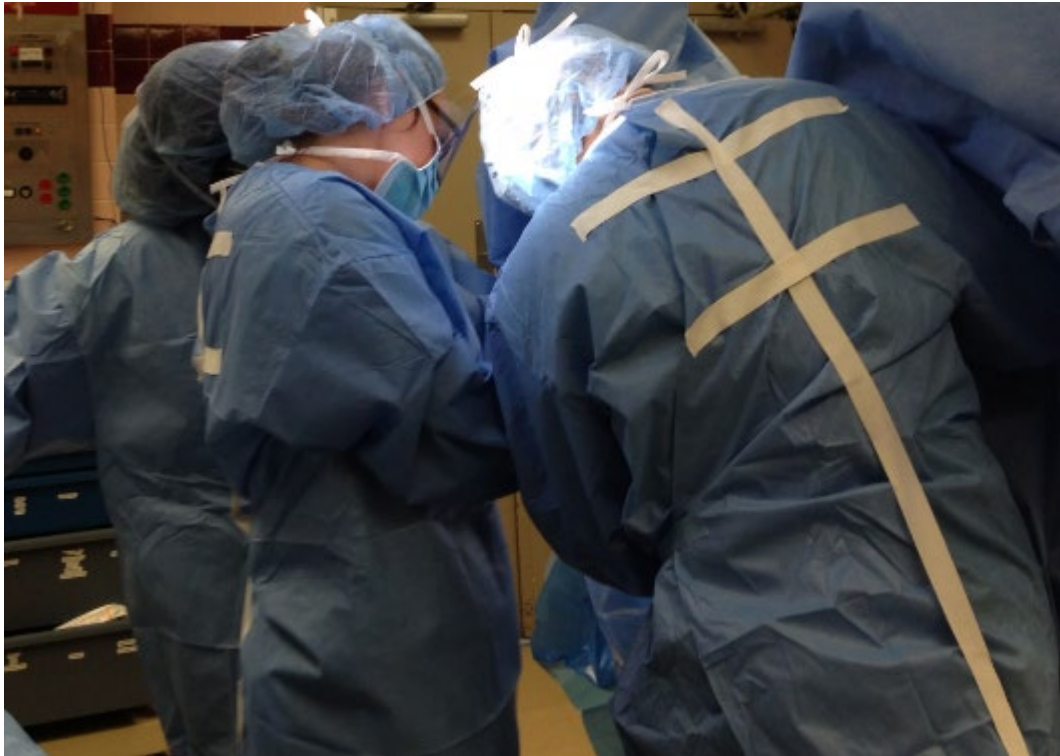
Appendix 1. The primary surgeon is leaning to left with weight bearing on left leg with excessive neck flexion. The assistant on the patient's left has trunk flexion, left neck deviation, and weight bearing on the left leg due to height discrepancy and poor visualization.

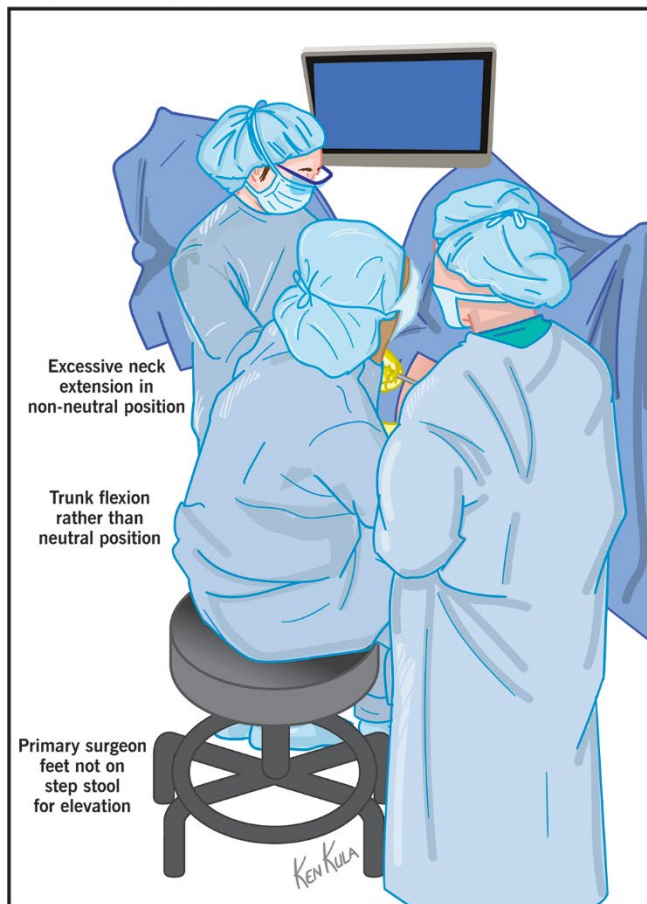
Vaginal surgery (seated) - Incorrect

Appendix 2: This is a cartoon depiction of incorrect ergonomic vaginal surgery. In the seated picture, the primary surgeon is trunk flexed forward and neck in excessive extension. There is no step stool to assure the seated surgeon has knees at 90°. There is significant difference in height between seated and standing surgeons causing assistants to have extreme neck flexion to see the surgical field. In the standing vaginal surgery cartoon the primary surgeon is significantly taller than the assistant surgeons causing the primary surgeon to flex trunk forward as well as neck. This causes less room to view the surgical field and thus the assistant on the left side of the patient is also flexed forward and weight on the left leg rather than evenly distributed. Reprinted with permission, Cleveland Clinic Foundation ©2022. All rights reserved.

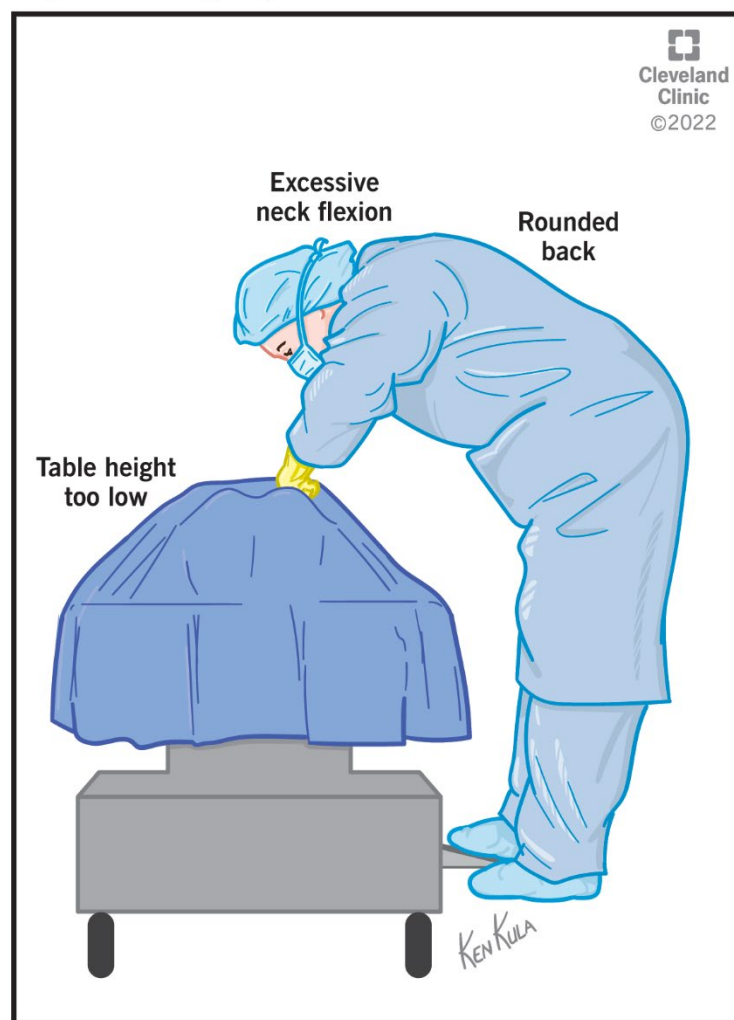
Open surgery - Incorrect

Appendix 3: This is a cartoon depiction of incorrect ergonomic open surgery. The surgeon is trunk flexion forward with excessive neck flexion. This is due to incorrect table height. Reprinted with permission, Cleveland Clinic Foundation ©2022. All rights reserved.

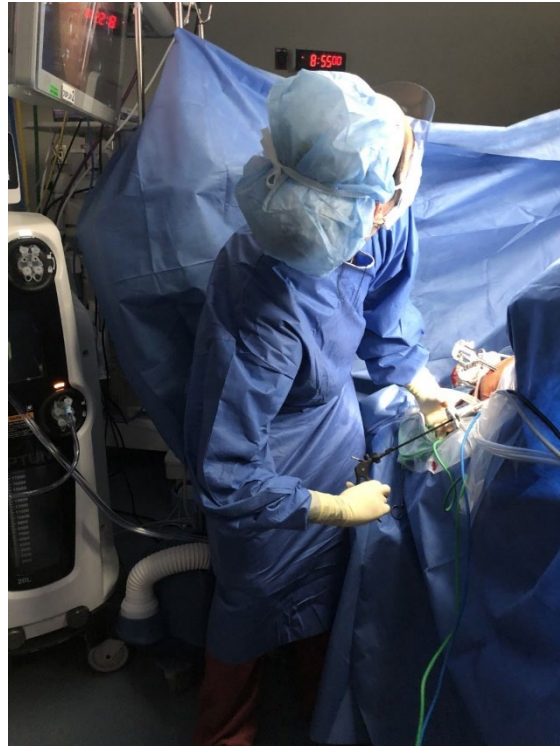
Appendix 4: This laparoscopic surgeon is excessively torqued with back flexion and neck extension, due to inappropriate table and monitor height.

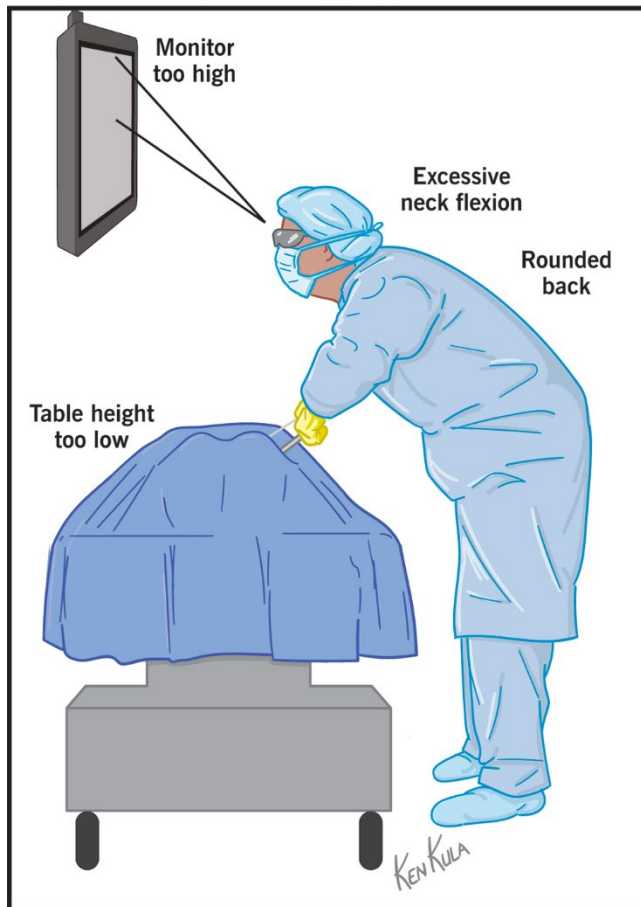
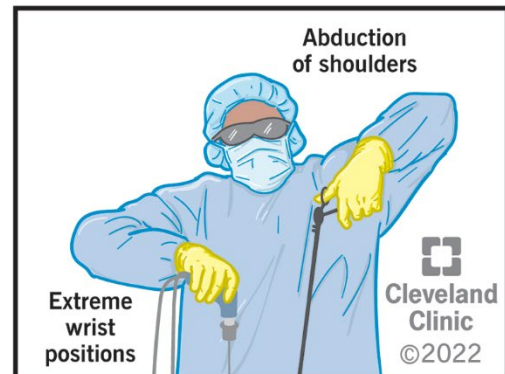
Laparoscopic surgery - Incorrect

Appendix 5: This is a cartoon depiction of incorrect ergonomic laparoscopy surgery. There is inappropriate screen and table heights causing neck extension and trunk flexion on the right. When correcting for inadequate trocar placement, the surgeon demonstrates shoulder abduction and extreme wrist movement for fulcrum effect. Reprinted with permission, Cleveland Clinic Foundation ©2022. All rights reserved.

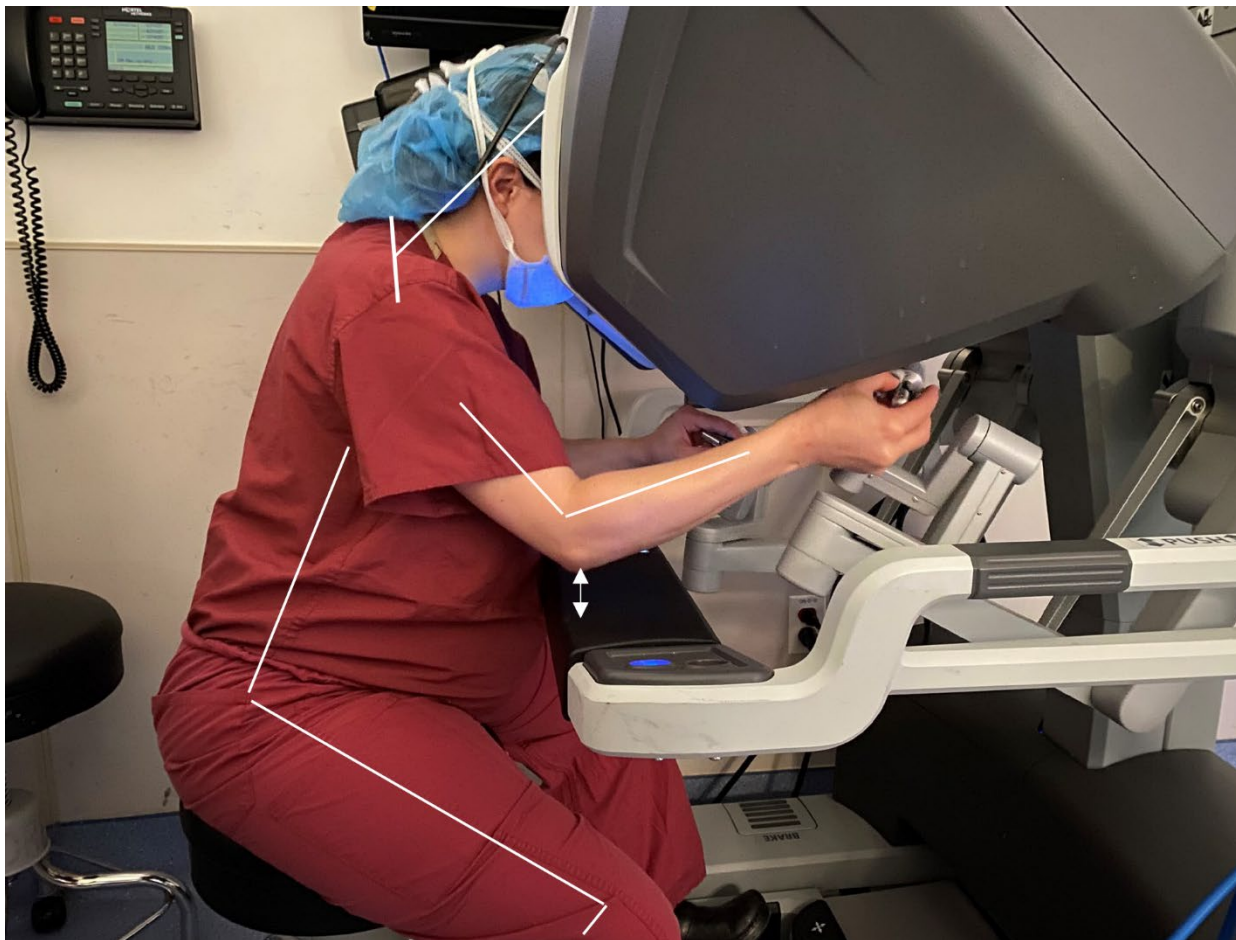
Appendix 6: This pregnant surgeon is pressing her forehead into the robotic console in excessive neck flexion, resulting in cervical strain. Her elbows are elevated off the armrest, resulting in lack of support for the elbows and shrugging of the shoulders, which causes neck muscle strain. The elbows should rest on the platform, at a 90–120° angle, with the shoulders relaxed. There is no back to the stool, resulting in back flexion and lumbar disc strain. The height of the stool and the foot console platform are inappropriately low. The angle of the hips and the knees should be perpendicular, in order to maintain the neutral position. The stool should be in the locked position, or have a rolled blanket behind the stool wheels, in order to prevent the surgeon from inadvertently pushing away from the console during surgery.

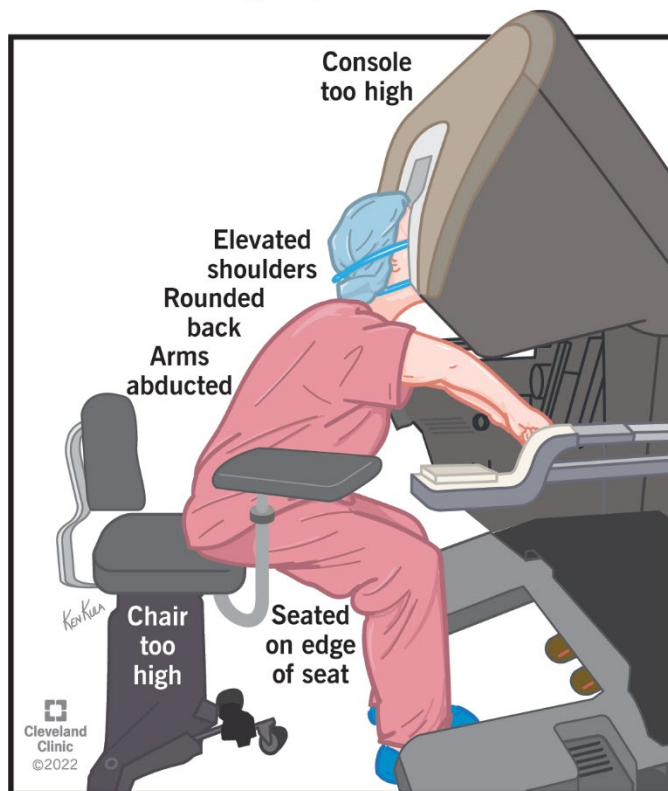
Robotic surgery - Incorrect

Appendix 7: This is a cartoon depiction of incorrect ergonomic positioning of a robotic surgeon. The chair is too high, preventing the robotic surgeons' knees to be in a 90° position. The surgeon is seated on the edge of the seat, often leading to numbness of the legs at the end of the case. Shoulders are abducted while trunk is flexed. The neck is extended due to high viewing from the console. Reprinted with permission, Cleveland Clinic Foundation ©2022. All rights reserved.
