Copyright © by The Journal of Bone and Joint Surgery, Incorporated Lazaro et al. Outcomes After Operative Fixation of Complete Articular Patellar Fractures: Assessment of Functional Impairment http://dx.doi.org/10.2106/JBJS.L.00012 Page 1 of 2

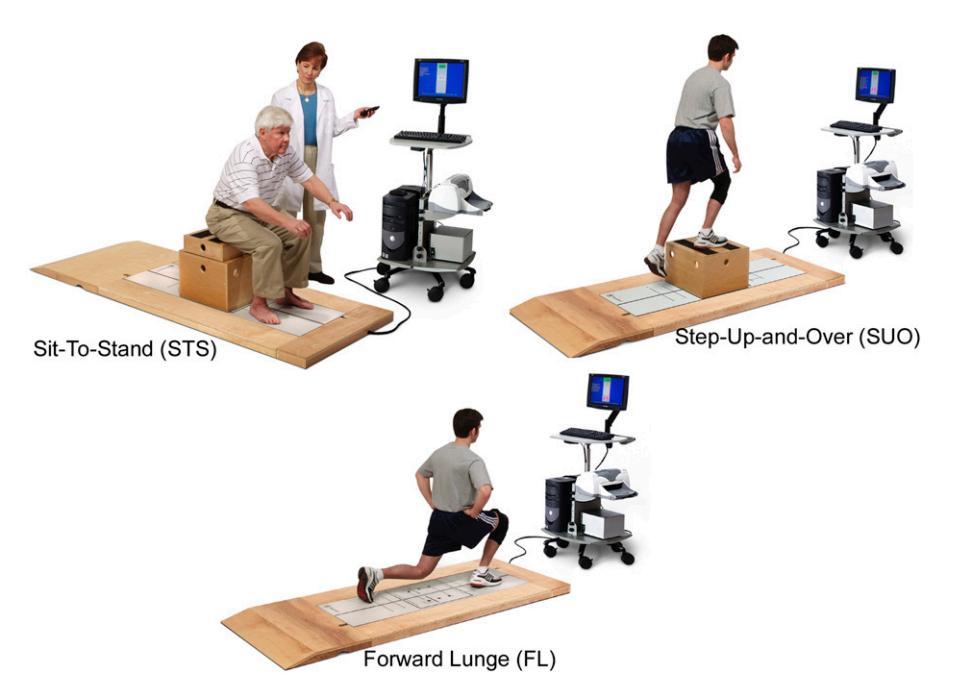
Fig. E-1

The Balance Master system (Long Force Plate; NeuroCom International) was used for closed kinetic chain functional testing, with use of the three tests pictured. (Reprinted with permission of Natus Medical, Inc.)

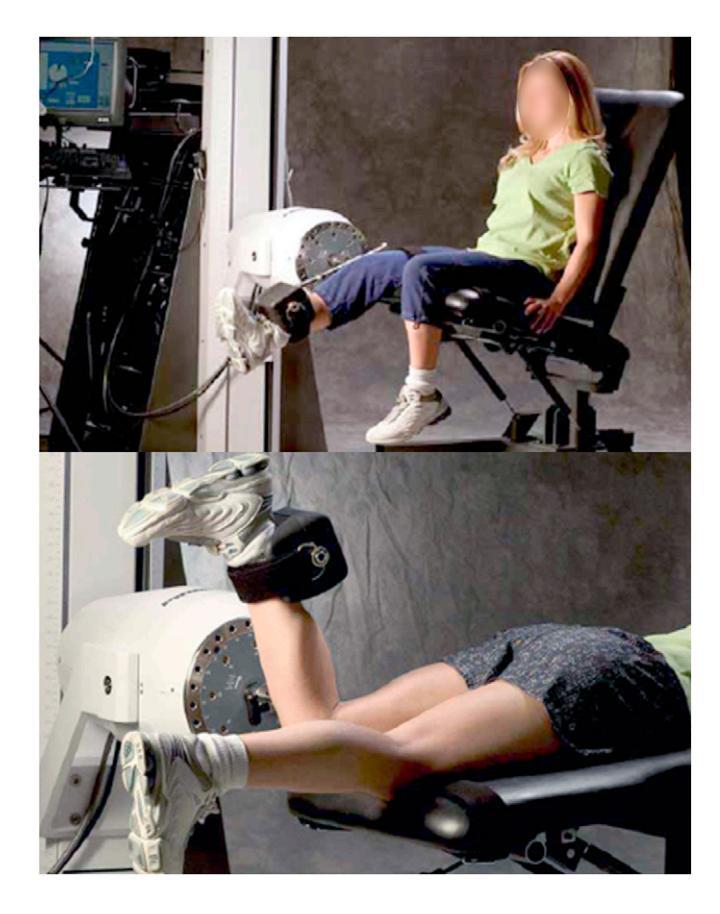
Fig. E-2

The BTE PrimusRS system was used for open kinetic chain muscle performance testing. Quadriceps performance was assessed with the patient seated (top image), and hamstring performance was assessed with the patient prone (bottom image). (Reprinted with permission of BTE Technologies, Inc.) Copyright © by The Journal of Bone and Joint Surgery, Incorporated Lazaro et al. Outcomes After Operative Fixation of Complete Articular Patellar Fractures: Assessment of Functional Impairment http://dx.doi.org/10.2106/JBJS.L.00012 Page 2 of 2

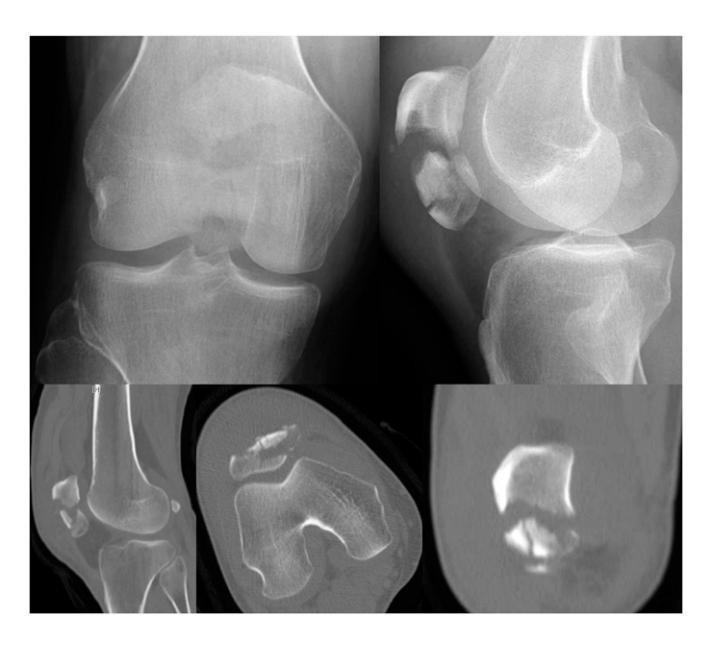
Fig. E-3A

Anteroposterior and lateral radiographs of a sixty-three-year-old woman who presented with a severe patellar fracture (AO/OTA type 34-C3.2) following a fall from a standing height. Severe comminution involving the distal pole was better visualized with computed tomographic scanning.

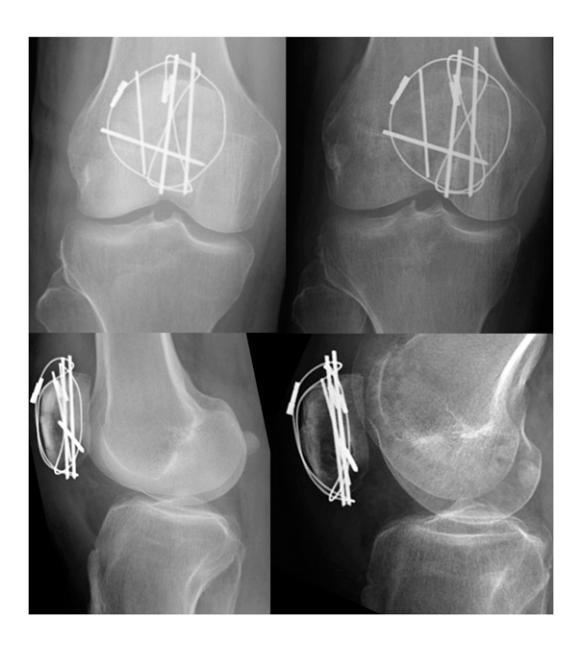
Fig. E-3B

Left images Immediate postoperative anteroposterior and lateral radiographs illustrate acceptable reduction and hardware placement; ORIF was performed with a tension-band construct and supplemental circumferential cerclage wiring. **Right images** Anteroposterior and lateral radiographs made at one year illustrate a healed patellar fracture with maintenance of reduction and joint congruency.
