Copyright © by The Journal of Bone and Joint Surgery, Incorporated Zelle et al. Primary Arthrodesis of the Tibiotalar Joint in Severely Comminuted High-Energy Pilon Fractures http://dx.doi.org/10.2106/JBJS.M.00544 Page 1 of 2

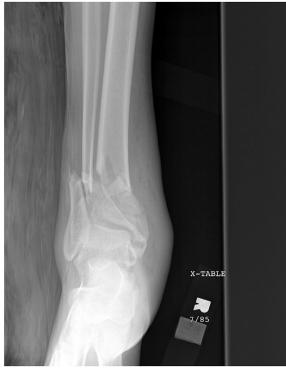
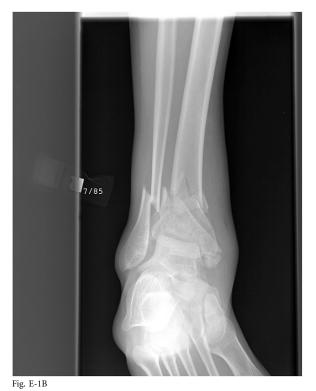
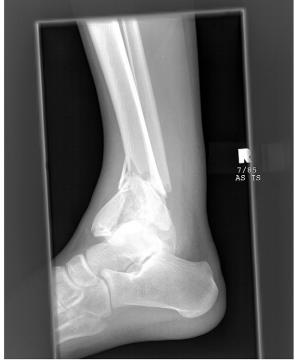
Fig. E-1A

Figs. E-1A through E-1F Radiographs and CT scan of the ankle. Figs. E-1A through E-1C Preoperative radiographs with anteroposterior, mortise, and lateral views of the ankle. Fig. E-1D CT scan demonstrating a comminuted pilon fracture with severe articular impaction.

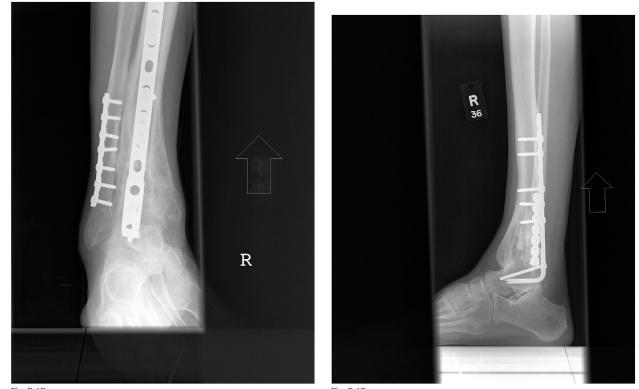
Fig. E-1E Fig. E-1F Figs. E-1F Figs. E-1F Postoperative radiographs demonstrating consolidated tibiotalar arthrodesis at the 5.5-year follow-up.
