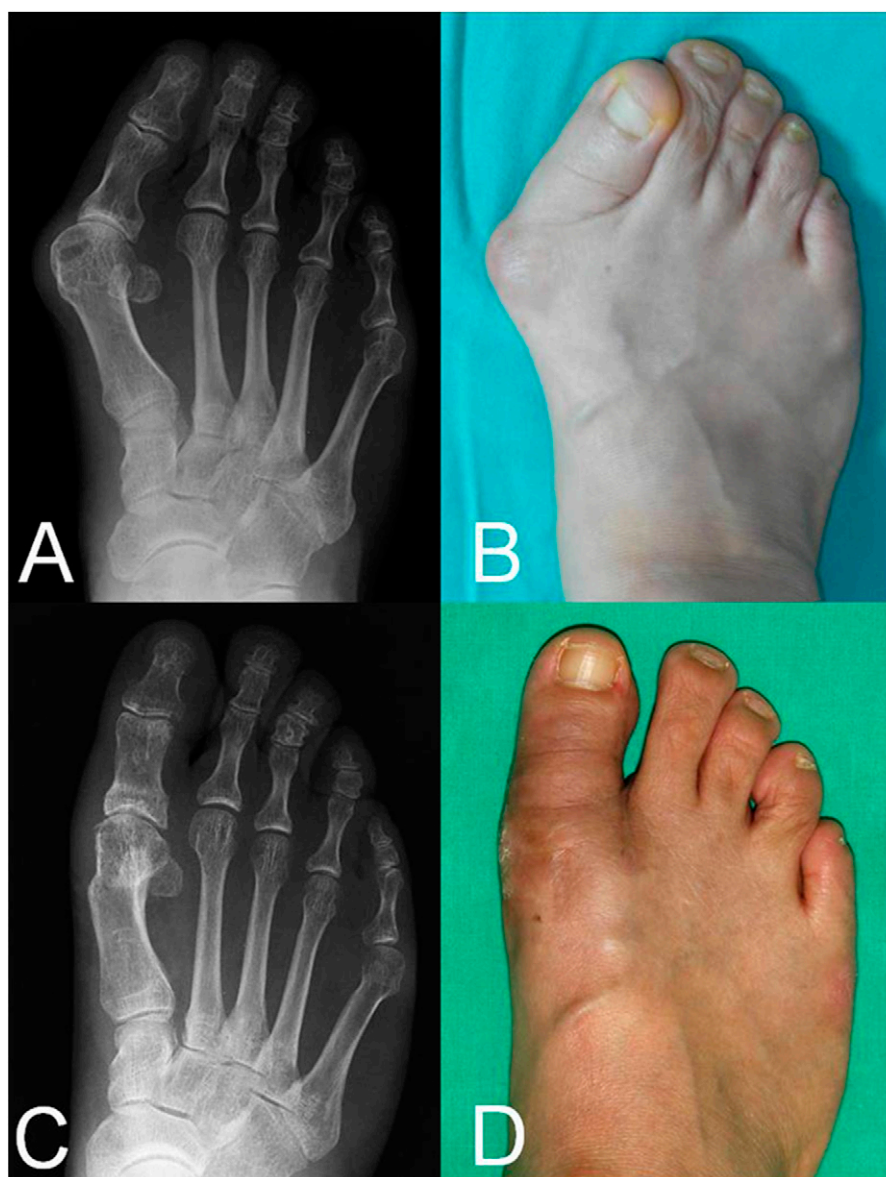
Fig. E-1

Figs. E-1A through E-1D Clinical photographs and radiographs of the right foot of a fifty-eight-year-old woman with severe hallux valgus deformity who underwent a distal chevron osteotomy with a distal soft-tissue release through the dorsal first web-space approach. **Fig. E-1A** Preoperative radiograph showing a hallux valgus angle of 42° , a first-second intermetatarsal angle of 18° , and a grade-3 tibial sesamoid position. **Fig. E-1B** Preoperative clinical photograph. **Fig. E-1C** Postoperative radiograph at the time of final follow-up, showing a hallux valgus angle of 12° , a first-second intermetatarsal angle of 6° , and a grade-2 tibial sesamoid position. **Fig. E-1D** Clinical photograph at the time of final follow-up.
