TABLE E-1 Summary of Results after Arthroplasty of the Proximal Interphalangeal Joint with a Pyrolytic Carbon Implant

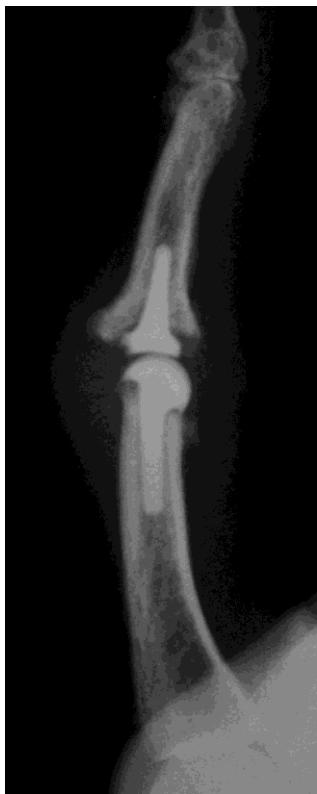
Fig. E1-A Immediate postoperative radiograph showing good alignment in the sagittal plane.

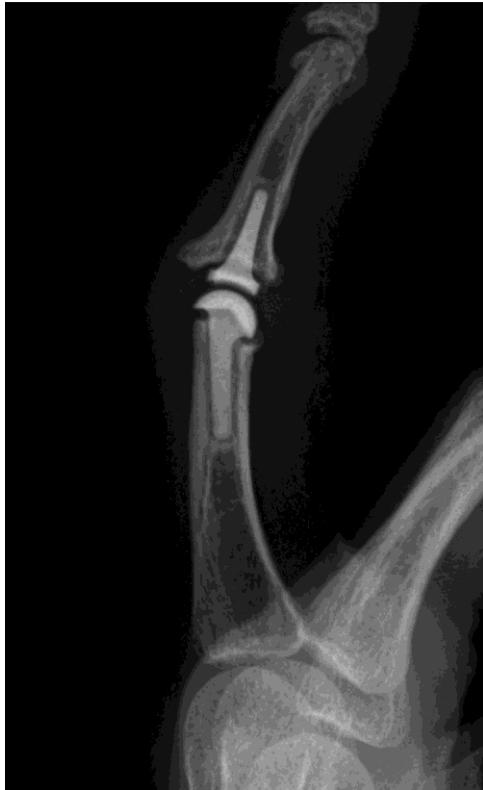
Fig. E1-B Radiograph, made fourteen months postoperatively, showing good alignment, with progressive radiolucency around the implants both proximally and distally.

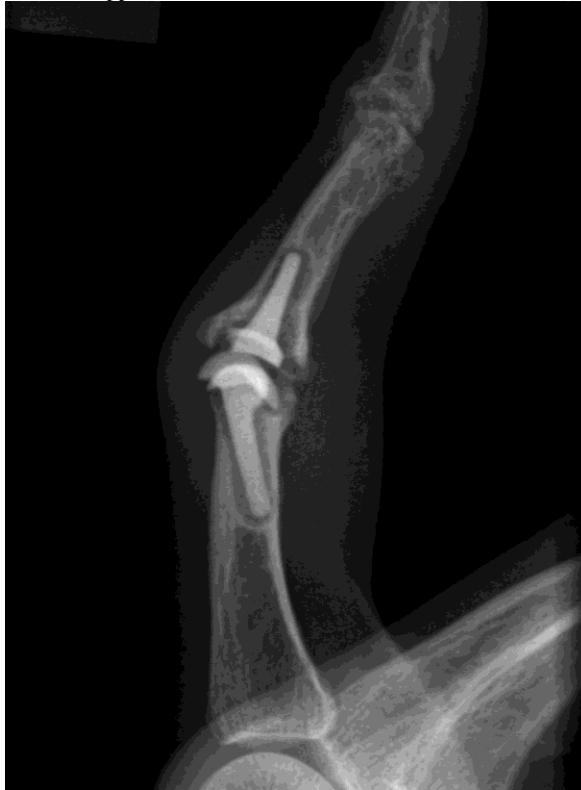
Fig. E1-C Radiograph, made forty-one months after surgery, shows grade-2 migration of the proximal implant and both implants with progressive periprosthetic radiolucency.
