Fig. E-1
The cementless Oxford unicompartmental knee replacement.

TABLE E-1 Radiographic Outcomes at One, Two, and Five Years

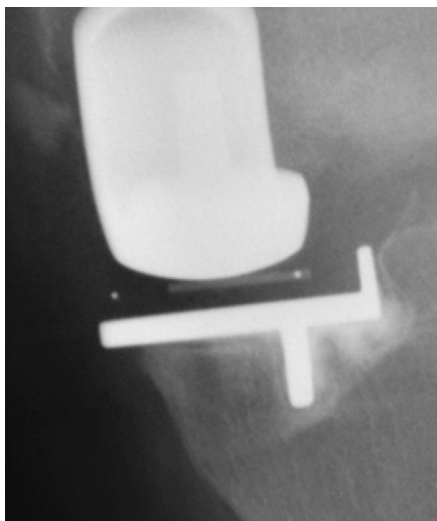
Fig. E-2A

Radiolucencies associated with a cemented prosthesis (partial radiolucency in **Fig. E2-A** and complete radiolucency in **Fig. E2-B**) and a cementless prosthesis (partial radiolucency in **Fig. E2-C**). This is the most marked radiolucency in any of the cementless cases.
