# Association of Near-Track Lesions with Arthroscopic Anterior Shoulder Stabilization

On-Track Lesions with a Small Distance to Dislocation Are Associated with Failure After Arthroscopic Anterior Shoulder Stabilization

Li et al. (2021) | DOI: 10.2106/JBJS.20.00917

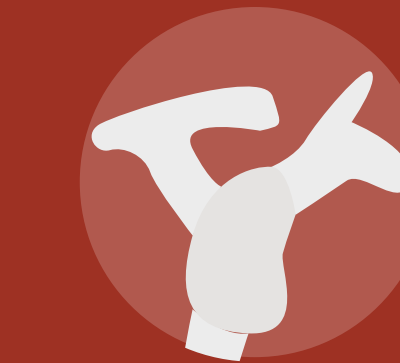
Glenoid bone loss

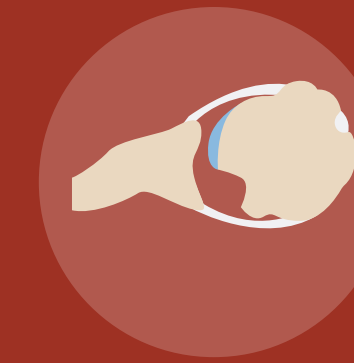
Hill-Sachs lesion length

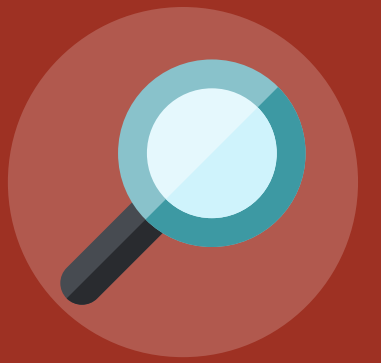
DTD

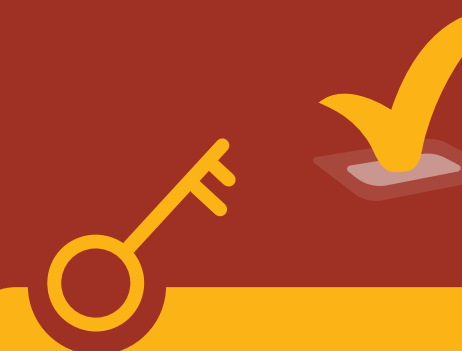
Critical DTD threshold of 8 mm could best predict failure

A near-track lesion with a DTD of <8 mm may be predictive of failure following arthroscopic Bankart repair
